Hit 9 – Air Defense Forward

Hit 10 – Starboard Structural Bulkhead at Frame 82

Hit 11 – Strike on Shell near Frame 83

Hit 12 – Sky Control

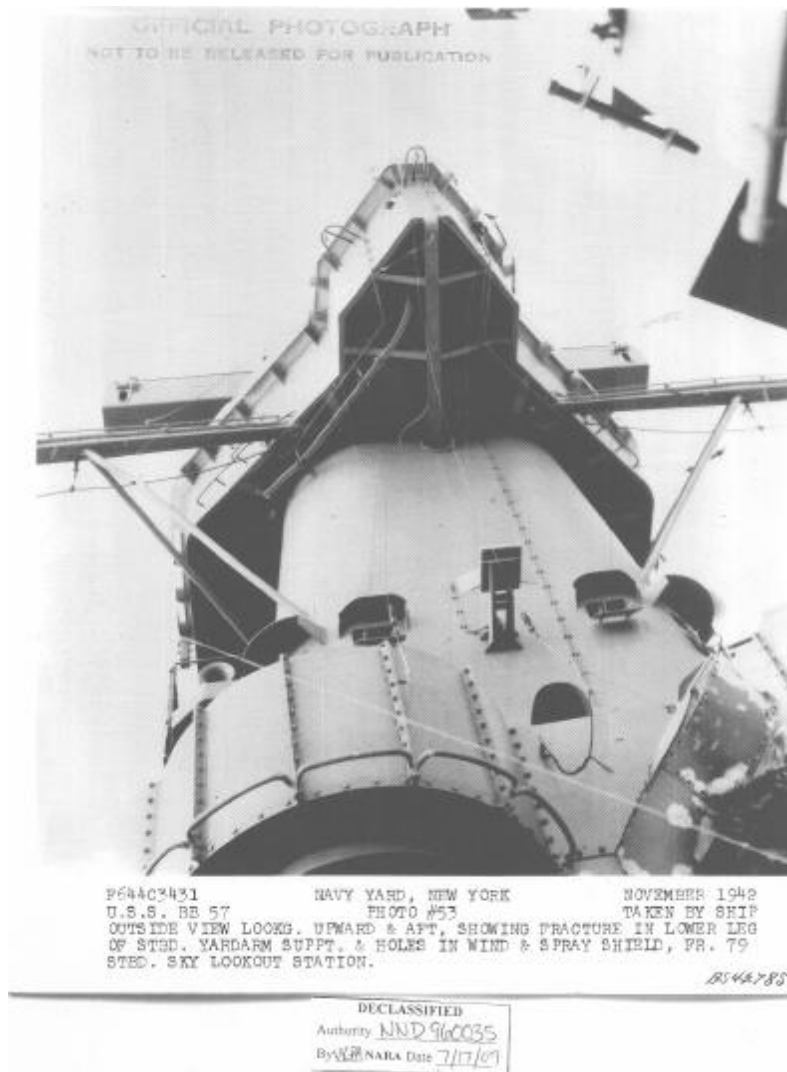
Figure 28 – Hit 9 – Sky Lookout Station

23. The wind and spray shield around air defense forward at frame 79 had one hole on the starboard side and two holes on the port side. It is possible that the two holes on the port side were caused by different projectiles. However, it appears more likely that the cap head of an 8-inch AP projectile broke off upon hitting the starboard side of the windshield and made the second hole in the port side of the windshield. Apparently the projectile or projectiles did not detonate.⁴⁹

Forward centerline section of wind and spray shield around search radar demolished. 3-17” holes.⁵⁰

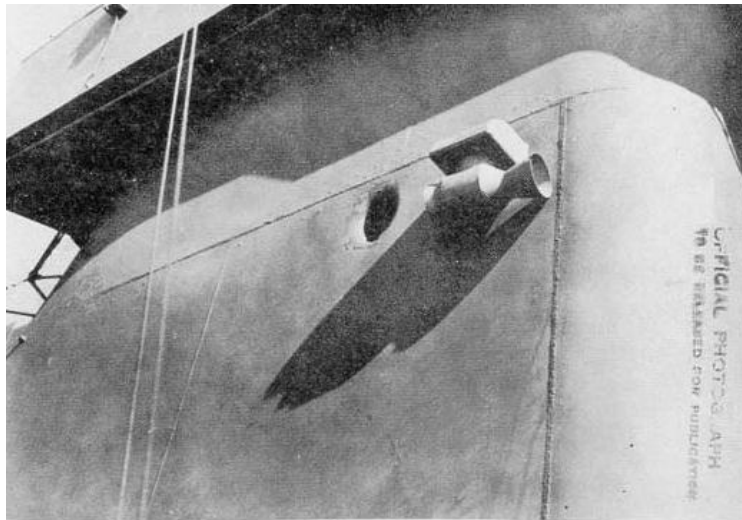
Figure 31 – Hit 10 – Entry Hole

24. A 10-inch hole was pierced in the starboard longitudinal structural bulkhead at frame 82 about 7 feet above the house top. The centerline bulkhead had a 10-inch hole about 30 inches above an 8-inch hole at frame 83. The port longitudinal structural bulkhead had a 10 inch hole about 6 feet above the first level above the house top at frame 84 and a 10 inch by 3 inch hole at the deck level. These holes were reported to have been caused by an 8-inch and a 5-inch projectile. It appears more probable that an 8-inch AP projectile cap head broke off the projectile upon penetrating the starboard bulkhead and made a second hole in the center line and port bulkheads, while the intact projectile made only one entry hole in the starboard bulkhead. The access ladders to the second level above the house top were damaged, and ventilation ducts demolished, but there is little evidence of a detonation associated with this hit.⁵²

1 10" shell hole through structural bulkhead and bulkhead stiffener, 6' above deck level, frame 82 starboard.
Web of I beam frame 83 twisted and distorted 6' inboard of starboard side.
10" x 8" hole in centerline bulkhead, frame 83. Arch reinforcement twisted and broken.
Gas radar tube fractured.
Access ladder from 06 to 07 level demolished.
Vent duct exhaust peppered with small bits of shrapnel.
Coil spring tensioning device and brackets for watertight hatch 07-84-1 demolished.
Natural vent exhaust duct through forward transversal structural bulkhead in #1 radar storeroom demolished.
Supply vent duct demolished in B-103L, 06 level.
Access ladder from 06 to -7 level demolished.
Tensioning device and brackets for watertight armored hatch 07-84-2 twisted and inoperative.
3/4" circulating cooling water pressure gage and booster pump severed and demolished.
W.R.S.R.⁵³ 0601. 2 1" holes in steel battle port.

Photo 13: Point of entry of hit No. 10 in starboard longitudinal bulkhead.

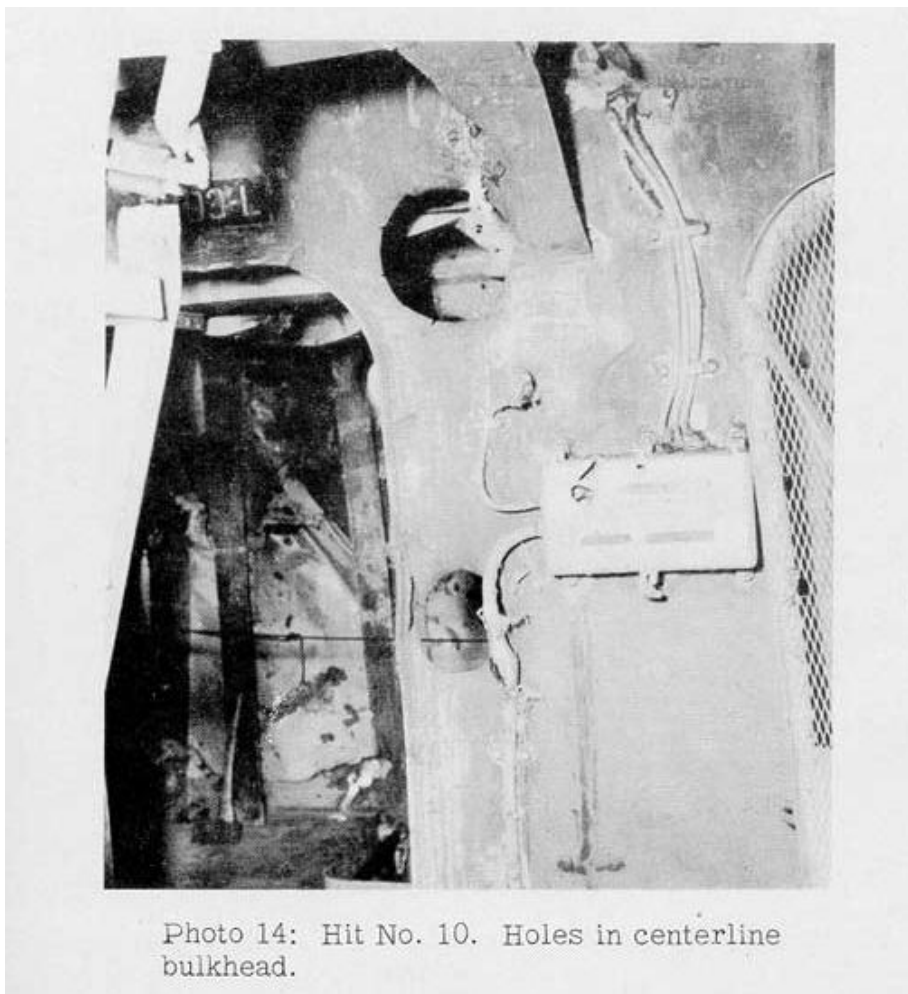
Figure 32 – Hit 10 – Centerline Bulkhead Damage

Photo 14: Hit No. 10. Holes in centerline bulkhead.

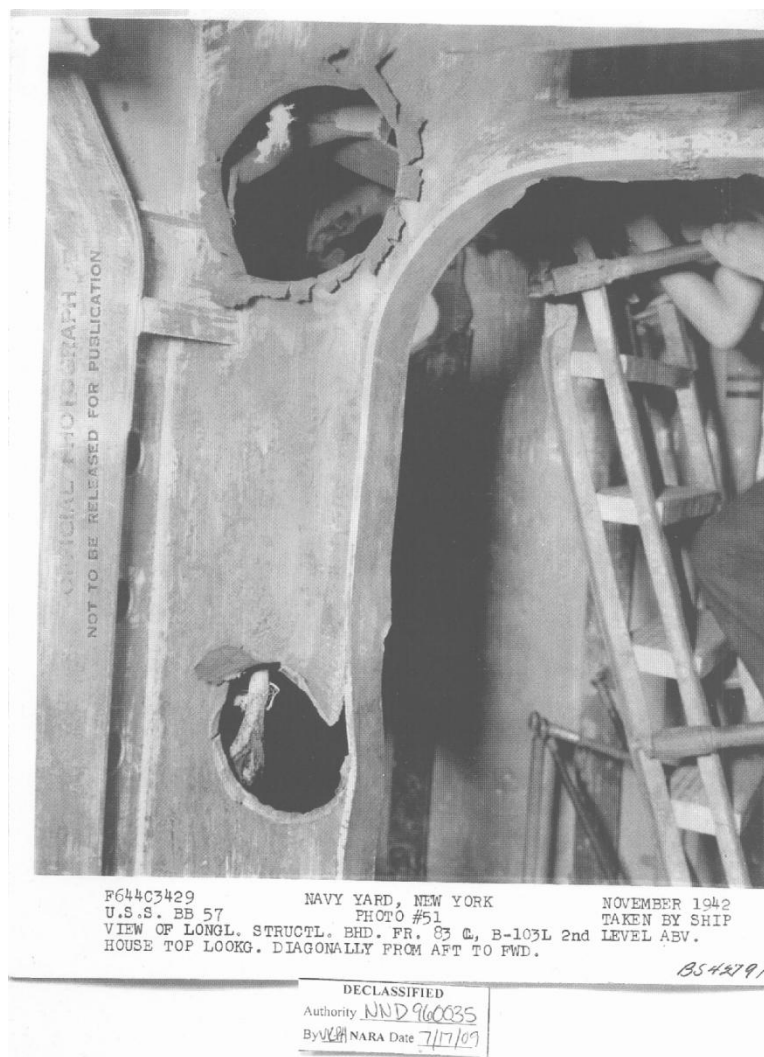
Figure 33 – Hit 10 – Longitudinal Structural Bulkhead Damage

There are no inconsistencies with BuShips' estimate of an 8-inch AP projectile. At high velocity, the rather blunt end of this kind of shell (flat if the cap head is gone) would shear out very thin plating more like a paper punch than a wedge, keeping the hole narrow with only some minimal widening around the hole as the plate bent back in a ring of truncated petals around the hole (the center area of the plate under the nose that usually forms the upper end of the petals in a pointed-nose impact is sheared off as a disk/plug; round if at right angles, oval otherwise). A 5-inch hole for the cap head sounds about right, though it cannot penetrate much due to its light weight – perhaps an inch of steel, but that would stop it. The timing of this hit is unknown.

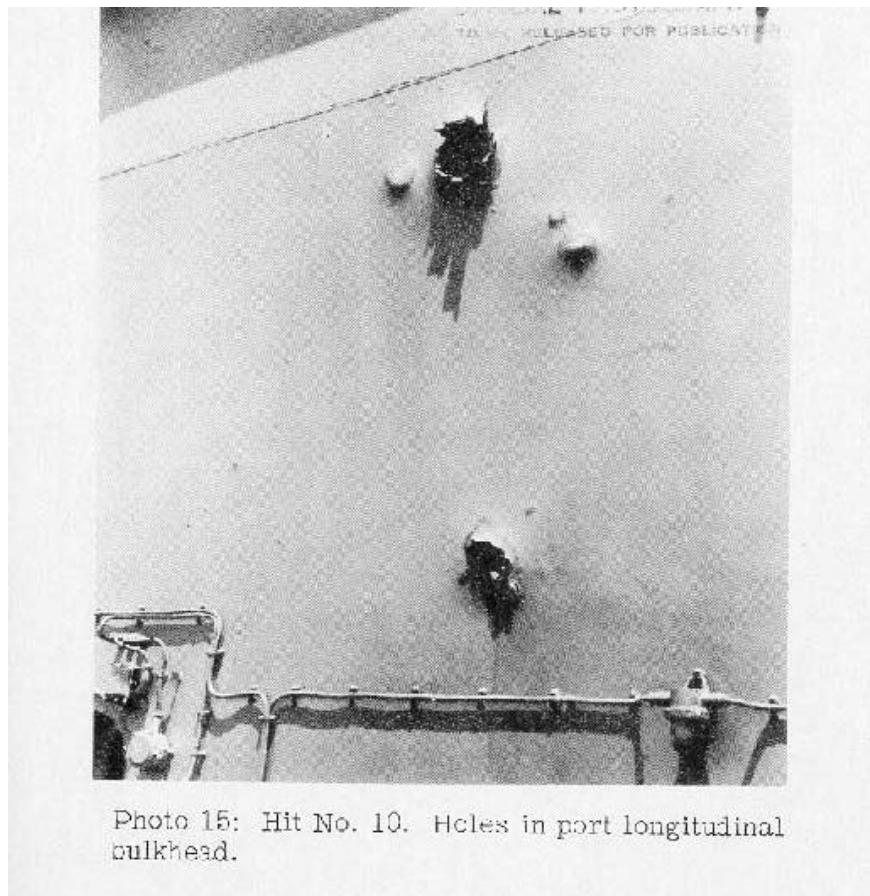
Figure 34 – Hit 10 – Port Longitudinal Bulkhead

10" hole 6' above deck level and frame 83 port.
1 bulkhead stiffener 8" torn and distorted throughout length.
Shrapnel hole 10" x 3" at deck level.
Insulation and sheathing on port longitudinal bulkhead entirely demolished.⁵⁴

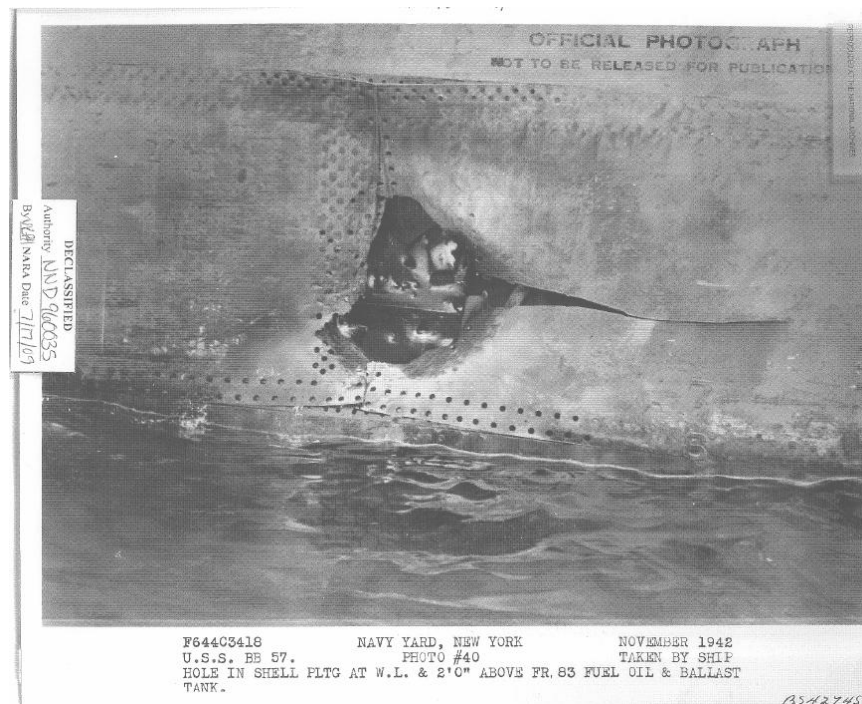
Figure 35 – Hit 11 – Damage to Shell Plating near Frame 83

25. An estimated 5 or 8-inch projectile detonated upon contact with “N” strake of the shell just aft of frame 83 between the second and third deck levels. A hole about 3 by 2 feet was blown in the shell and torpedo bulkhead No. 2 was holed in numerous places by fragments. A tear in the shell plating extended forward to about frame 81-1/2. The rivets in the “N” strake were loose or missing between frames 82-1/2 and 84-1/2. Transverse bulkhead 83 was ruptured and distorted between the shell and torpedo bulkhead No. 2 from the second deck to the third deck. As a result of this hit tanks B-23-F, B-31-F, and B-39-F were flooded.⁵⁵

The STS plate at this point was 1.25 inches thick. The long tear in the plate to the right implies that the projectile hit at a quite high velocity and was coming from the right at a rather high angle of obliquity (about 45 degrees or so from the normal). The detonation blast split the plate, possibly due to a pre-existing lamination or other weakness (the crack is very straight and probably is parallel to the rolling direction used when the plate was manufactured). There are few deep pits in the plate around the big hole, although there are no other holes other than those made by torn-out rivets and bolts. The hit was up against a vertical seam between two of the STS plates where the plates are reinforced by doubling plates and straps and braced from behind by girders, using rather a lot of rivets and bolts. A number of large holes, tears and folds were made in the thin bulkhead representing the upward continuation of the first inboard anti-torpedo bulkhead in front of the armor belt, most probably by chunks of the 1.25-inch hull armor punched out by the projectile impact.

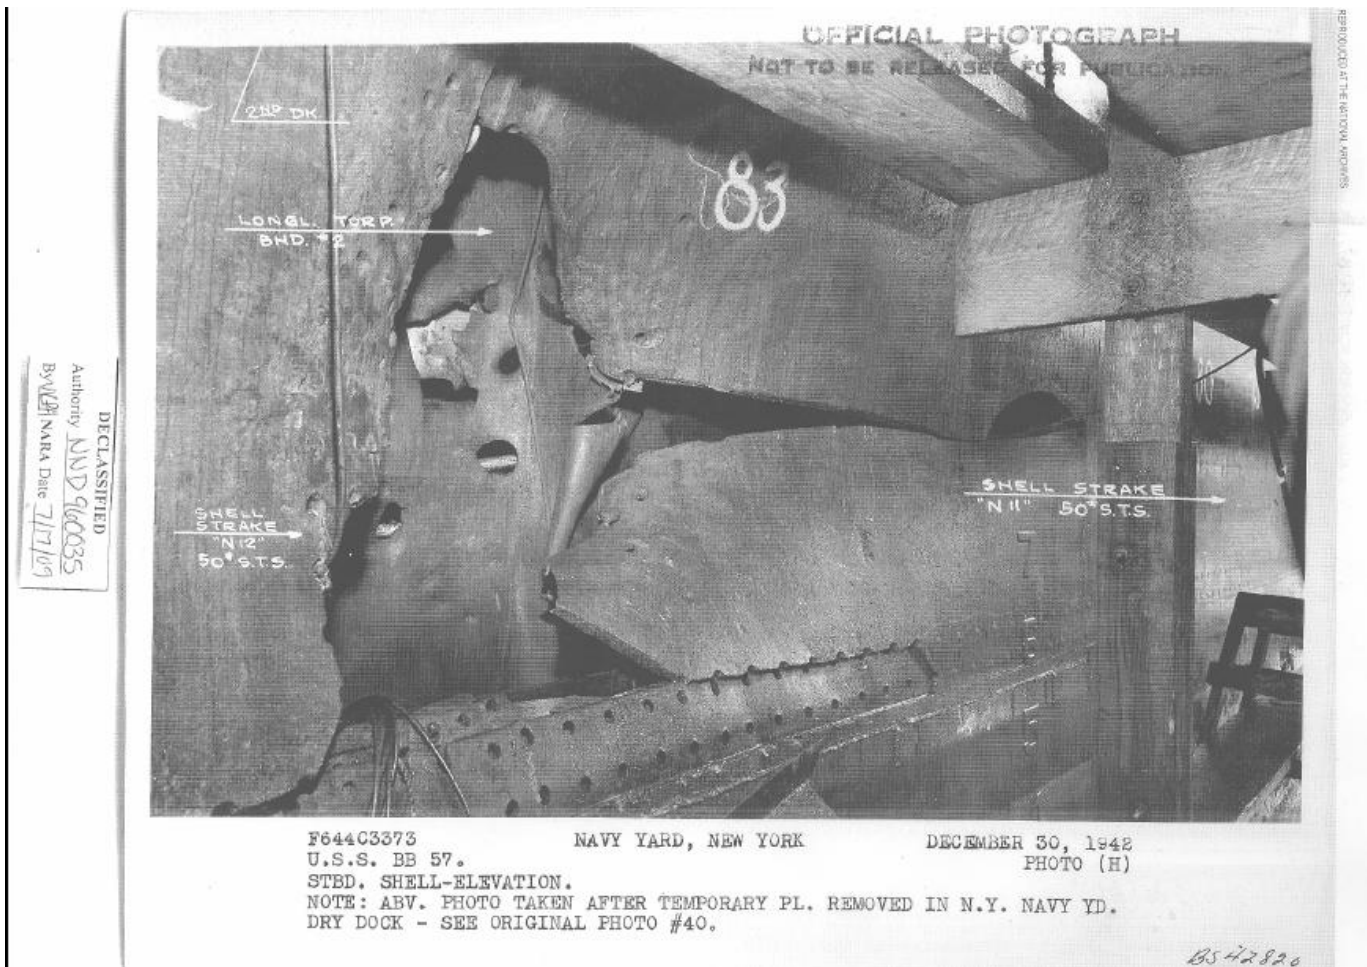
Figure 37 – Hit 11 – Close-up of Damage to Shell Plating

This is extremely close to the 3 foot hole documented in South Dakota's damage report. Thus, the best estimate for this damage is that it was made by a 14-inch Type 0 HE shell.

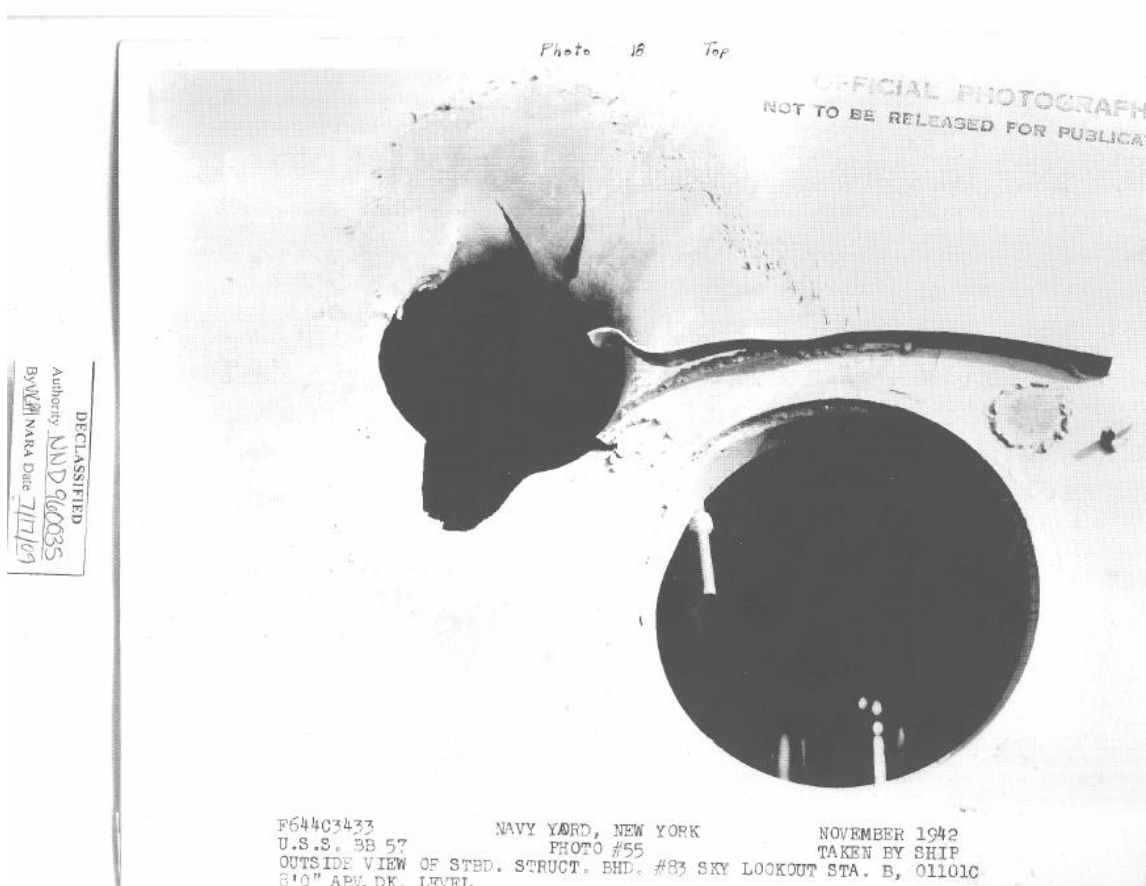
Figure 39 – Hit 12 – Entry Hole

26. Another projectile, probably 8-inch AP, hit frame 83-1/2 about 8 feet above the deck of air defense forward. The projectile passed through two 60-pound STS bulkheads and shattered the top of the port spray shield at about frame 84 without detonating. Two 3-inch fragment holes were blown in the director tube.⁵⁶

Sky Control – 10" shell hole through 1¼" STS bulkhead frame 83 starboard.

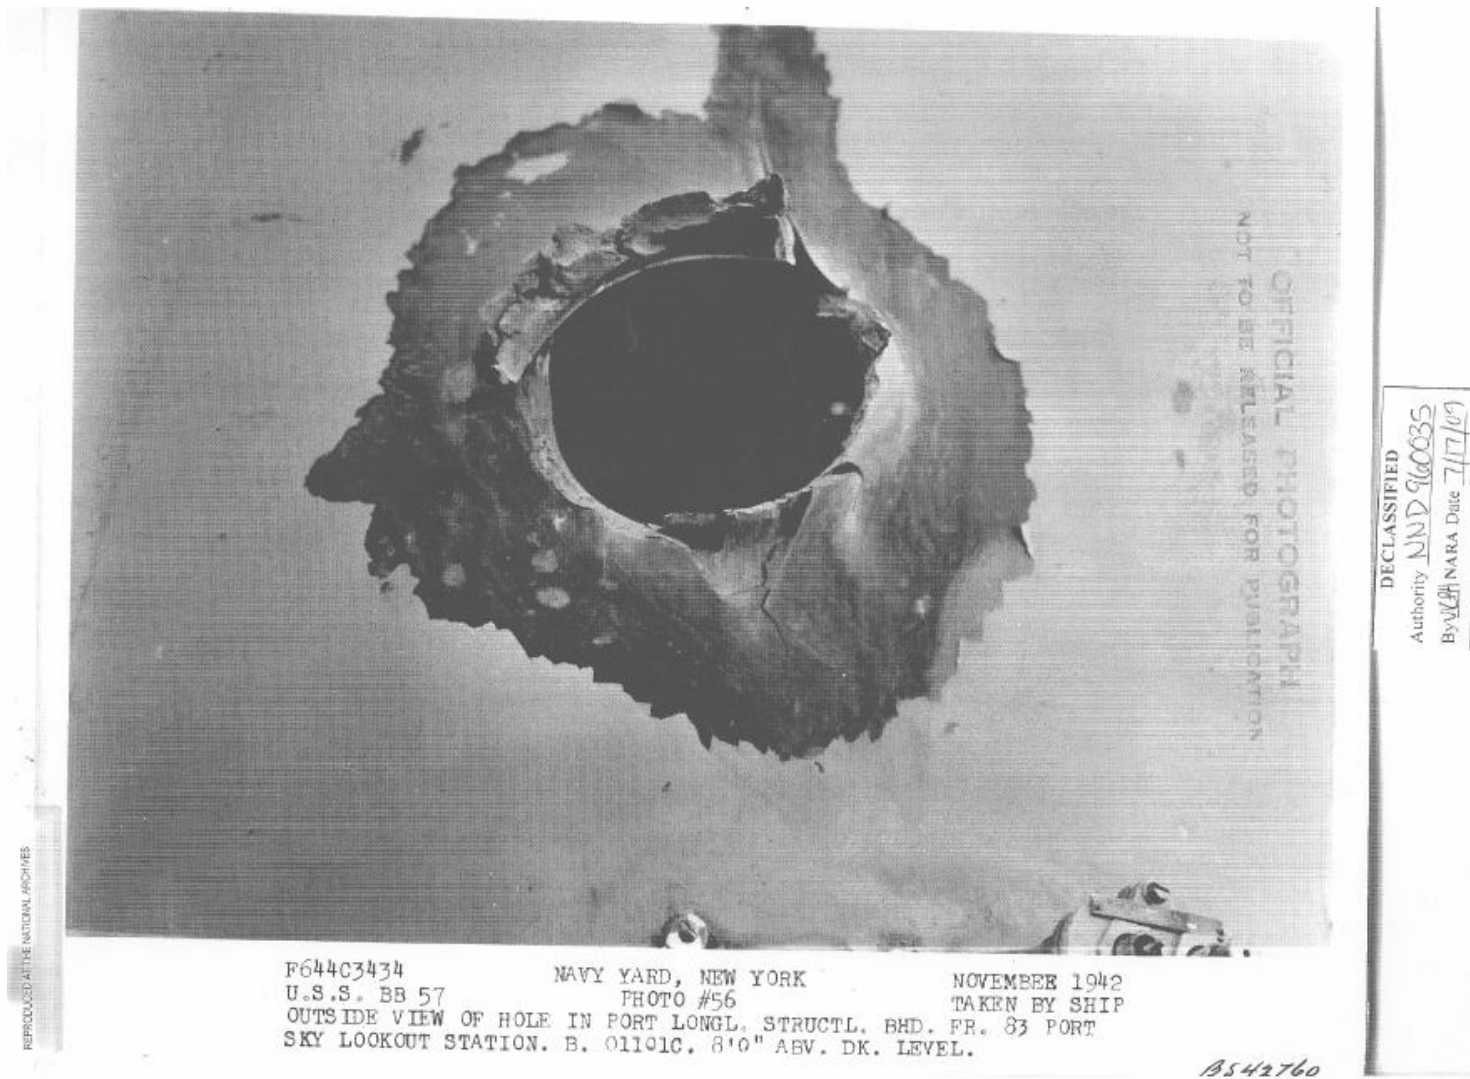
Figure 40 – Hit 12 – Exit Hole

10" hole through 1¼" STS bulkhead frame 83½ port.

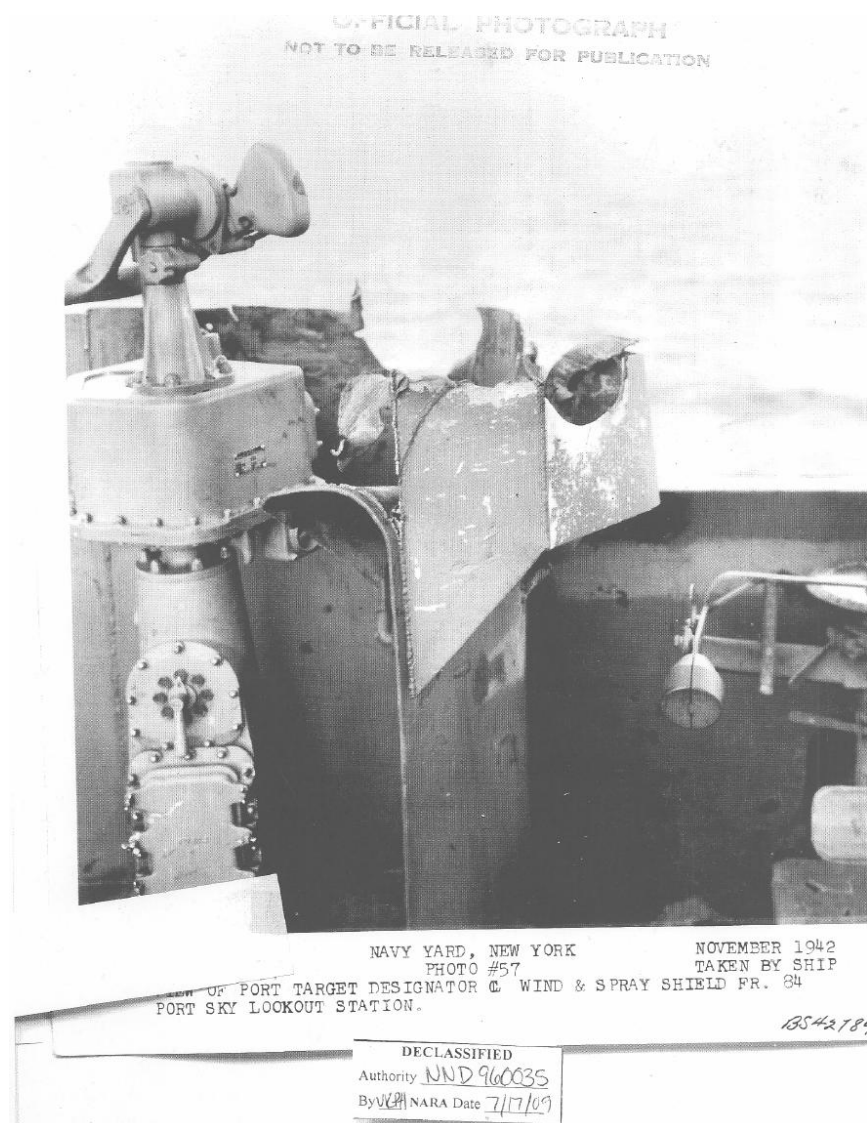
Figure 41 – Hit 12 – Damaged Area

This station received three direct hits, two 8" and one 6", none exploded.
Damage follows:-
JY selector switch inoperative.
20MC and 21MC speakers destroyed.
Five telephone cables out to director 1.
Director tube pierced cutting 23 cables.
Battle ports carried away.
Electric heater destroyed.
Port target designator damaged.
5JP selector switch damaged.
Numerous cables cut, and lookout seat damaged.⁵⁹

around between 0052 and 0055 (see Figure 69). *Takao* will be the first heavy cruiser to open fire at 0102, long after this damage is documented to have occurred.⁶¹ Therefore, the best estimate for this damage is that it is from a dud 5.5-inch base-fuzed projectile fired by one of the light cruisers.
