## **Hits 13, 14 and 15 – Radar Plot and Transverse Passages**

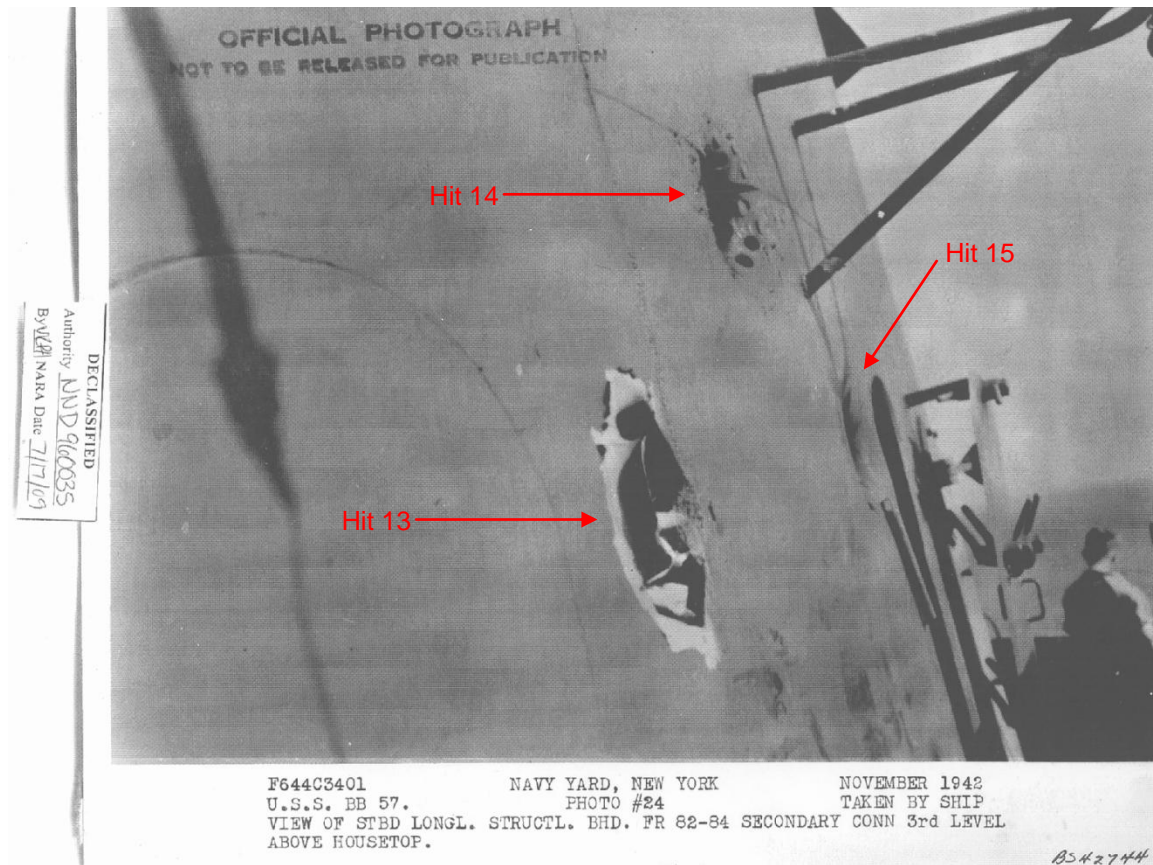
**Figure 42 – Hits 13, 14 and 15 – Entry Holes – View A**

In looking at the entry holes shown in Figure 42, the hole created by Hit 13 is visibly larger than the other two and is 18 inches in diameter. Referencing the sketch in Figure 53, this impact occurred at point (A) and this shell then blew a 36-inch hole in the centerline bulkhead (D) and began to break up. The door

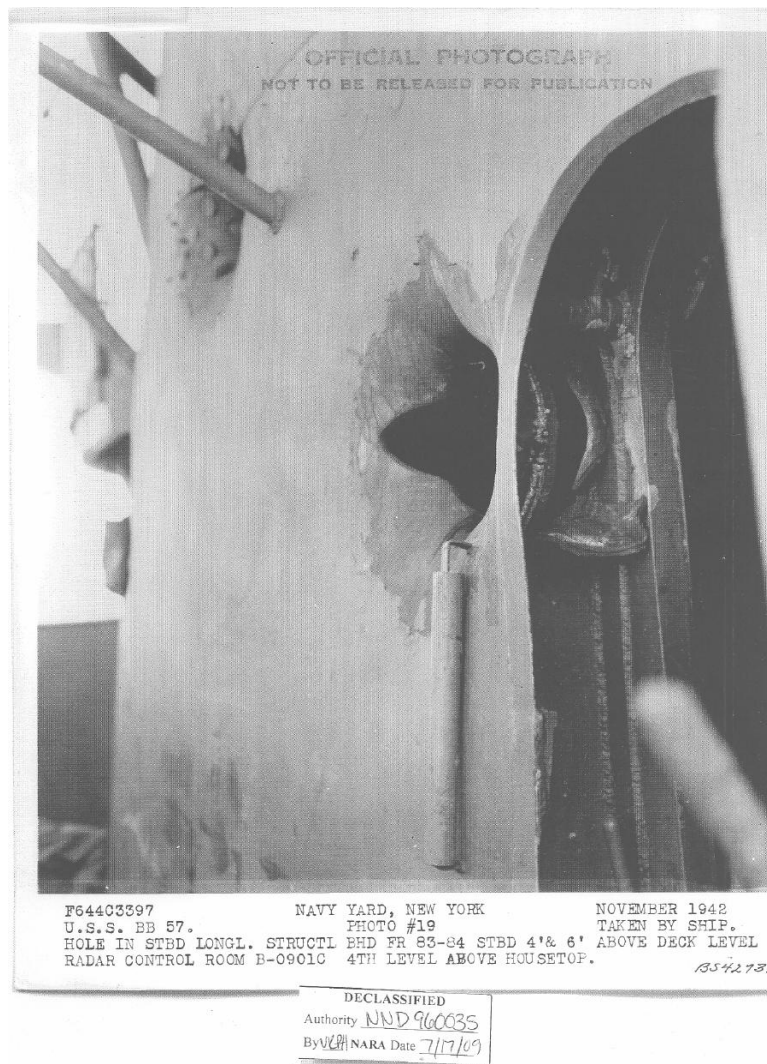
Figure 43 – Hits 14 and 15 – Entry Holes – View B

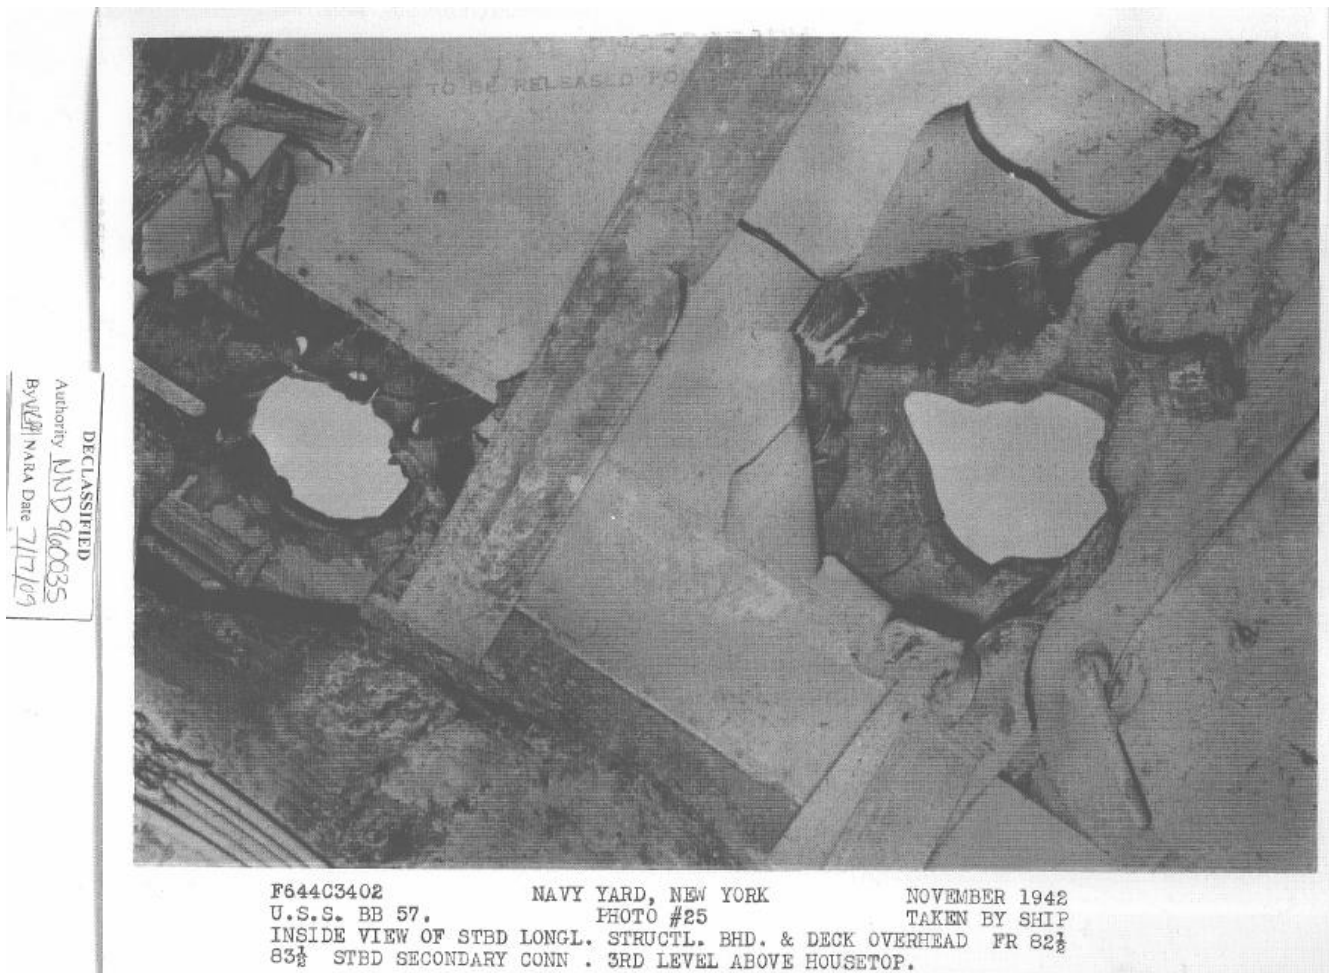
Figure 44 – Hits 14 and 15 – Reverse view of Entry Holes

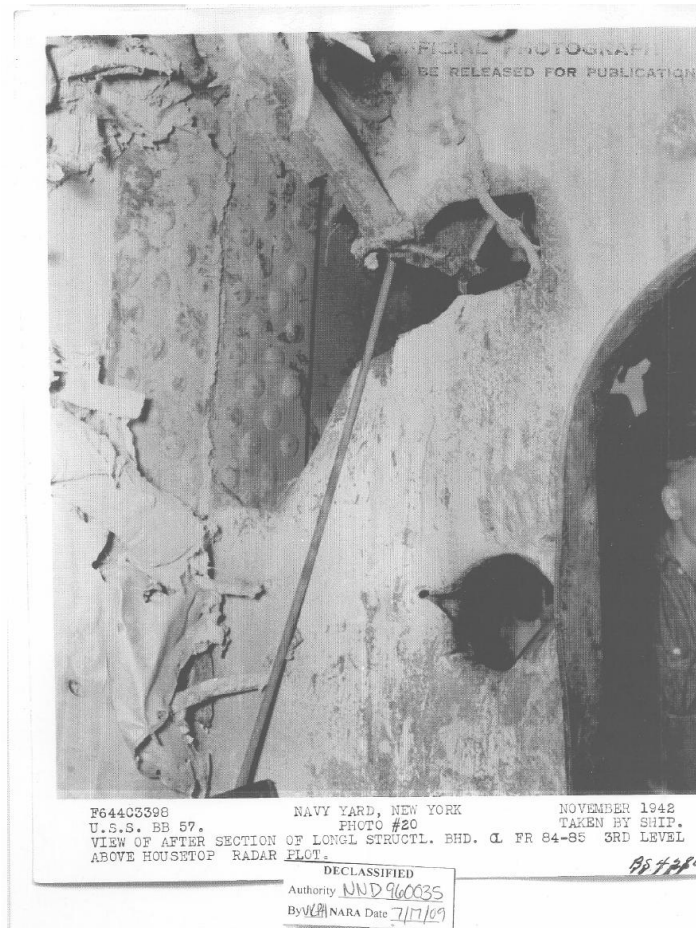
Figure 45 – Hits 13, 14 and 15 – Internal Damage – View A

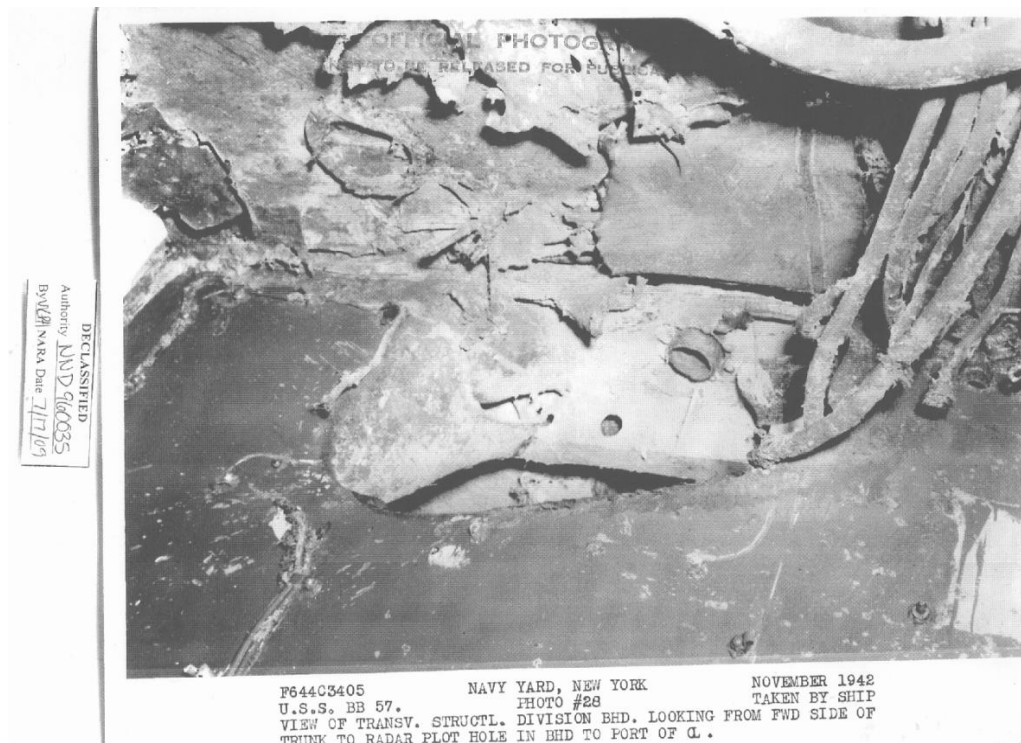
Figure 46 – Hits 13, 14 and 15 – Internal Damage – View B

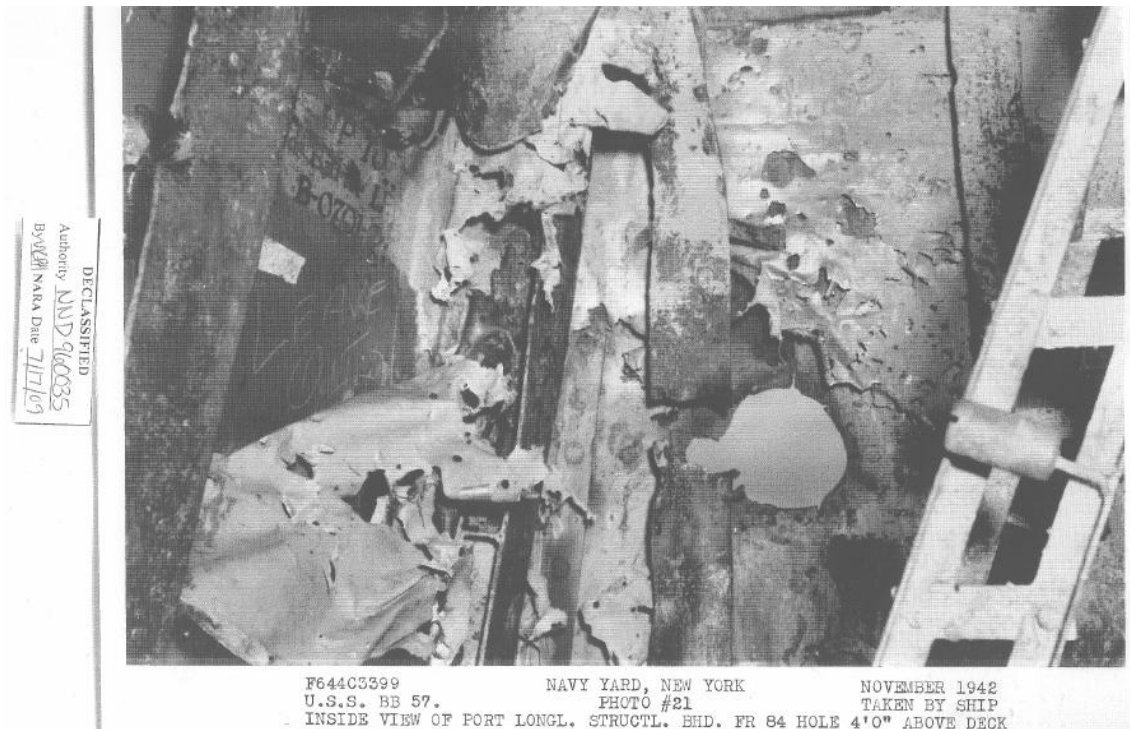
Figure 47 – Hits 13, 14 and 15 – Internal Damage – View C

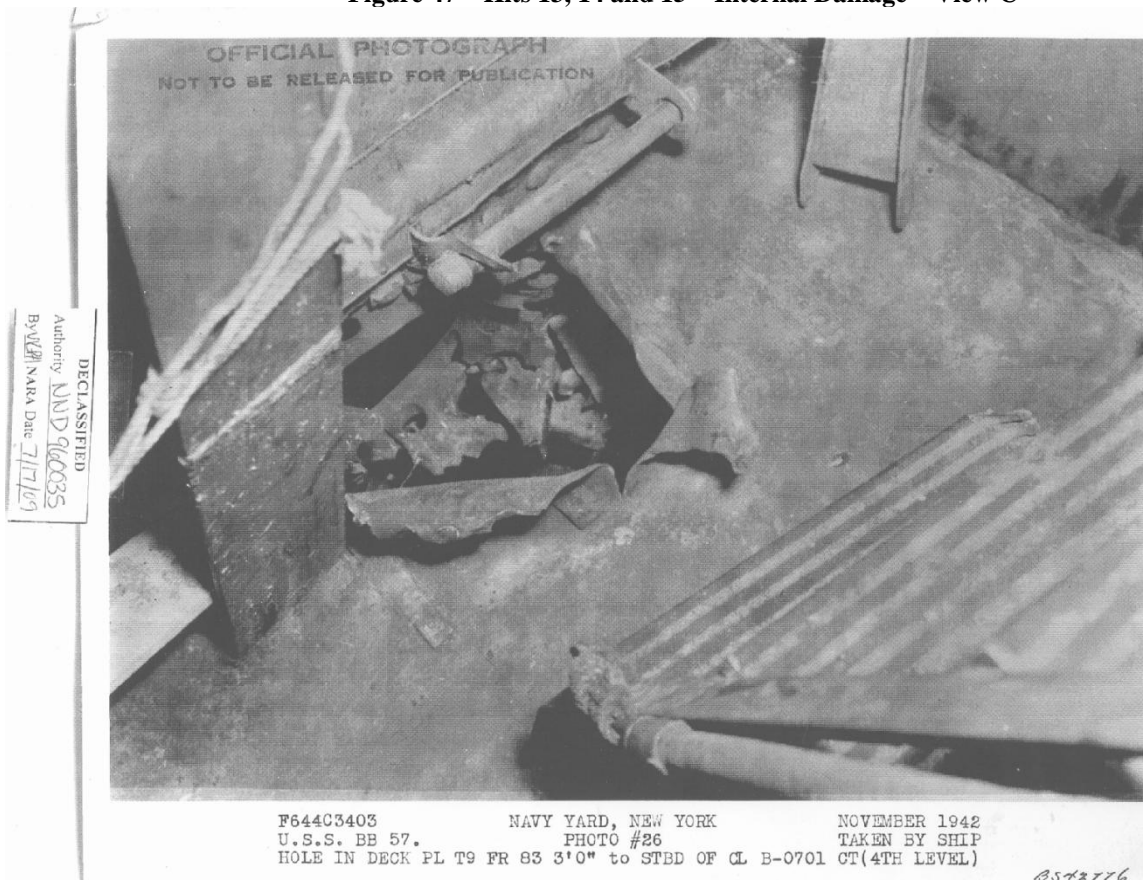
Figure 48 – Hits 13, 14 and 15 – Internal Damage – View D

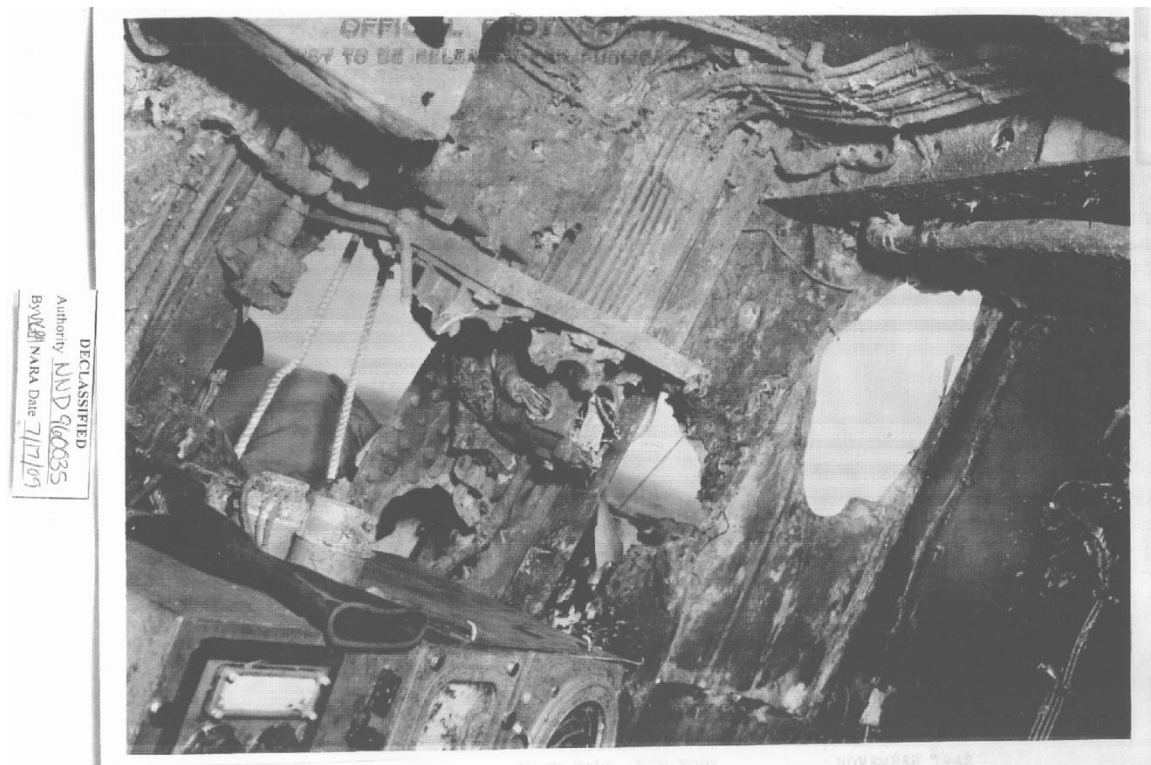
Figure 49 – Hits 13, 14 and 15 – Internal Damage – View E

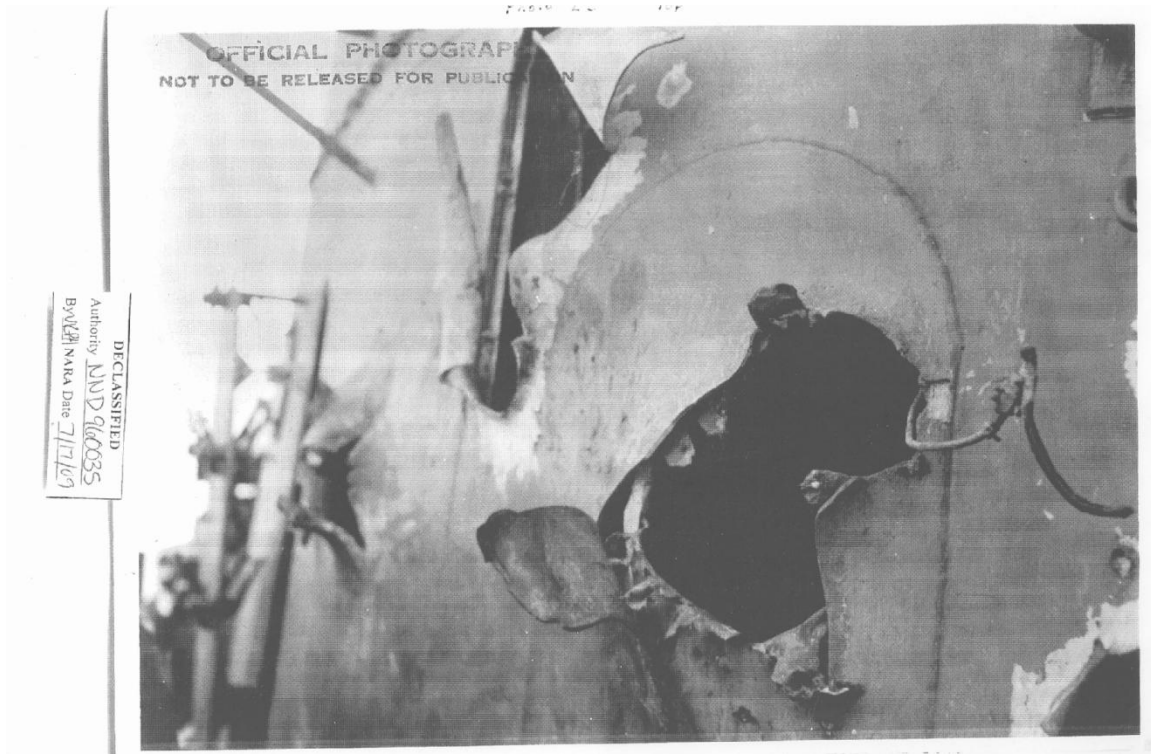
Figure 50 – Hits 13, 14 and 15 – Exit Holes – View A

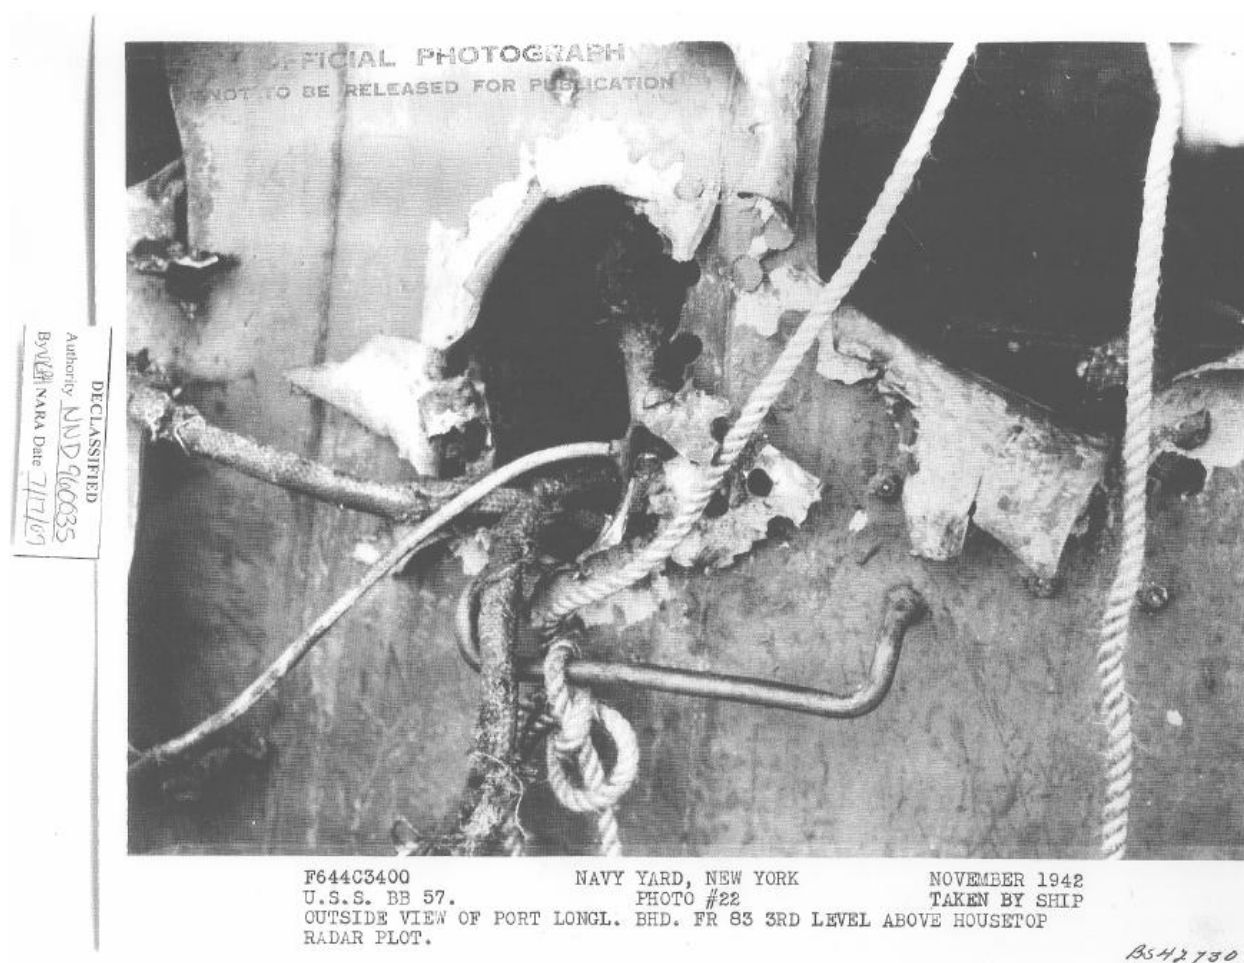
**Figure 51 – Hits 13, 14 and 15 – Exit Holes – View B**

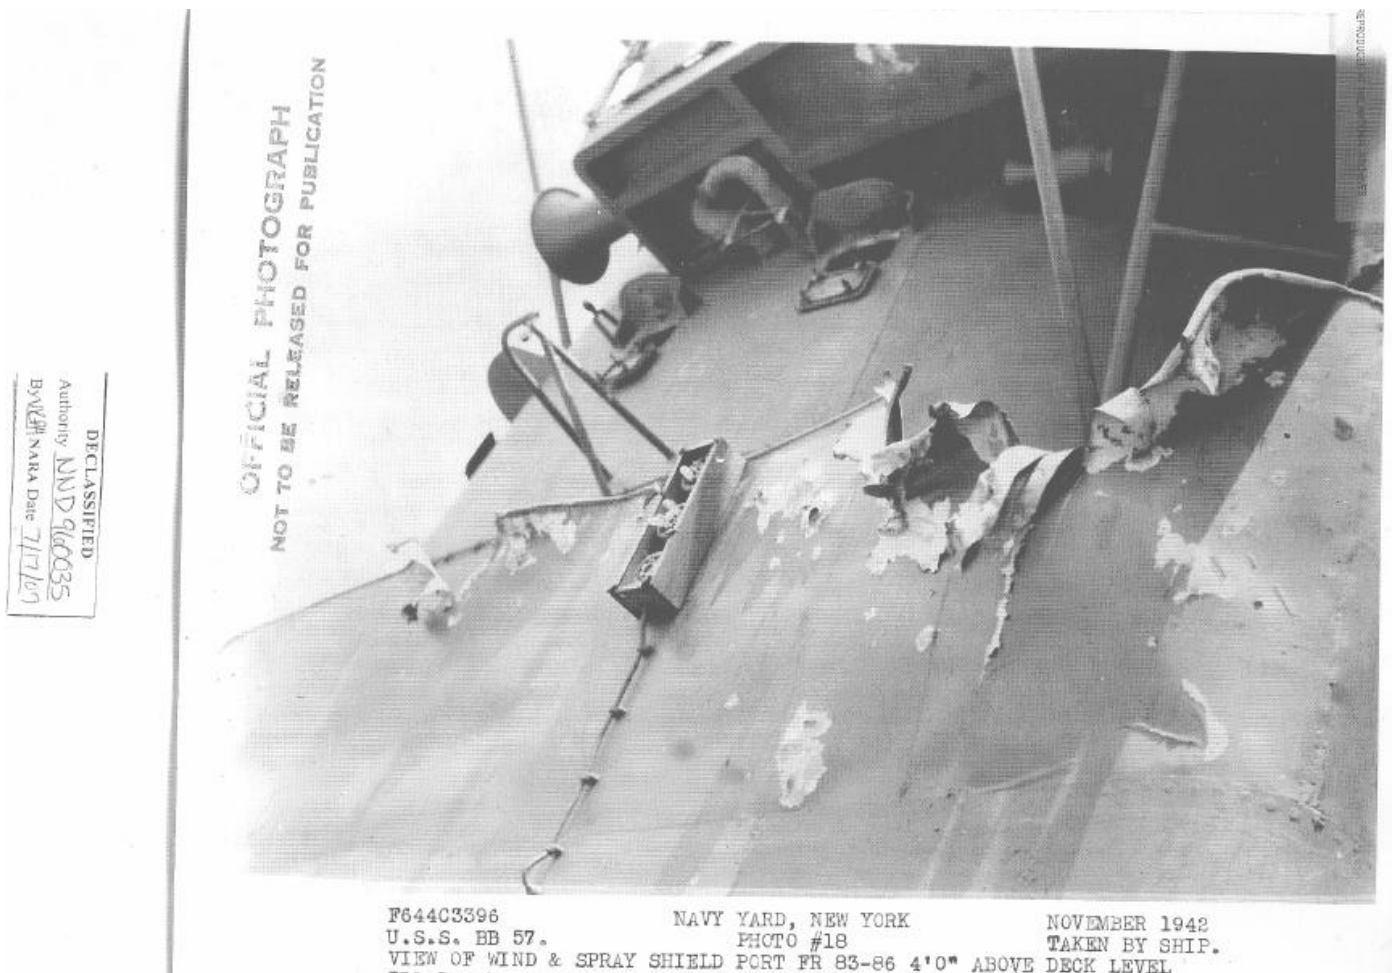
Figure 52 – Hits 13, 14 and 15 – Exit Holes – View C

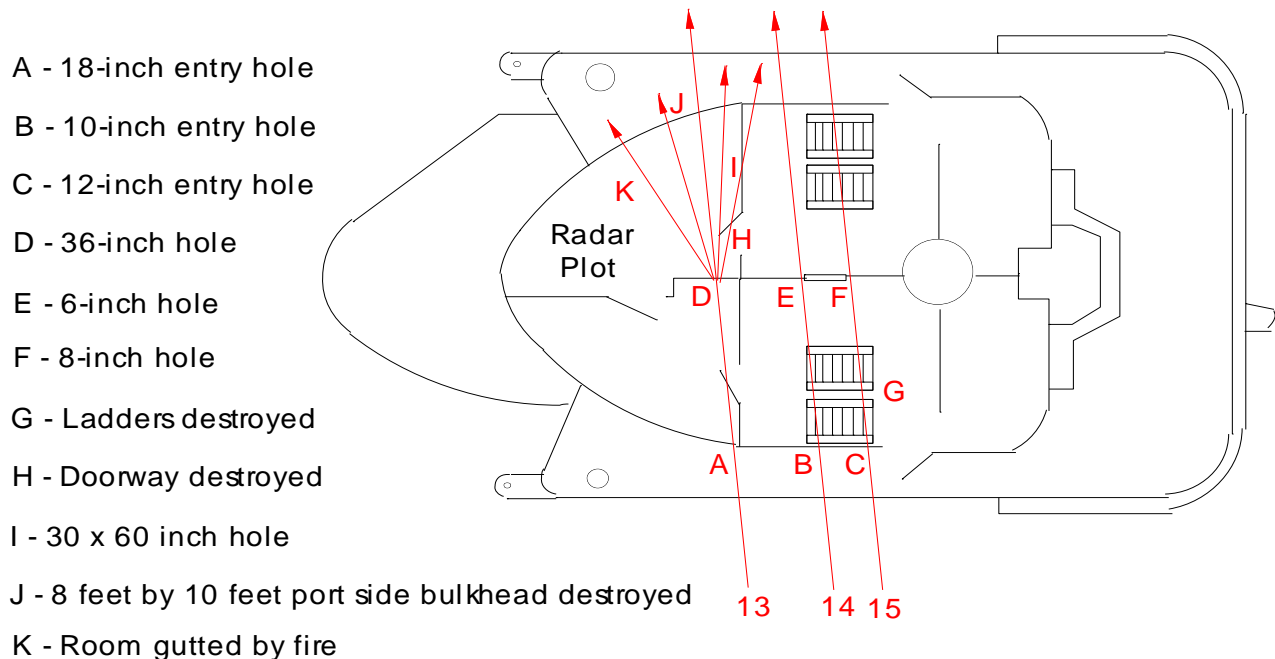
Figure 53 – Hits 13, 14 and 15 – Paths of the Shells and Fragments

leading to radar plot (H) and the passageway were blown out. Shell sections and fragments then hit the transverse bulkhead (I) at Frame 84, blowing a 30 by 60 inch hole. This projectile continued to disintegrate, breaking up completely and exiting through the port side in an area of 8 by 10 feet (J) and creating at least five holes in this area that are over 24 inches in diameter. The photographs for this damage show circular but also irregular shaped exit holes, a characteristic that indicates that the shell broke apart. Although this shell did not explode, it did start a large fire which gutted this compartment. In addition, the surrounding catwalk, wind and spray shields and the radio direction finder were all showered with shrapnel, causing many small holes.

This damage is consistent with two 6-inch shells and one 14-inch Type 3 incendiary shell. The nose fuze on the 14-inch Type 3 and the long fuze rod that ran down the middle of the shell to its base would have snapped under impact, preventing the detonation of the small explosive charge. As the shell ripped through bulkheads, the wood nose and thin sides of the shell would be torn away and the shell would disintegrate, throwing its shrapnel in every direction like a shot gun blast, taking out the doorways and bulkheads in its path. Some of the 3-inch long incendiary tubes ignited, probably low-order because the shell did not detonate properly, which started the fire within the compartment. From Admiral Kondo's point of view, it looked as if the shell had blown off the top of *South Dakota's* main mast. The display of the incendiary tubes igniting from this hit must have appeared to the eyewitnesses on the other ships like a giant firework. Two nights previously, two 14-inch Type 3 shells had struck the heavy cruiser USS *San Francisco* and these shells also broke apart and started low-order fires in the areas they went through. In her case, the shells passed through the lower superstructure and upper hull and hit the forward barbette such that most of the incendiary tubes were trapped inside the ship, causing much larger fires. In *South Dakota's* case, it appears that much of the contents of the Type 3 shell passed clean through the ship and went overboard, leaving relatively few tubes to ignite or be recognizable during the clean-up afterwards.
