Hits 16, 17 and 18 – Damage to Second Deck Superstructure

From the BuShips damage report:

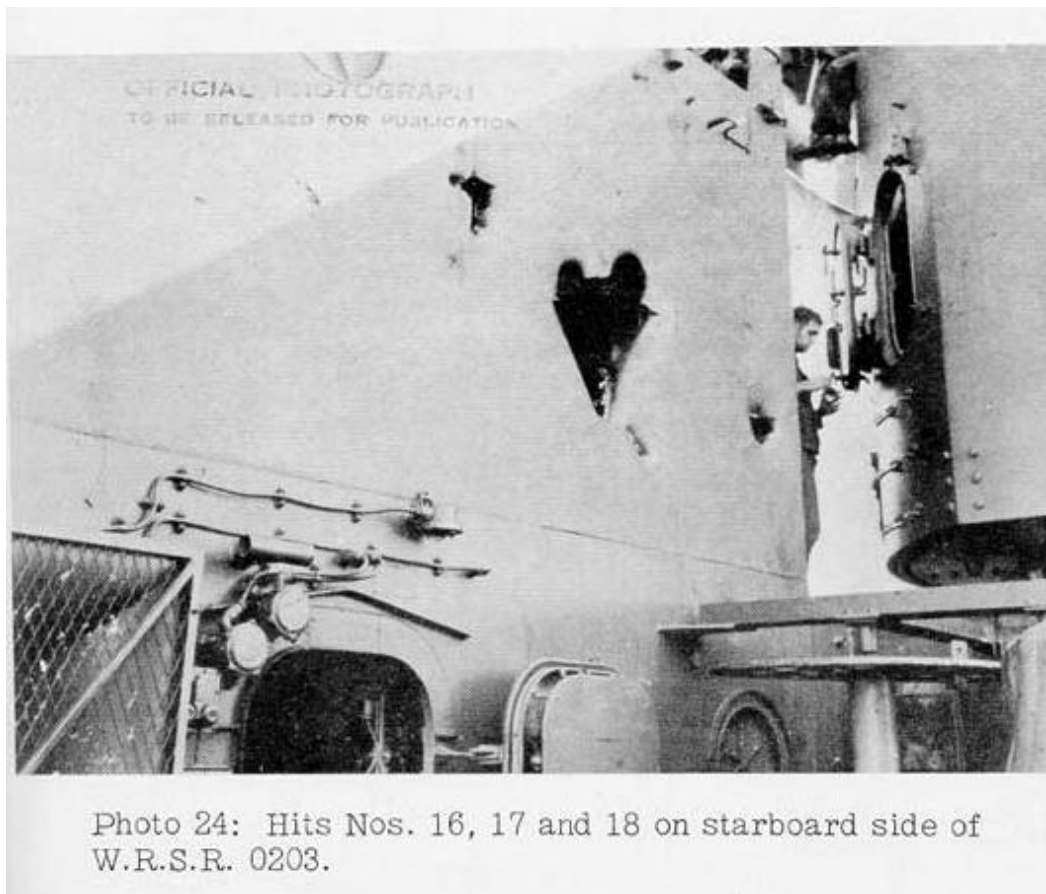
Figure 54 – Hits 16, 17 and 18 – Entry Holes

The documentation on these three hits is very inconsistent, but in the end the estimate of two 6-inch and one 8-inch projectiles appears to be correct. First, the photograph labeling the entry hits at WRSR 0203 (Figure 54) is misleading in that two of the shells actually entered WRSR 0205 and into the starboard Signal Flag Locker room and only Hit 18 actually entered via WRSR 0203. Secondly, the shells were not part of a single salvo as the shell trajectories of the two 6-inch shells (Hits 16 and 18) are from forward moving aft while the 8-inch shell (Hit 17) must have come from aft moving forward or else it would have completely missed mount two. This can be seen in Figure 56 where Hit 17 came through a bulkhead moving right to left while Hit 18 was moving left to right. The two 6-inch shells appear to have detonated, causing blast and fragment damage to the staterooms. The relatively small 10-inch entry holes seen for these hits appear to be more consistent with 6-inch shells.

Based on the photographs, it appears that the entry hole caused by the shell passing through to hit mount 2 is significantly larger than 10 inches. The first clue to its identity is the shape of the entry hole shown in Figure 54 and Figure 55. Examining these two photographs show that Hit 17 made a "V" shaped entry hole along with two circular holes at the top giving it "Mickey Mouse" ears. This is an odd shape for an entry hole, as can be seen comparing it with the round holes made by Hit 16 and Hit 18.

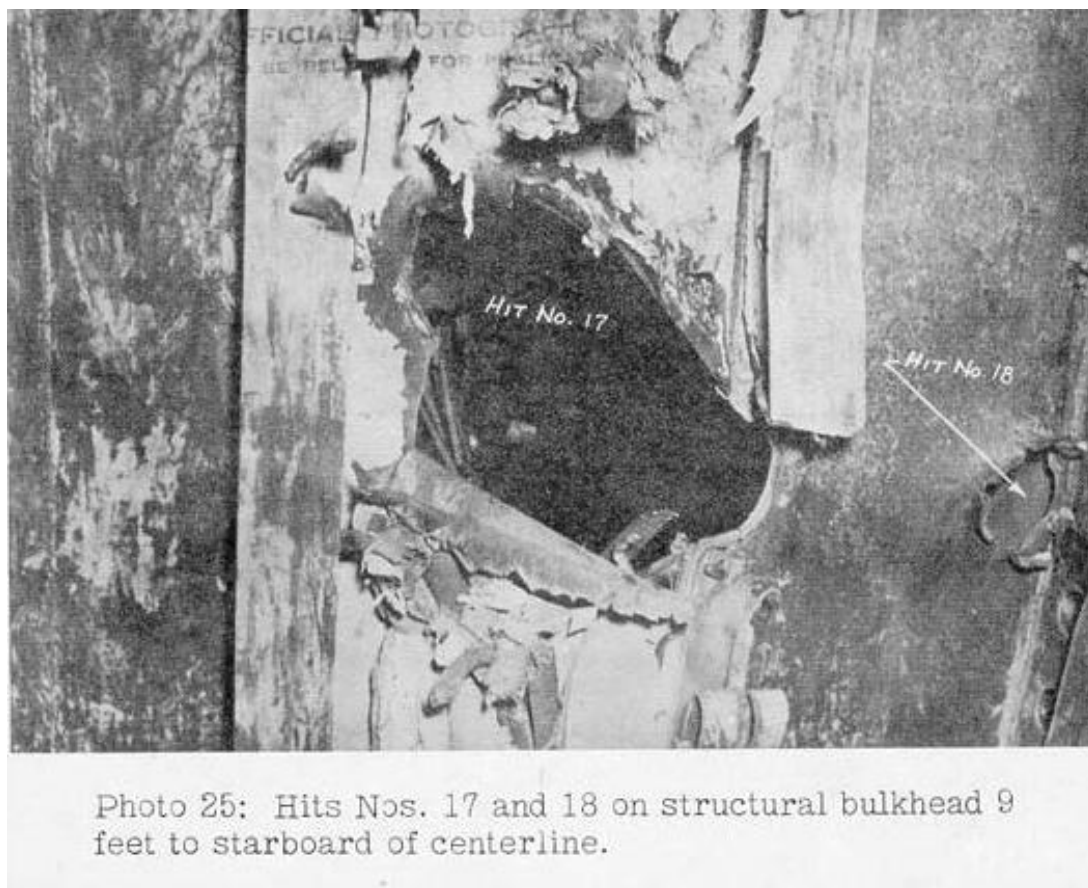
Figure 56 – Hits 17 and 18 – Strikes on Internal Bulkhead

While the direction of the yaw changed due to the nutation, the amount of yaw stayed more-or-less at the same 20-30 degrees it had when it initially made part of the Mickey Mouse Hole over most of its path through the superstructure, as shown in Figure 56 (the picture here is from the exit side of the hole, so it is a mirror image of the actual direction that the yaw was pointing when it punched through the bulkhead toward the camera).

The projectile then hit the longitude inboard bulkhead of compartment 203 (Refer to Figure 65 Point C). The nutation angle at this point had progressed to -124 degrees based upon Figure 56. The yaw angle remained at about 20-30 degrees. The distance from the exterior bulkhead to this inboard bulkhead is 16.0 feet and taking into account that the trajectory is on an approximate 10 degree composite angle, this changes the actual distance traveled to 16.24 feet [$16 \text{ feet} \times 1/\cos(10 \text{ degrees}) = 16 \text{ feet} \times 1.015 = 16.24 \text{ feet}$]. There has been a total of 139 degrees change in nutation (-15 degrees + -124 degrees = -139 degrees), so $-139 \text{ degrees}/16.24 \text{ feet} = -8.5 \text{ degree change per foot of travel}$.

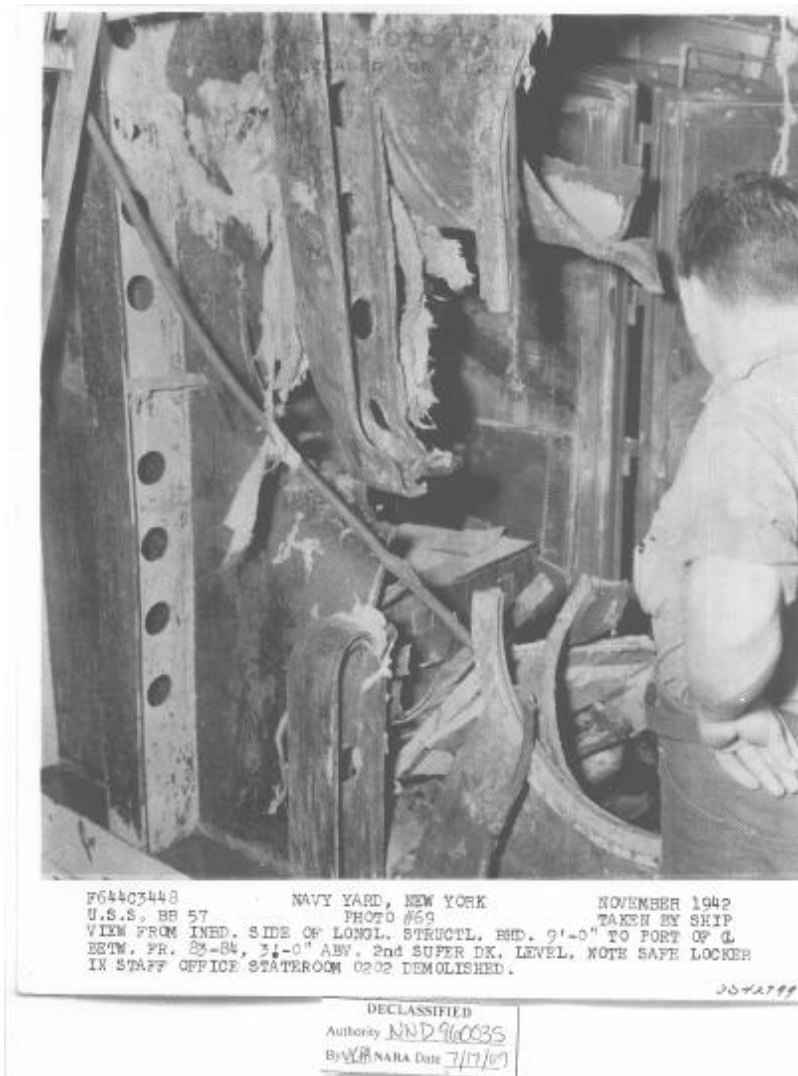
Figure 57 – Hit 17 – Damage to Internal Bulkhead of Staff State Room – View A

This photograph also shows the damage to the safe, the front of which seems to be badly wrecked but “demolished” appears to be a bit of an overstatement. The word “demolished” is used many times in Enclosure D as something of a synonym for “needing to be replaced.”

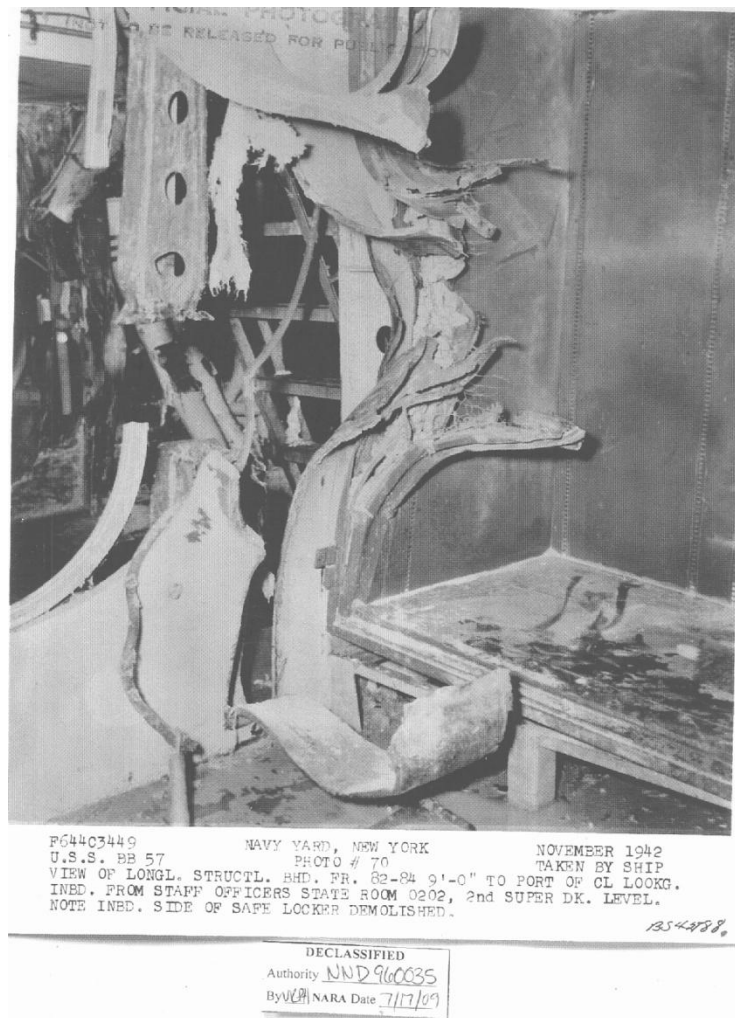
Figure 59 – Hit 17 – Damage to Internal Bulkhead of Staff State Room – View C

However, there was a wall safe on the other side of this bulkhead inside compartment 202. The now-nearly-horizontal projectile's lower body broad-sided the 2-inch-thick left side of the large double-door safe, as shown in Figure 59 (also shown in Figure 57 and Figure 58, but not as clearly).⁷⁵ That violent middle-body impact with the safe caused the yaw angle to begin swinging wildly in and out, to angles well above the original 20-30 degrees, perhaps up to 60 degrees away from directly along the flight path,

⁷⁵ As shown in Figure 59, this shell made a huge gouge into the side of the safe, knocked off the left-side door, snapped open the right-side door, and partially pulled the safe from its heavily-reinforced foundation, tossing the left door and the safe's contents all over the room. This safe was made of metal similar to homogeneous armor steel, so its effect on the projectile's motion thereafter was considerable.

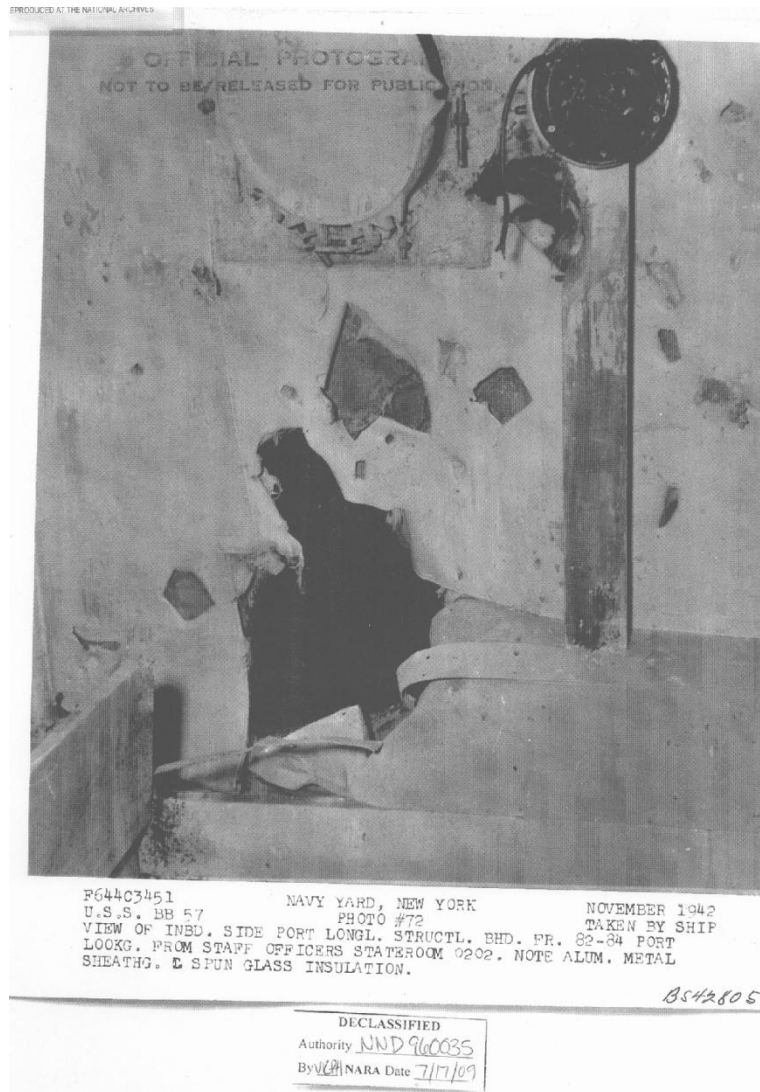
Figure 60 – Hit 17 – Damage to Port Longitudinal Structural Bulkhead in Staff State Room

Intake and exhaust ventilation ducts demolished, starboard.
Port longitudinal structural 30 pound bulkhead and stiffeners completely demolished.
Seams to fresh water gravity tanks leaking.
Stanchions on access ladder cut and broken.
Combing of access hatch to first superstructure deck bent and distorted.

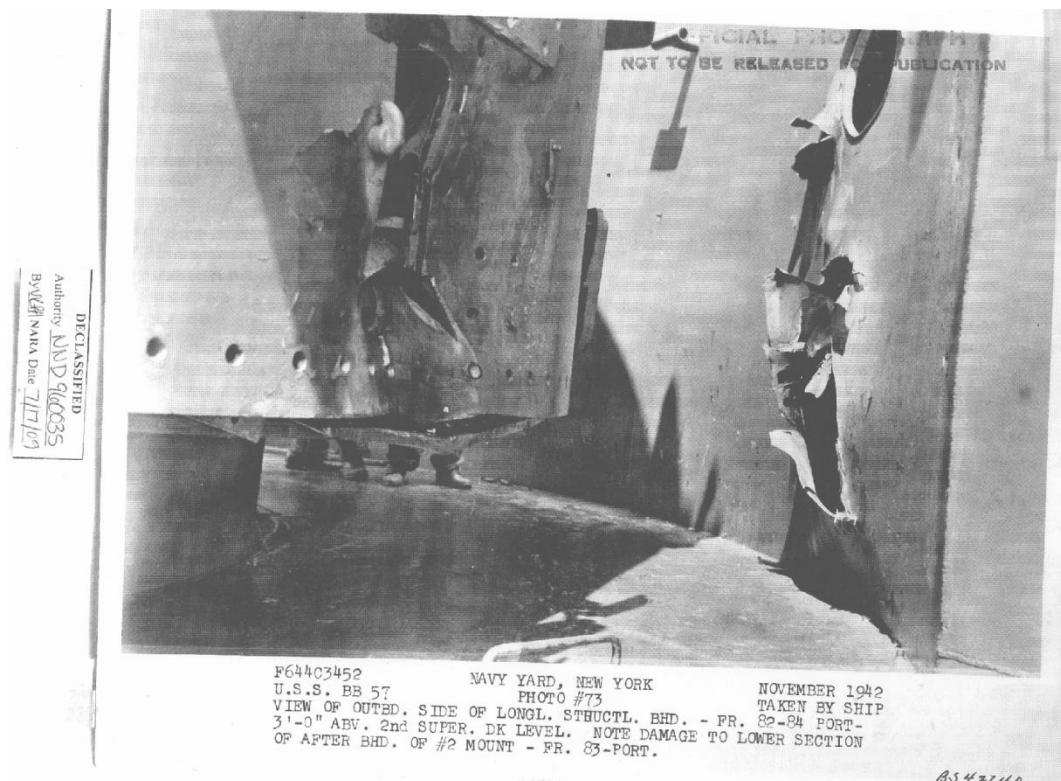
Figure 61 – Hit 17 – Damage to External Bulkhead and to 5-inch Mount #2

The small hole below and to the left of the blown out porthole shown in Figure 61 is either from the cap head paralleling the path of the 8-inch AP projectile body or is from a chunk of something in the superstructure that was knocked out so hard that it tore its own hole through the outer bulkhead just above the 8-inch projectile body slot. It does not seem to have hit the back of the gun mount with enough force to make any noticeable dent or perhaps it went through the punched-out doorway in the mount rear and ended up inside the mount, although the damage report does not state that any part of the projectile was found inside the mount.

As shown in Figure 61 and Figure 62, the projectile kept that high yaw angle in the gap between the port bulkhead and the back of the 5-inch gun mount (Refer to Figure 65 Point G). The gap distance is 3.25 feet and, using the nutation rate of -5.3 degrees per foot; -5.3 degrees x 3.25 feet = -17 degrees change in nutation angle), the shell impacted the gun mount at a nutation angle of -2 degrees (+15 degrees + -17 degrees = -2 degrees), angled almost exactly vertical, nose up, at the point where its forward motion was finally stopped.

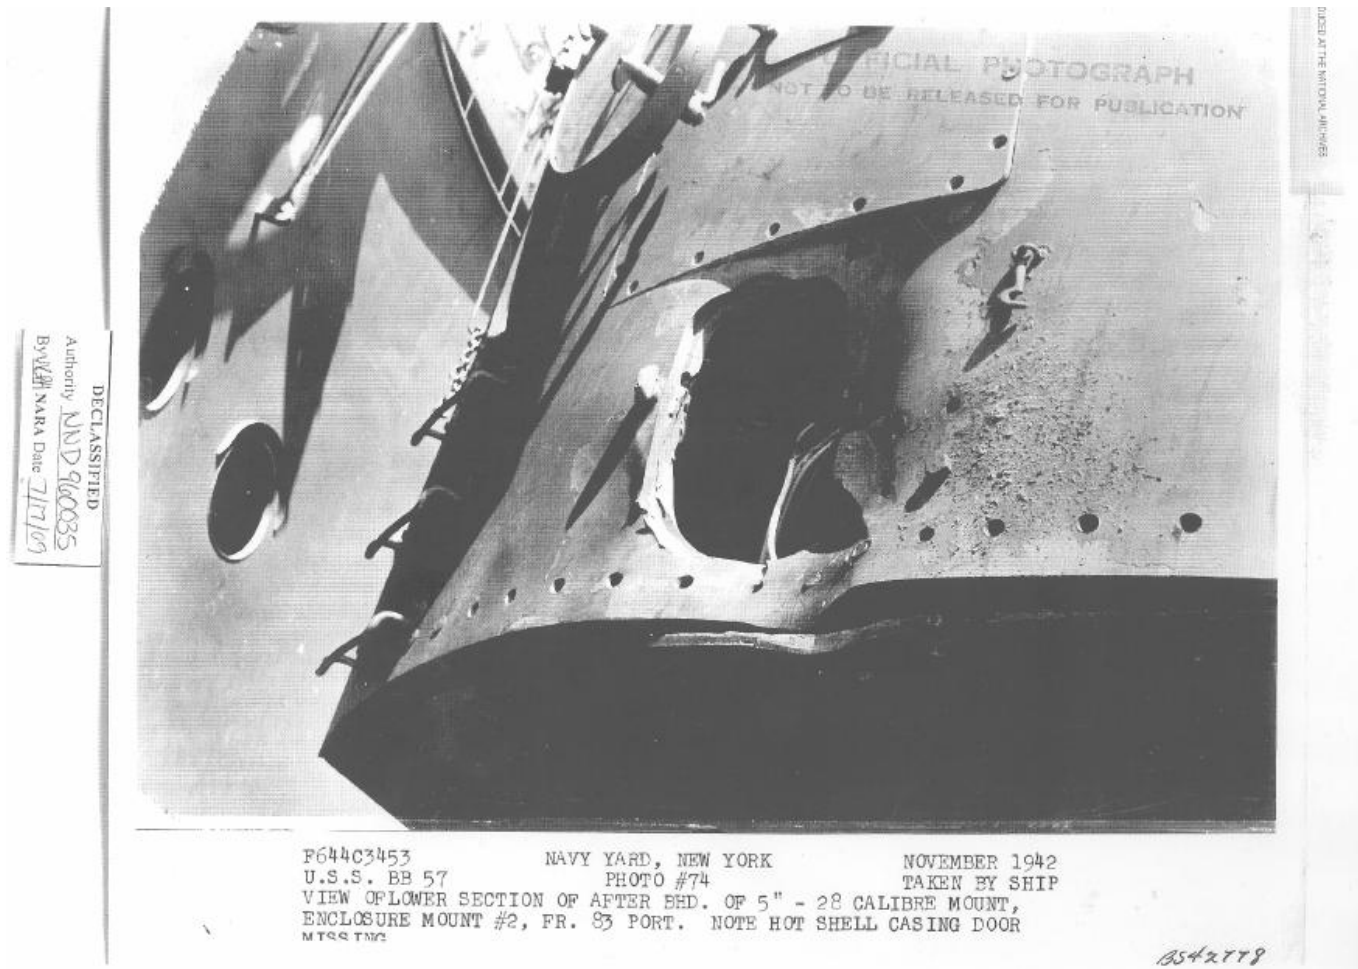
Figure 62 – Hit 17 – Damage to 5-inch Mount #2

. . . Mount #2 was struck by 6.1" projectile which had passed through superstructure from starboard side. This projectile did not explode. The projectile struck door to left hit case chute, then up rear of shield. The rear armor plate is pushed in and broken loose from top, sides, and bottom plates. The angle beam is cut. Oil reservoir tank of left shell hoist punctured.⁷²

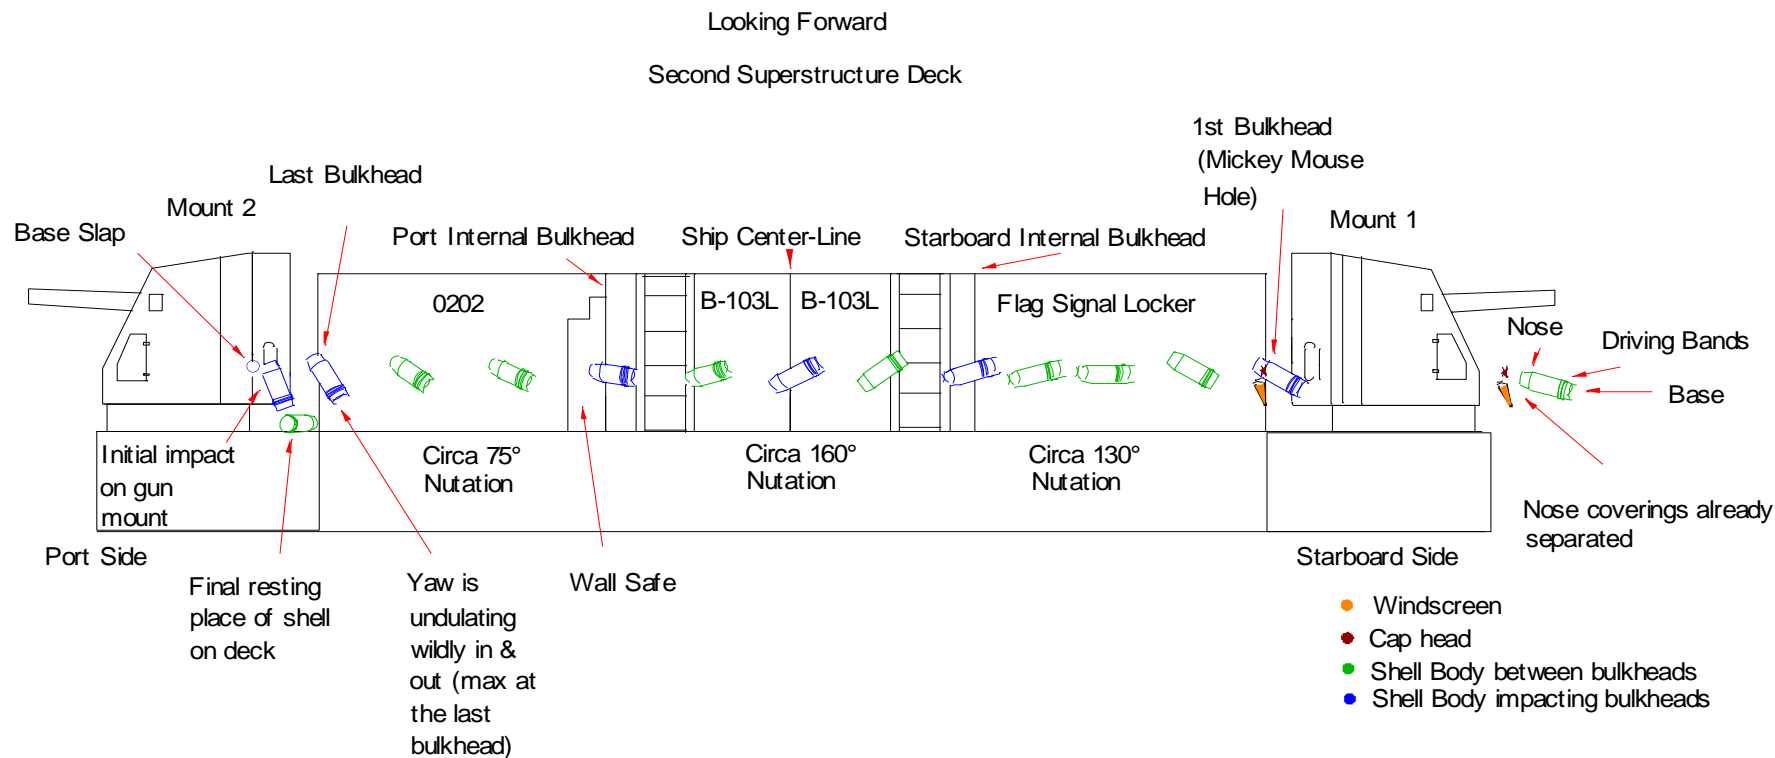
Figure 64 – Hit 17 – Path of the Shell

After hitting the water, the windscreen and cap head of the 8-inch AP shell were knocked off and the projectile slowed down considerably before ricocheting upward at a very shallow angle, slamming into the starboard bulkhead to form the Mickey Mouse Hole. In the water ricochet process, the nose acquired a significant “yaw” angle, which is the tilt of the nose away from the direction of motion of the projectile caused by the water impact pushing on the upper end of the projectile with a different force than on the base end. The projectile thus began to move forward like a surfboard, cocked off at an angle to the direction it was moving, in this case about 20-30 degrees, as shown by the oval hole in Figure 56. Since the projectile was still spinning at a high rate, however, this yaw started to “nutate”⁷⁴ as soon as it left the water so that the nose punched through the superstructure bulkheads with the yaw angle pointed in progressively different directions, as shown in Figure 64.

The distance from the wall safe to the curved exterior bulkhead of compartment 202 (Refer to Figure 65 Point F), is 12.35 feet. With the new nutation rate, the projectile nutated an additional -65 degrees (12.35 feet x -5.3 degrees = -65 degrees), so that the shell on impact with the port exterior bulkhead had a nutation of +15 degrees (+80 degrees + -65 degrees = +15 degrees). As shown in Figure 61, the projectile then “belly-flopped” through this bulkhead and made that long slot that was almost identical, though longer, to the initial slot (mostly masked by the long windscreen hole) it made on the starboard bulkhead. The projectile nose had thus spiraled through one complete circle during its passage through the superstructure (see Figure 64).

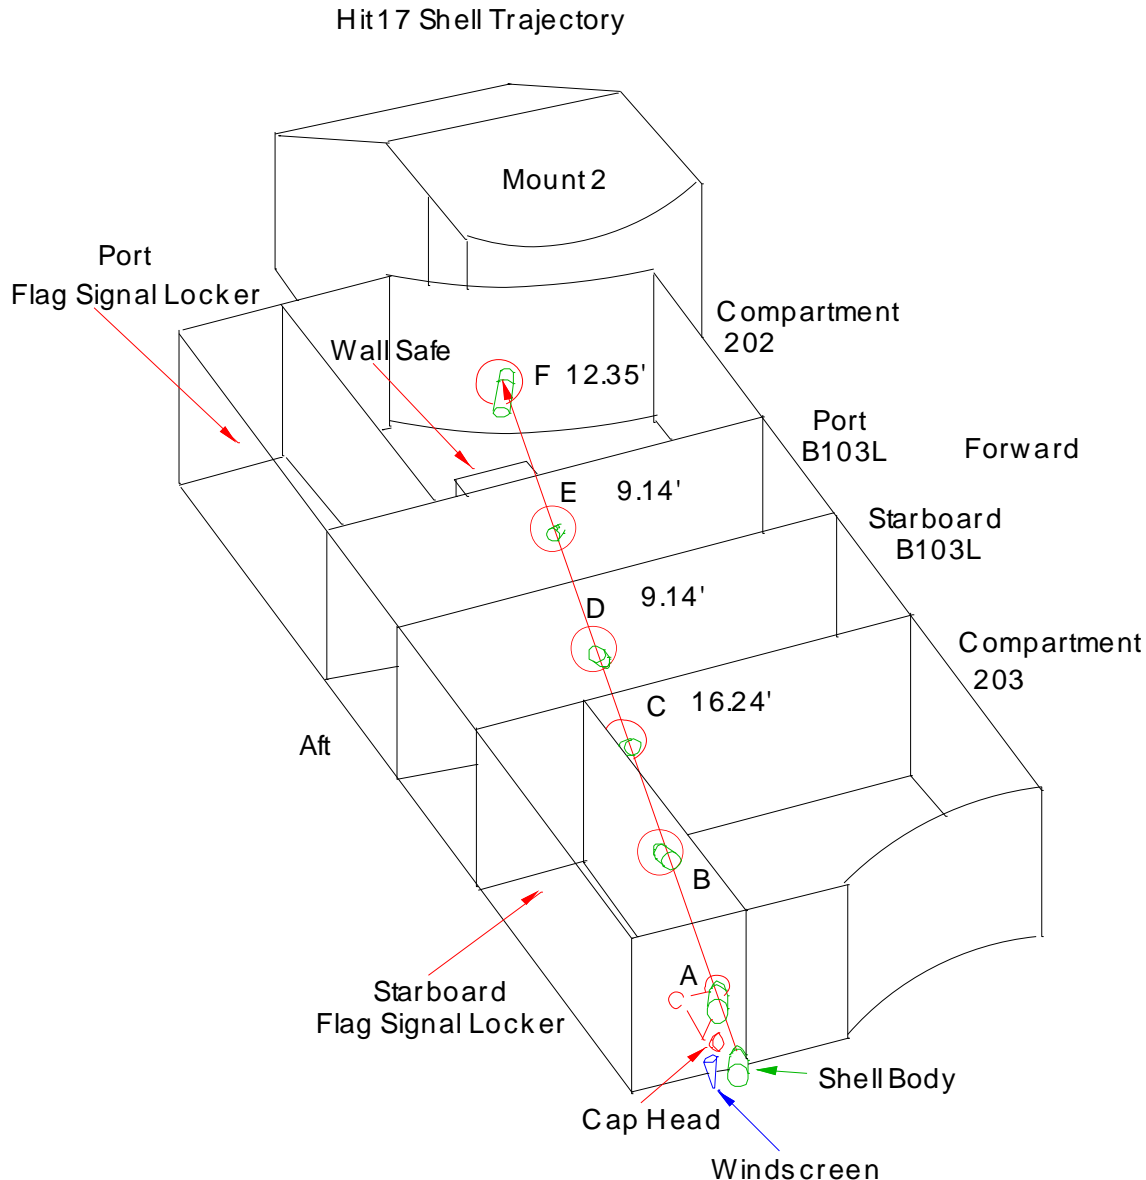
Figure 65 – Hit 17 – Path of the Shell – 3D View

For Hit 17, when this shell entered the exterior starboard bulkhead of the Flag Signal Locker, the shell nose was at a nutation angle of +15 degrees (Refer to Figure 65 Point A). The shell was nutating in a counter-clockwise direction.

The shell then ripped through a thin transverse bulkhead to exit the Flag Signal Locker (Refer to Figure 65 Point B) and entered Compartment 203 at a highly oblique angle, but very close to its inboard end, so the bulkhead has little deflection effect as the projectile tears through it. Since the projectile body has a flat nose and such a small yaw, the forces generated are still very close to directly down the centerline of the shell, so any added yawing effect (increasing or decreasing) by penetrating this transverse bulkhead was minimal.

The next bulkhead is the centerline bulkhead of the ship in Compartment B103L (Refer to Figure 65 Point D). This bulkhead is 9.0 feet from the inboard bulkhead of compartment 203. The 10 degree angle for the shell trajectory adjusts the actual distance traveled to 9.14 feet [$9 \text{ feet} \times 1/\cos(10) = 9 \text{ feet} \times 1.015 = 9.14 \text{ feet}$]. Maintaining the same nutation rate of -8.5 degrees per foot, an additional -78 degrees ($9.14 \text{ feet} \times -8.5 \text{ degrees} = -78 \text{ degrees}$) will result with the shell impacting this bulkhead with a nutation angle of +158 degrees ($-124 \text{ degrees} + -78 \text{ degrees} = -202 \text{ degrees} = \text{Equivalent Positive Angle } +158 \text{ degrees}$) with the yaw remaining constant.

The next bulkhead is the inboard side of compartment 202 (Refer to Figure 65 Point E). This bulkhead is also 9.0 feet away from the ship's centerline. The distance and nutation rate remains the same as for the previous bulkhead, so the projectile's nose impacted this bulkhead with a nutation of +80 degrees ($+158 \text{ degrees} + -78 \text{ degrees} = +80 \text{ degrees}$).

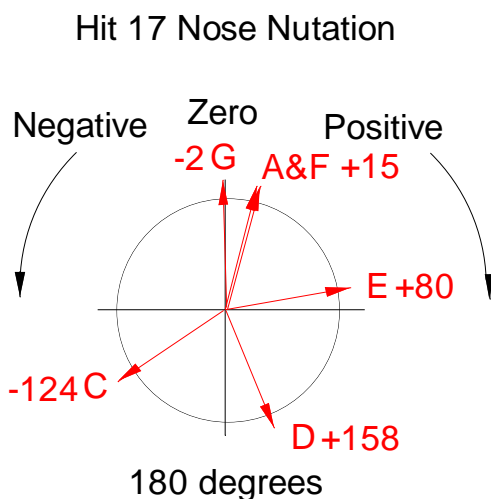
Figure 66 – Hit 17 – Nose Nutation

Figure 66 shows how the nutation angles are used in this document. Zero degrees nutation is directly on top. Positive degree nutation angles are in a clockwise direction while negative degree nutation angles are in a counter-clockwise direction from the zero point. Negative angles may also be referred to as a Positive angle by measuring in the clockwise direction. For example: -124 degrees is equivalent to a Positive Angle of +236 degrees. The letters shown in Figure 66 refer to the nutation angles as the shell body impacted the bulkheads as it traveled through the superstructure as labeled in Figure 65.

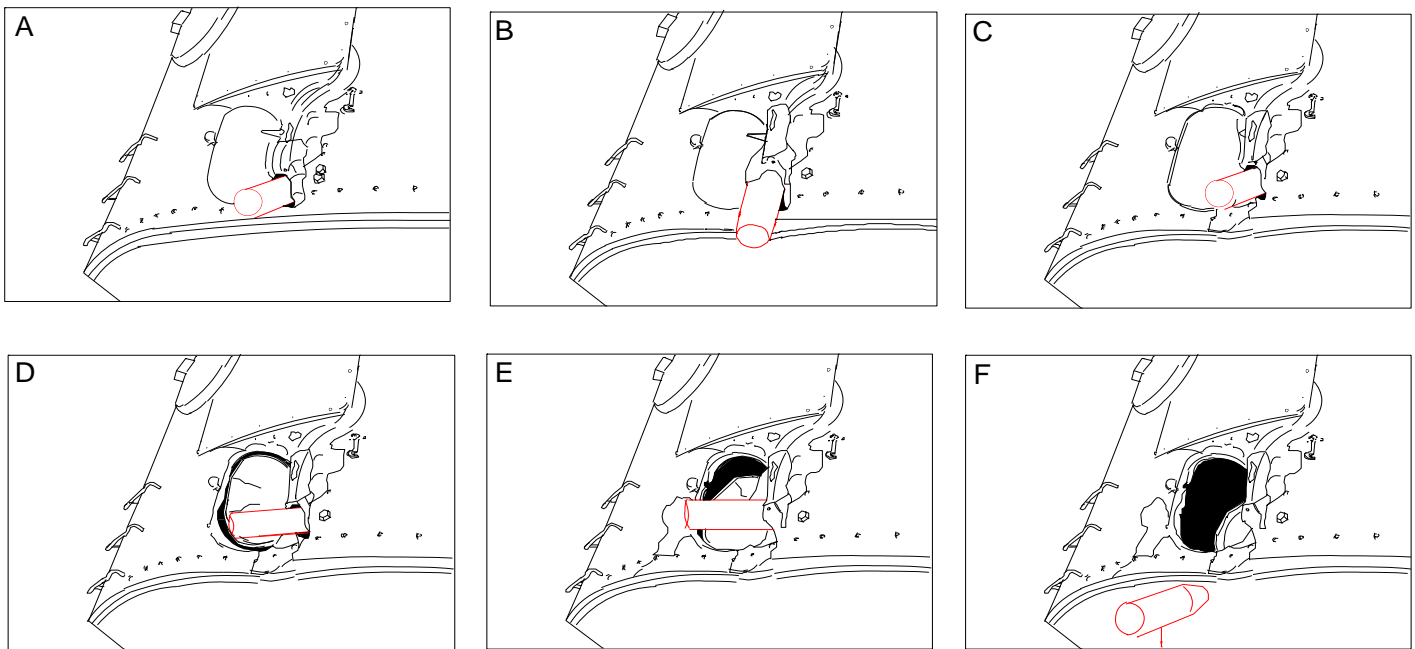
Figure 68 – Hit 17 – Impact on 5-inch Gun Mount 2

Referencing Figure 68, the nose hit the 5-inch mount at the lower-right-hand corner of the left-side-gun's shell casing ejection hatch (A) and punched a deep pit and hole, but did not completely penetrate. The tapered flat nose was jammed into that hole and could not move while the base continued forward, slamming vertically nose-up into the rear of the gun mount (90 degrees yaw angle and -2 degrees nutation angle), as noted by the curved dent in the lower edge of the rear armor and the gash in the edge of the armor floor plate below that (B). As the nose was jammed into the deep dent and hole, this rotation pulled out the armor just above the nose hole, since it is now shallower than the dent higher up on the right edge of the case-ejection hole. The projectile body hit the lower-edge armor sideways at a high nutation rate, as shown by the depth of the dent, and then rebounded outward, pivoting on the jammed nose (C). The nutation inertia was still in force, however, so the rotation of the lower projectile body toward the horizontal, reducing the 90 degrees yaw angle toward zero, was accompanied by the nutation of the projectile base to the left, counter-clockwise, just as before the armor impact, but now pivoting on the nose tip, not the shell center-of gravity about halfway down the shell length (D). This caused the base to move in a curve like a question mark without the bottom dot and end up slamming horizontally on the far left side of the case-ejection opening from the nose hole (90 degrees yaw angle and a 90 degrees nutation angle), as shown by the rectangular dent there (E). This cross-wise slam across the closed hatch covering the case-ejection opening rammed the hatch cover through the opening into the gun mount, tearing out the edge hinges and locking clamps and causing deep tears/dents all around the edge of the opening. In the process, the nose pulled out more of the armor trapping it, pulling up the raised torn area to the right and below the nose hole.

After this second horizontal base impact, the projectile no longer had any energy and the base fell downward, so the weight of the shell finally twisted the nose free of the hole in the mount. The projectile then fell to the deck, still spinning for a few minutes in a circle, but not moving very far (F). It was found right there by crewmen after the battle and thrown over the side.

This shell did not explode on impact with the safe or gun mount because it was moving so slowly (at the range of the gun which fired it, a shell with no yaw that was not slowed down considerably by the water impact would have easily punched entirely through that 5-inch mount); hit rather soft, thin (compared to the shell diameter, that is), and easily dented steel (the force on the fuze firing pin was reduced because it was spread over a longer time than a sharp penetrating-impact shock); and hit at such a high yaw angle that the firing pin was probably jammed sideways and could not move in the fuze, even with a stronger force than actually occurred (such fuzes are not designed for such yawed impacts). This form of base-slap for this projectile will be seen to be similar to the one that struck [Turret III barbette](#), as will be discussed later. Both of these impacts had rotations along two planes; one along the direction of flight (the base moving forward to hit the same plate the nose had previously hit) and one at right angles to that direction rotating from a nose-down vertical yaw to a horizontal yaw parallel to the deck using a counter-clockwise one-quarter-circle turn with the projectile nose tip as the pivot point.

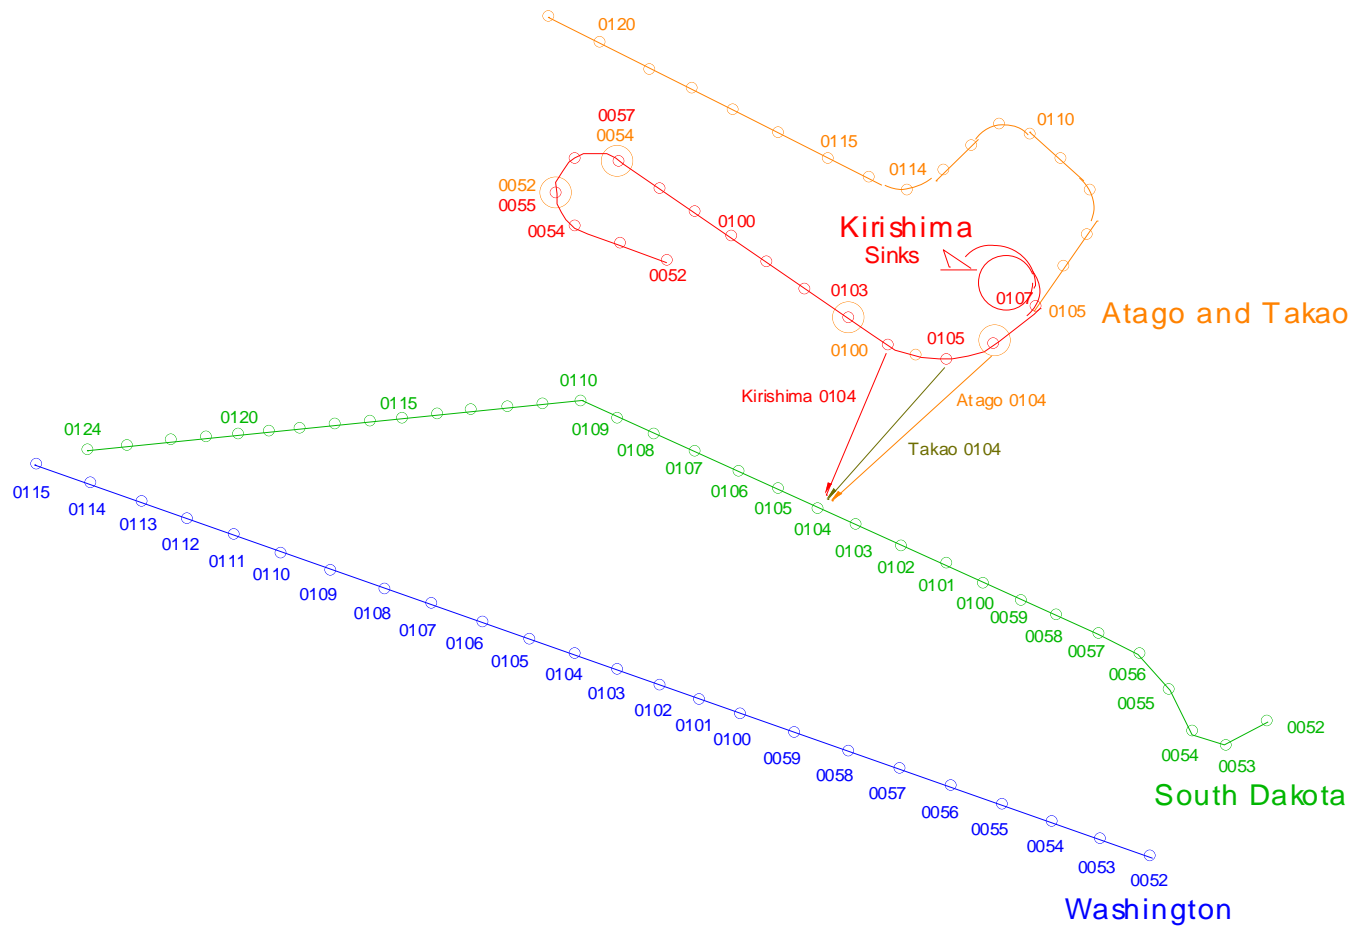
Figure 69 – Hits 16, 17 and 18 – Ship Locations at time Projectiles Struck⁷⁶

We believe that Hit 17 was from the 8-inch AP shell that was later found on deck and that the correct shell size was indeed 8-inches, even though South Dakota's logs confuse which gun mount was hit. The heavy cruisers opened fire late, at which time they were abreast and then aft of *South Dakota* during their firing passes. The shell trajectory and timing of the 8-inch shell matches the heavy cruisers position while the trajectories of the 6-inch shells match *Kirishima*'s position (see Figure 69) at 0104 when this damage was listed as occurring in *South Dakota*'s time logs. This also eliminates the possibility of the shell being a larger caliber one as at the time this hit was made *Kirishima* was still forward of *South Dakota* and not aft. For Hits 16 and 18, the best estimate is that they were base-fuzed 6-inch Type 4 Common projectiles, as these shells did not explode on impact with the outer bulkhead but were able to penetrate inside the ship before they detonated.
