## Hit 19 – Damage to Searchlight No. 3

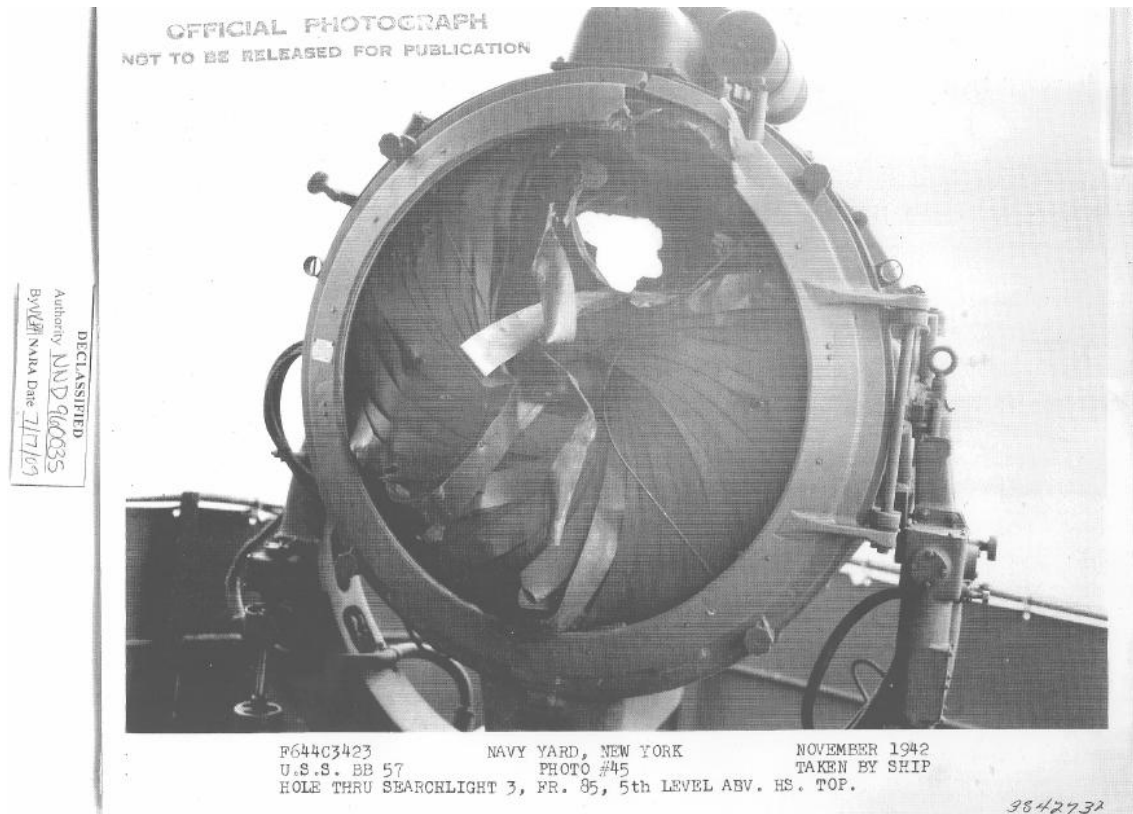
29. No. 3 36-inch searchlight received a direct hit estimated to have been an 8-inch projectile that passed through without detonating.<sup>77</sup>

Searchlight 3 - pierced by projectile passing through lens, shutter and reflector.<sup>78</sup>

Figure 70 – Hit 19 – Damage to Searchlight No. 3

The amount of damage to the search light was minimal. The shell did not detonate, indicating that it was not a nose-fuzed projectile. It also does not appear to have been an 8-inch AP projectile as the light windscreen of that shell would have ripped-off and flattened, causing much more damage than was the case (for example, [Hit 6](#) from an 8-inch AP projectile created an 18-inch wide hole in a 0.25-inch thick STS plate and [Hit 9](#) made a 17-inch hole). An 8-inch AP projectile would thus have created a hole approximately half of the diameter of the 36-inch searchlight. A smaller base-fuzed 5.5-inch Type 2

Common projectile or 6-inch Type 4 Common projectile would have nothing to come off and these are basically solid rounds. A hit by one of these projectiles would have gone right on through the searchlight, which is consistent with the damage as shown in Figure 70. Based upon examining this photograph; the hole is about 10 to 12 inches in diameter, which is consistent with the other 5.5-inch and 6-inch caliber hits. The timing of this hit is not known. Our conclusion is that Hit 19 was made by either a 5.5-inch Type 2 Common or a 6-inch Type 4 Common projectile.

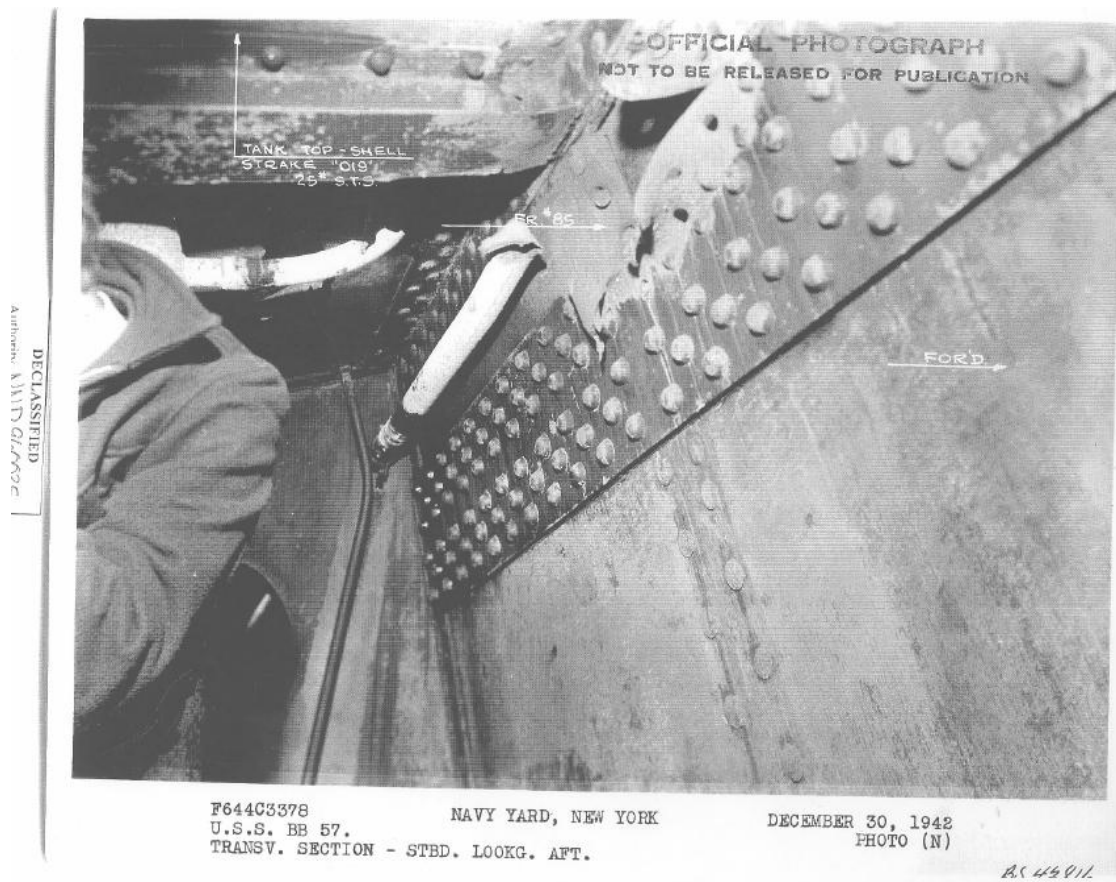
30. An estimated 6-inch projectile hit the tank top at frame 85-1/2, penetrated the armor backing bulkhead between the main and second decks and detonated. Transverse bulkhead 85 was ruptured and distorted over an area 15 by 24 inches. Fragments sprayed lockers in supply office stores and started a small smoldering fire in stationery and clothing lockers.<sup>79</sup>

Supply office – Shell struck top of fuel oil and ballast tank, B-39F, at frame 87 starboard (6½” hole). Shell exploded inside tank blowing hole in compartment B-207L (hole 10” x 18”) piercing 2 lockers and gear locker.<sup>81</sup>

Figure 71 – Hit 20 – Interior Damage to Transverse Section

There are no inconsistencies with this estimate and the best estimate is by a 6-inch Type 4 Common projectile from *Kirishima*. The base fuze allowed the shell to penetrate the outer layer and it exploded on the next bulkhead.

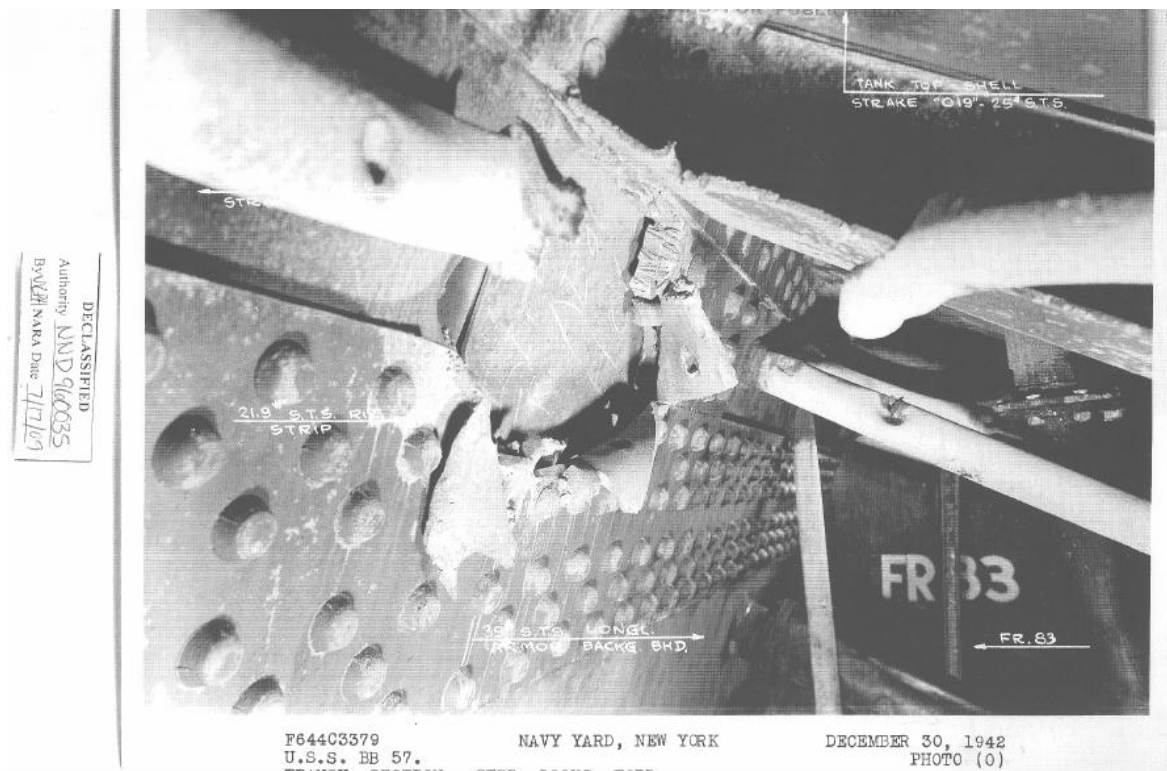
Figure 72 – Hit 20 – Interior Damage near Frame 83

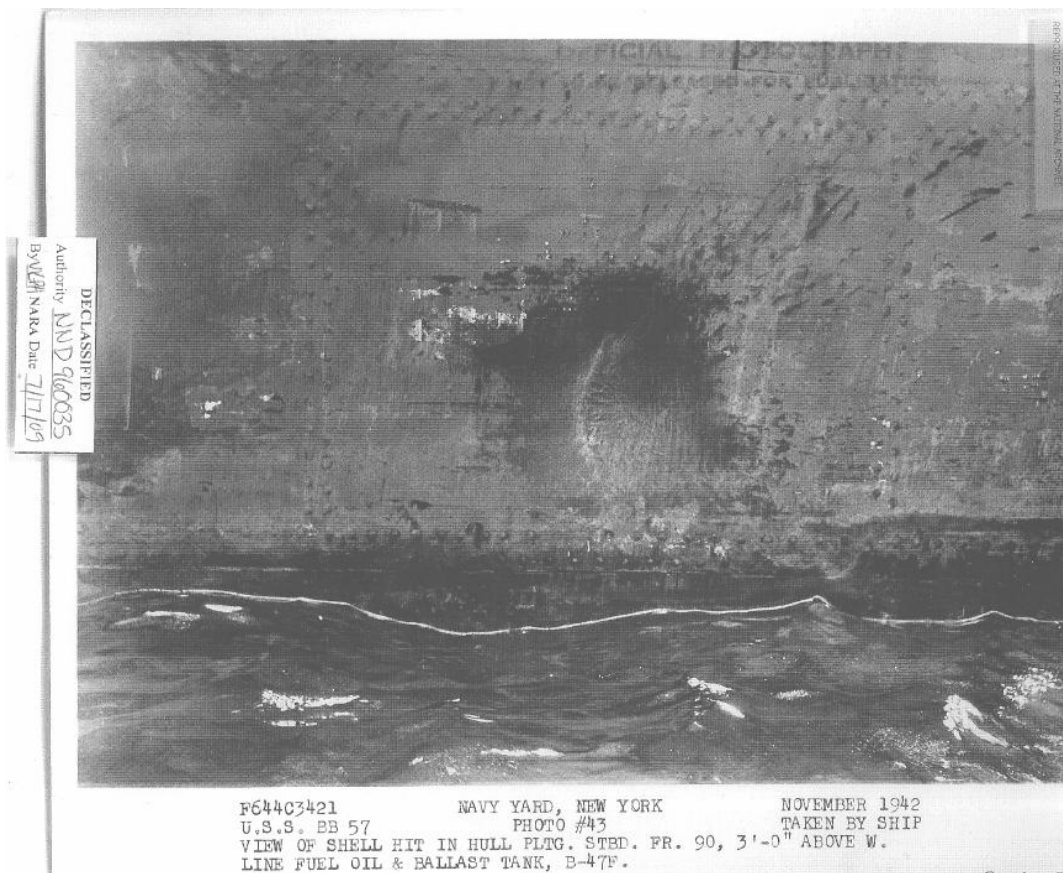
31. An area of the 50-pound STS shell 24 inches in diameter at frame 87 starboard between the second and third decks was indented to a depth of six inches. It was reported this was a glancing hit by an 8-inch projectile. If so, the performance of this 50-pound STS plate was most unusual. Another possibility is that this indentation was made by the windscreen or cap head of hit No. 11 or No. 20.<sup>82</sup>

One 14" hole in ship's side at frame 72 starboard, 5 feet above waterline. Dented in over a 6' diameter area.<sup>83</sup>

**Figure 73 – Hit 21 – Damage to Hull Plating**

This impact was estimated by BuShips to be either a glancing hit from an 8-inch shell or the windscreen and cap head of an 8-inch shell. We believe this estimate to be incorrect. [Hit 4](#) showed that at these ranges that even an 8-inch shell traveling underwater could penetrate the outer shell. Next, most nose-fuzed HE shells exploding on impact at a small angle would have punched a hole into the plate rather than denting it as was the case for this hit. That this blow was at a small oblique angle can be seen in Figure 73. A 5.5-inch nose-fuzed shell would punch a hole in any plate less than 1.36 inches thick, which means that the actual 1.25 inch plate is too thin to have prevented this from happening. A 5-inch shell fired from a 5°/40 would have only left a dent, but we believe that this projectile is too small to have caused the size of dent actually made in this plate.

In BuShip's original report, the authors proposed that this damage may have come from the windscreen and cap head from either [Hit 11](#) or [Hit 20](#). However, these two hits came from a forward direction while Hit 21 came from astern, which therefore eliminates any relationship between Hit 21 and the other two

hits. After eliminating these other possibilities, what we are left with is that this damage appears to have been caused by the impact of a cap head and windscreen from an AP shell. Further work is needed to determine the size of this projectile.

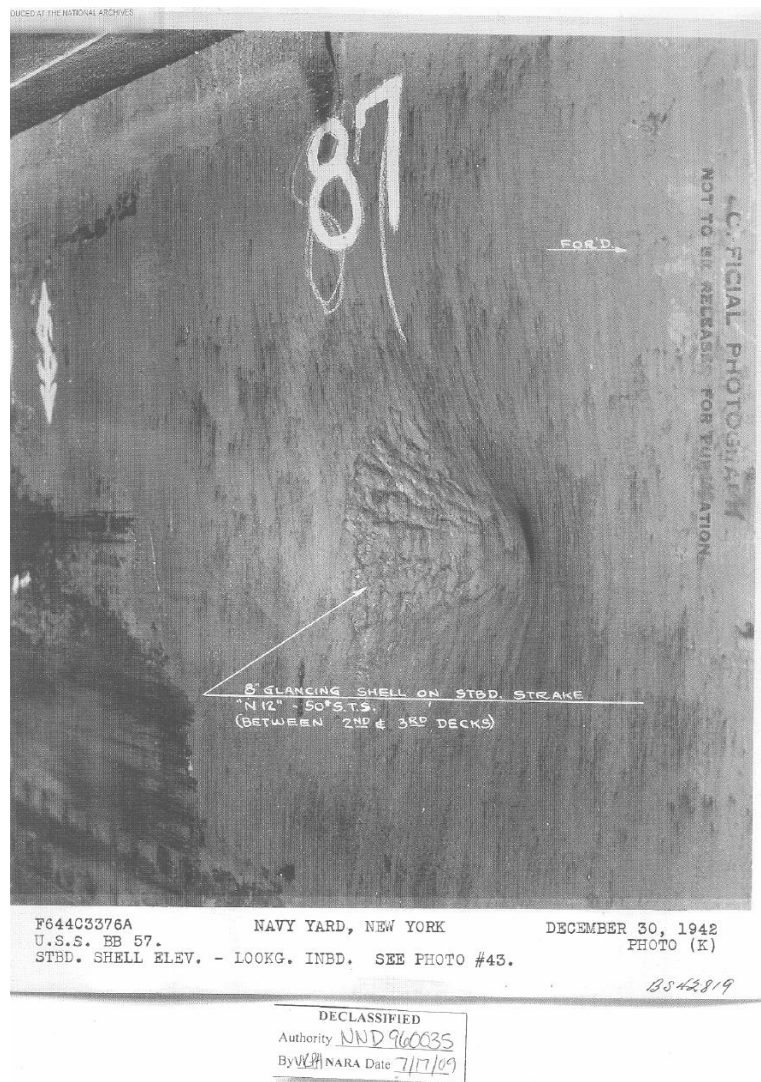
Figure 74 – Hit 21 – Damage to Hull Plating – Side View

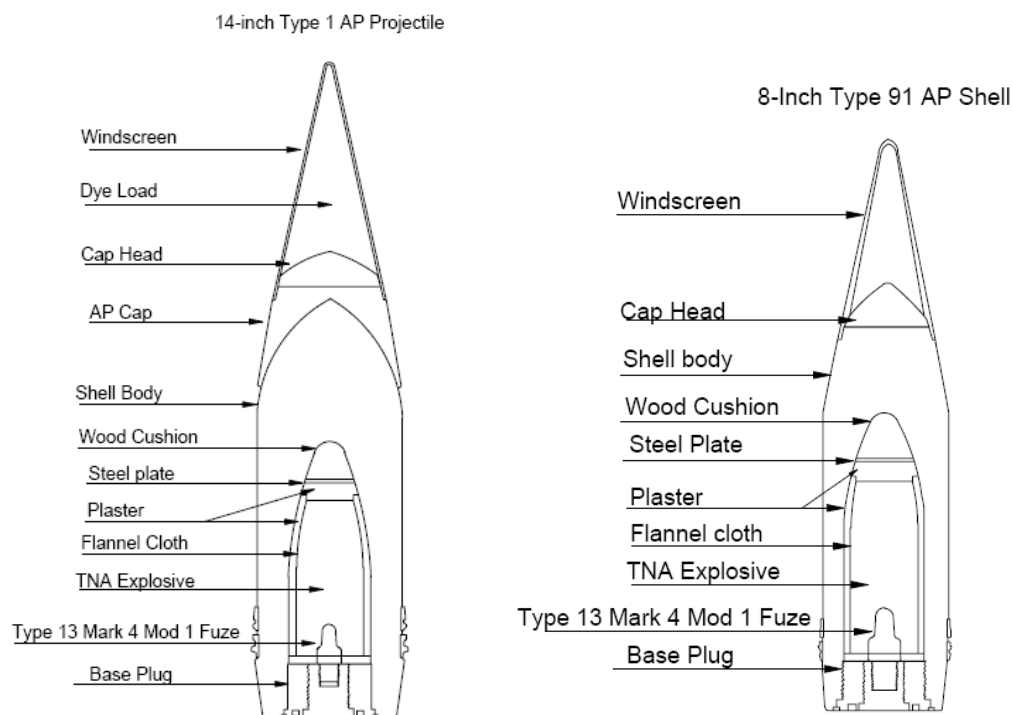
**Figure 75 – Hit 21 – Comparison of Japanese 14-inch and 8-inch AP Projectiles**

These size differences between these two projectiles is also significant in that the 8-inch cap head is only 5.5 inches in diameter, is 5 inches thick and weighs 7.9 lbs. The 14-inch cap head is 12 inches in diameter by 8 inches thick and weighs 63 lbs. The struck plate is 1.25 inches thick, which is not an insignificant thickness. An area in this plate over 24 inches in diameter was pushed in to a depth of 6 inches. The shape of this dent matches the oval shape of the 14-inch cap head and the heavier cap head is

by far more capable of pushing in this amount of steel than the much lighter cap head of the 8-inch shell. This damage largely matches the dimensions of the 14-inch cap head. Our conclusion is that Hit 21 was the result of a 14-inch Type 1 AP cap head and windscreen.

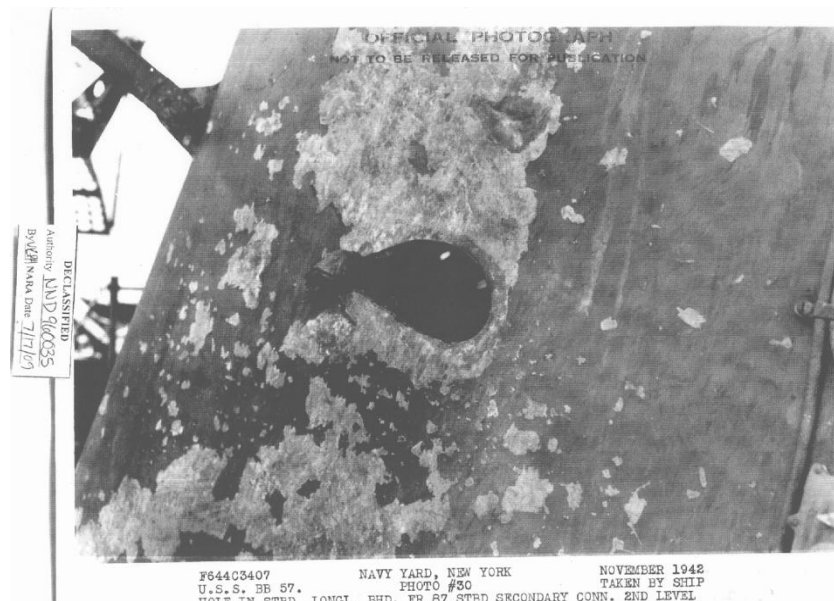
32. This hit was just above the second level and above the house top at frame 87 on the starboard side of the structural longitudinal bulkhead and was estimated as a 5-inch projectile. This projectile pierced the foremast housing tube and passed through the port longitudinal structural bulkhead near frame 86. The port bulkhead stiffeners at frame 86 were distorted and the first aid locker was penetrated by three fragments. Five panels of sheathing and insulation in the first aid station were damaged.<sup>85</sup>

- 1 8" hole, through after side of structural bulkhead, frame 87.
- 1 10" hole through both sides housing tube for radar mast, frame 87.
- Lowering wire for foremast damaged.
- 1 4" hole through bulkhead plating at frame 86 port.
- Bulkhead stiffener frame 86, punctured, twisted and distorted.
- 5 panels of sheathing and insulation torn out.
- 2-3" shrapnel holes at base of bulkhead just above bounding angles, frame 87 starboard.
- 3 shrapnel holes, through medical locker. Doors distorted beyond repair.
- 2" shrapnel hole through back of wash basin.<sup>86</sup>

**Figure 76 – Hit 22 – Damage to Structural Bulkhead, Frame 87**

This shell detonated on impact, indicating a nose-fuzed projectile. The bulkhead is probably 25 lbs. or 0.625-inches STS or HTS plate based on similar hits on the exterior superstructure of the forward mast such as Radar plot. The timing of the hit is unknown, so the exact range and velocity of the shell is also unknown. The following analysis is meant as a rough estimate.

Using Equation 1, the calculations show that a 5.5-inch projectile striking at 1,300 fps would produce a 14-inch hole in STS plate 0.625 inches thick while a 5-inch projectile at the same velocity would produce a 9-inch hole in the same STS plate. This latter figure is closer to the size of the exterior hole in Figure 76 and slightly under the 10 inch hole seen in Figure 77. A 5-inch Type 0 HE projectile appears to be the best estimate for this damage and this is consistent with BuShip's original estimate. This shell came from either the 5"/50 caliber guns on the destroyers or one of the 5"/40 caliber secondary battery guns on *Kirishima*, *Atago* or *Takao*.

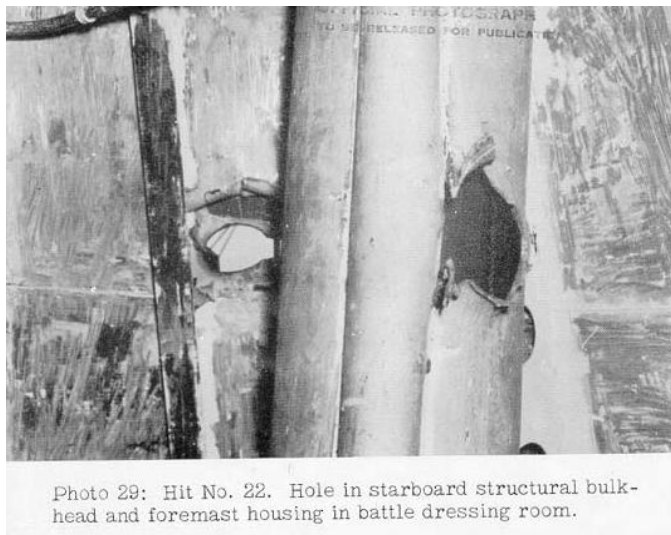
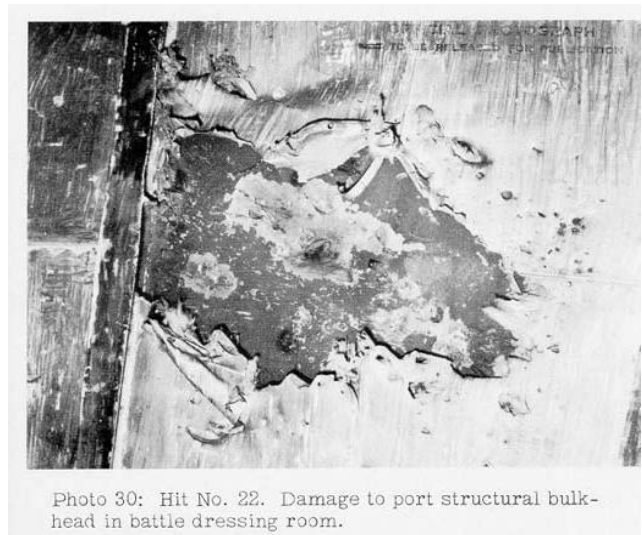
**Figure 77 – Hit 22 – Views of Interior Damage**

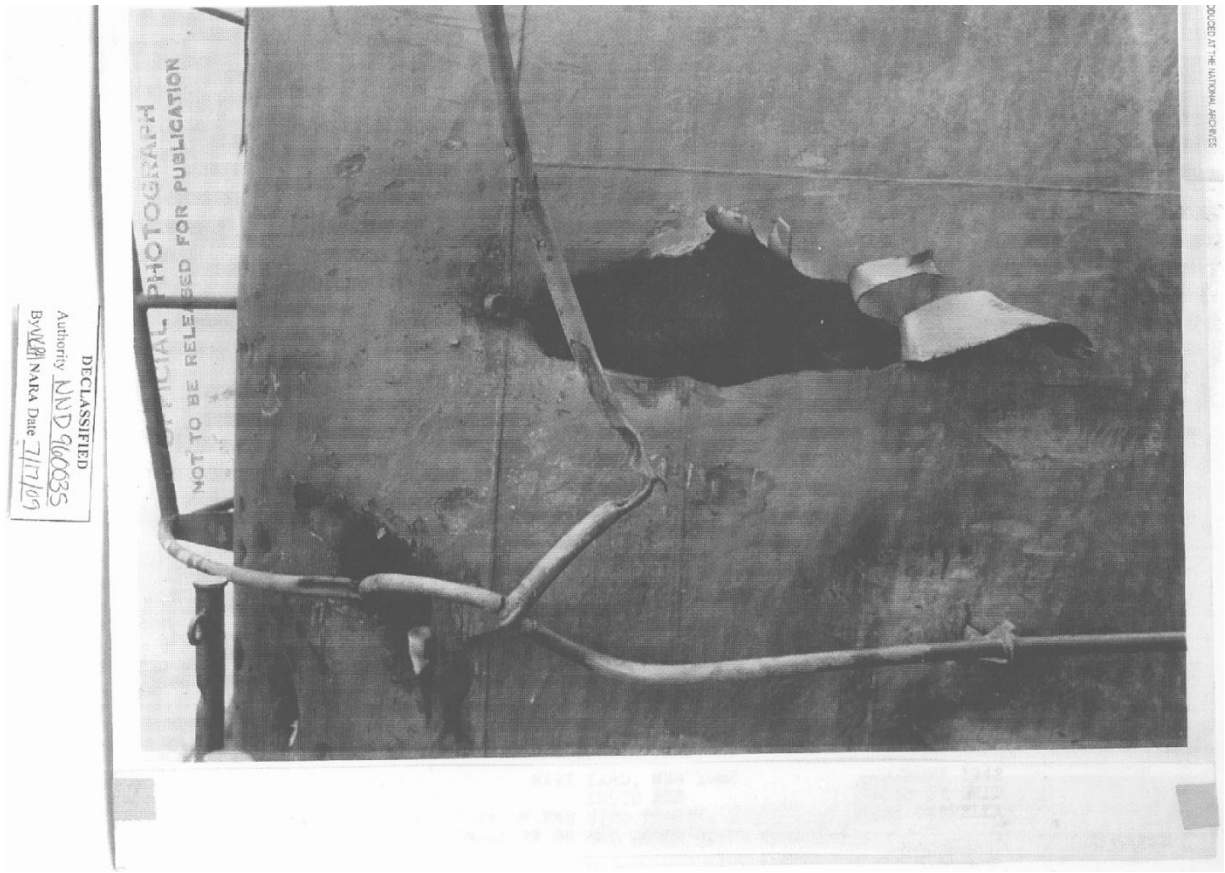
34. An estimated 8-inch AP projectile hit the radar antenna of 5-inch director No. 3. Fragments of the windscreen and cap head broke off and sprayed the starboard side of the stack hood in the vicinity of frame 89. The projectile pierced the stack hood and continued on through the radar antenna of 5-inch director No. 2.<sup>87</sup>

Forward Face – Shell hole 12” by 30” part of shell continuing through 4 partitions inside hood and out port side. All holes approximately 15” in diameter. Part of shell broke off after entering hood and went through 1 partition aft with a hole of 23” by 14”.

Shell entered 2" from starboard side hood 4' above 07 superstructure deck. There were also other holes in forward face of hood of the following size: 6" diameter, 6" by 18", 2 holes 3" by 6", four holes about 2" in diameter, 2 holes approximately 3" by 8". Also 10 dents about 1" deep by 6" in diameter in forward face of hood.

**Figure 78 – Hit 23 – Stack Damage on Starboard Side**

This damage is very inconsistent with an 8-inch AP shell especially as the shell did not detonate. This shell disintegrated on impact which sent large numbers of small pieces of shrapnel into the surrounding structures. This type of damage is more typical of a 14-inch Type 3 incendiary projectile. The only ship to fire this shell type was *Kirishima*. The shell began breaking up on Secondary Battery (SB) director 3 which sent some of the stays and incendiary tubes into the stack. Some of the incendiary tubes ignited at the base of the stack and around 5-inch mounts 3 and 7. The nose of the shell entered into the stack and then the shell probably broke in half and continued to break up within the stack with parts hitting SB director 2 and sent shrapnel all over the superstructure. We believe that what is being described in the damage report as pieces of life jackets are actually the small rubber thermite incendiary tubes from the Type 3 shell which are 1 by 3 inches in size. These tubes burned at low-order as the shell did not detonate properly. CO<sub>2</sub> fire extinguisher gas would have had no affect on them due to their magnesium filler and they could burn as hot as 3,000 degrees Fahrenheit (1,650 degrees Centigrade), but for only 5 seconds. These tubes were quite capable of starting these small fires throughout the superstructure as described in the report. 5-inch Mount 7 reported that the armor shield had been exposed to extreme heat and 5-inch Mount 3 was reported on fire, but when fire fighters arrived they only found burnt-out fragments. Fires at the base of the stack but not at the point of impact are also an indication of incendiary tubes. For these reasons, we have concluded that the best estimate for this damage is that it was from a 14-inch Type 3 incendiary shell.

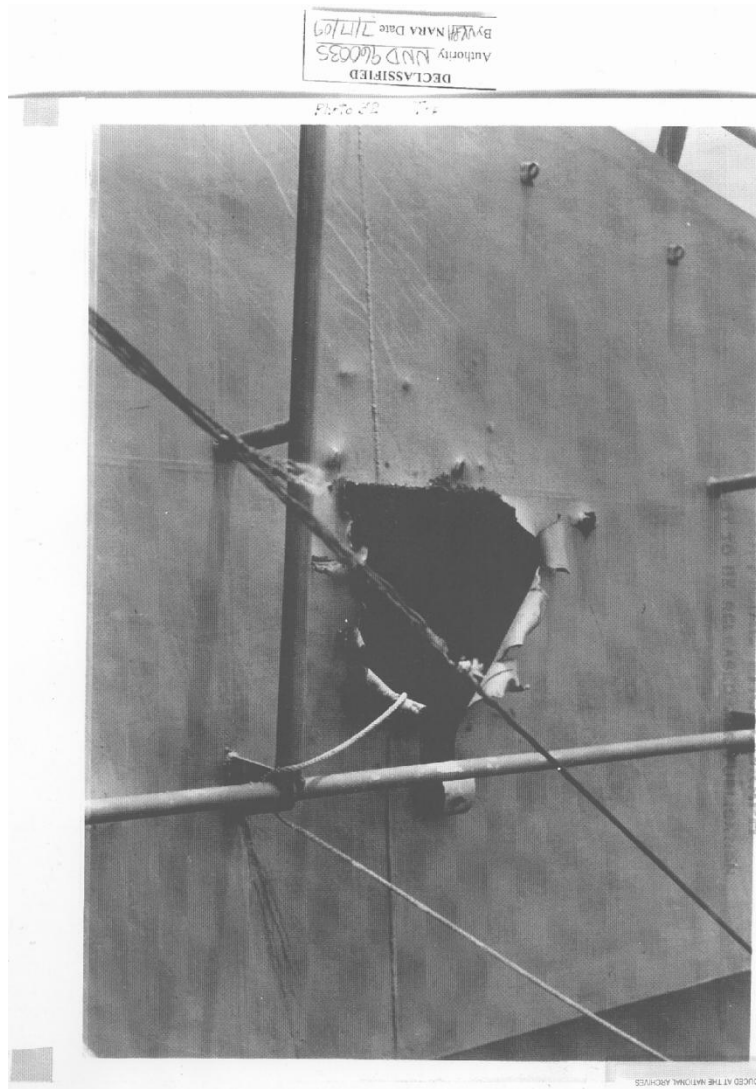
**Figure 79 – Hit 23 – Stack Damage Exit Hole on Port Side**

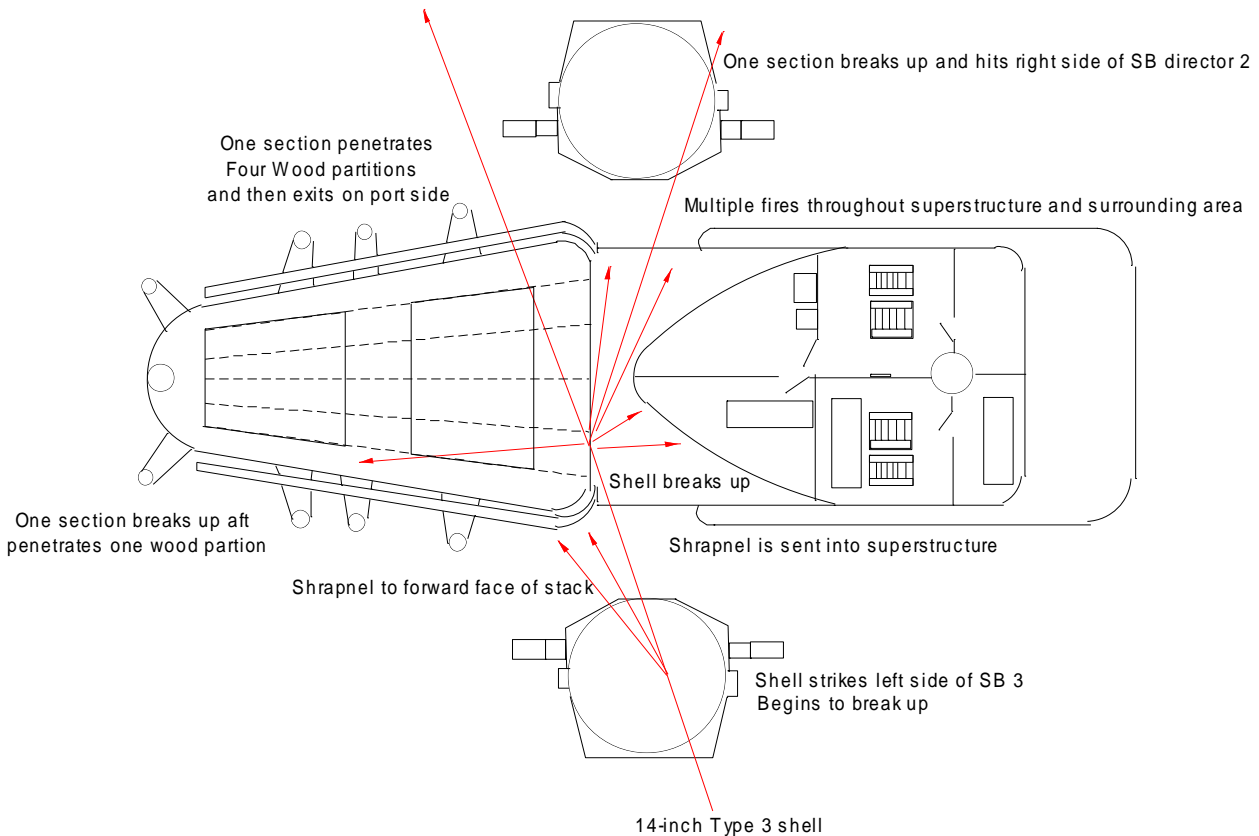
**Figure 80 – Hit 23 – Path of Shell and Fragments**
