Hit 24 – 5-inch Mount No. 5

Hit 25 - Strike on Shell at Frame 109-1/2

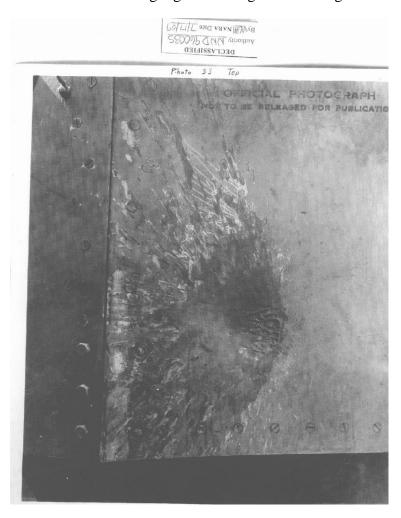
Figure 81 – Hit 24 – Damage to 5-inch Mount #5

34. Five-inch mount No. 5 was hit a glancing blow by an estimated 6-inch projectile. The 2-inch STS was sprung but not penetrated and minor structural damage was sustained inside the mount. Apparently the projectile detonated on impact. Fragments gouged both guns of 5-inch mount No. 7 and sprayed the starboard side of the deckhouse on the first and second superstructure decks between frames 93 and 100. 93

... Mount 5 – Fragment gouged left gun, not serious.

Armor sprung with minor structural damage inside mount from glancing hit.

There are no inconsistencies with this estimate. The timing of the hit is unknown. The shell detonated on impact indicating a nose-fuzed projectile, probably a 6-inch Type 0 HE projectile. The other possibility as the timing is not known would be a 5.5-inch Type 0 HE projectile from one of the light cruisers.

Note that this calculated thickness is less than the 2 inches of STS that was actually on the back of the mount. Thus, the denting with no cracks caused by this hit is consistent with a 6-inch Type 0 HE shell.

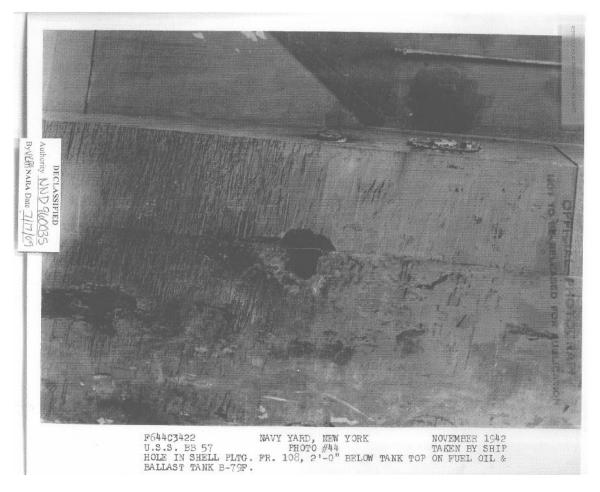
Figure 82 – Hit 25 – Impact Hole

35. An estimated 8-inch AP projectile hit the shell at the second deck, frame 109-1/2. The projectile pierced the shell at a seam between a 25-pound and a 50-pound STS strake, furrowed through the 20-pound STS second deck, pierced 10-pound longitudinal torpedo bulkhead No. 2 and penetrated the 12.2-inch longitudinal armor bulkhead to a depth of 7 to 8 inches at the top edge of the armor. Fragments went aft and pierced and distorted frames 109-112 and penetrated the third deck between torpedo bulkhead No. 2 and longitudinal armor bulkhead. Although the hole in the shell was above the waterline, compartments B-71-F, B-75-V, B-77-F, and B-79-F flooded as a result of this hit. This was reported by *South Dakota* to have been a 6-inch projectile, but it is not believed that a 6-inch projectile would have penetrated so much armor. 95

South Dakota's action report only lists a five-inch entry hole at Frame 113, three feet above the waterline. 96

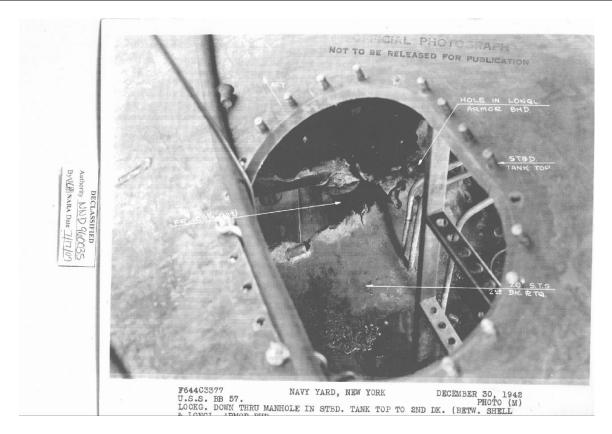
Figure 83 – Hit 25 – Damage inside Tank

There are no accurate, documented measurements for this damage. The hatch shown in Figure 83 is 26 inches long which would allow us to estimate that the hole is possibly 11 to 12 inches wide. The pipes in Figure 84 are no larger than 6-inch and this gives us a crude estimate as to the size of the pit in the plate. Only two types of projectiles would be capable of digging into the main belt as shown in this photograph and they are the 8-inch Type 91 AP and the 14-inch Type 1 AP. Based upon the size of the impact holes, this damage appears to be from the 8-inch projectile. This AP projectile ripped through the outer shell, losing its windscreen and cap head in the three prior impacts before it reached the main belt. The shell body impacted the main belt at its edge and it appears that the shell shattered at this point. If it exploded, then the explosion was probably low-order.

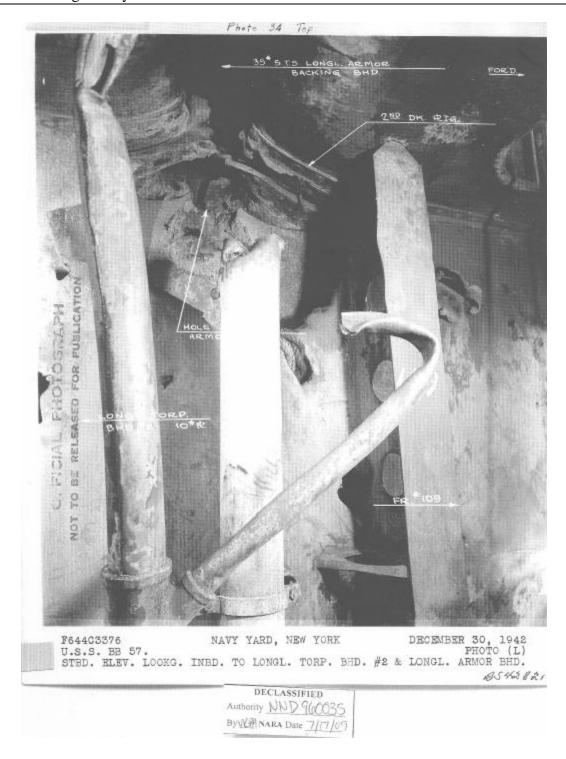
Figure 84 – Hit 25 – Damage to Main Armor Belt

The hard face of the plate failed due to the close-range, high-velocity impact shock and compression force so near the edge of the hard, brittle face material, which cracked and folded back the face there like a door on its hinge, but the shell did not penetrate the back layer because, one, it broke up as it penetrated the face layer (the 8-inch Type 91 AP shell has no AP cap and had already lost its cap head), which reduced its penetration ability considerably, and, two, the armored second deck was bracing the Class "A" armor plate edge and preventing any of the back layer from being forced out of the broken projectile's path.

A 14-inch Type 1 AP projectile would have done much more damage due to its true AP cap not being removed by the thin plates this shell passed through before it reached the belt armor. Loss of the cap head would have reduced the penetration ability of the shell somewhat, but at near right-angles and at this close range, this 14-inch AP shell would still have been able to punch entirely through the belt and gouge a deep notch in the edge of the armored deck prior to slowing to a stop and exploding. None of this happened and the holes shown are too small to have been made by a 14-inch shell. The best estimate for this damage is that it was made by an 8-inch Type 91 AP shell.
