Hit 26 – Turret III Barbette

From the BuShips damage report:

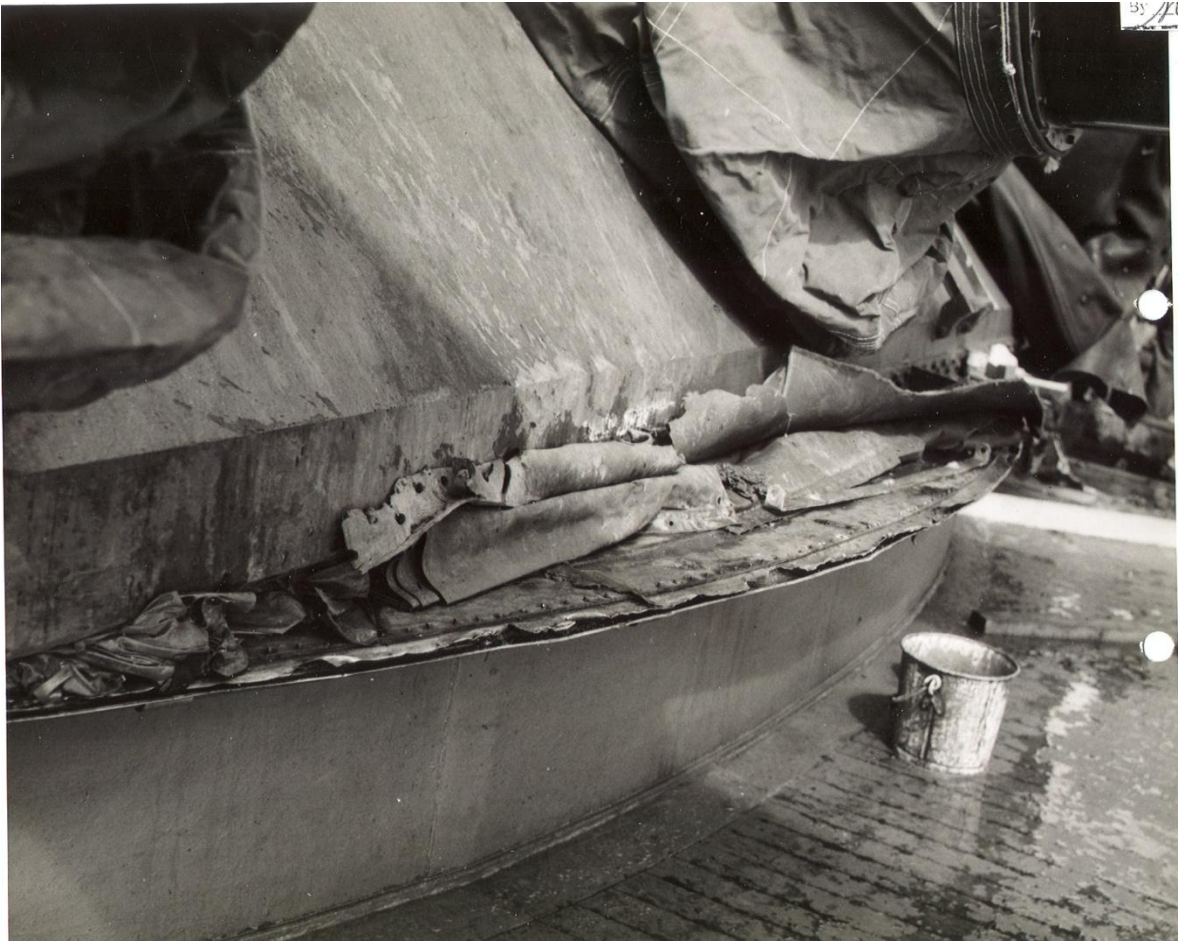
Figure 87 – Hit 26 – Damage to Turret Face

This photograph of *South Dakota* (Figure 87) shows that the forward flange, normally at the bottom of the turret face, has been destroyed and the steel bent up, which means that the blast occurred underneath the flange. In addition, two of the ladders have been blown off the face of the turret. Only the far left ladder remains attached of which the lower legs can still be seen on the right side of Figure 87. The turret in this photograph has been turned back to the centerline, which is why there is no deck damage seen in this photograph. The bloomers were reported to have caught fire after the explosion.

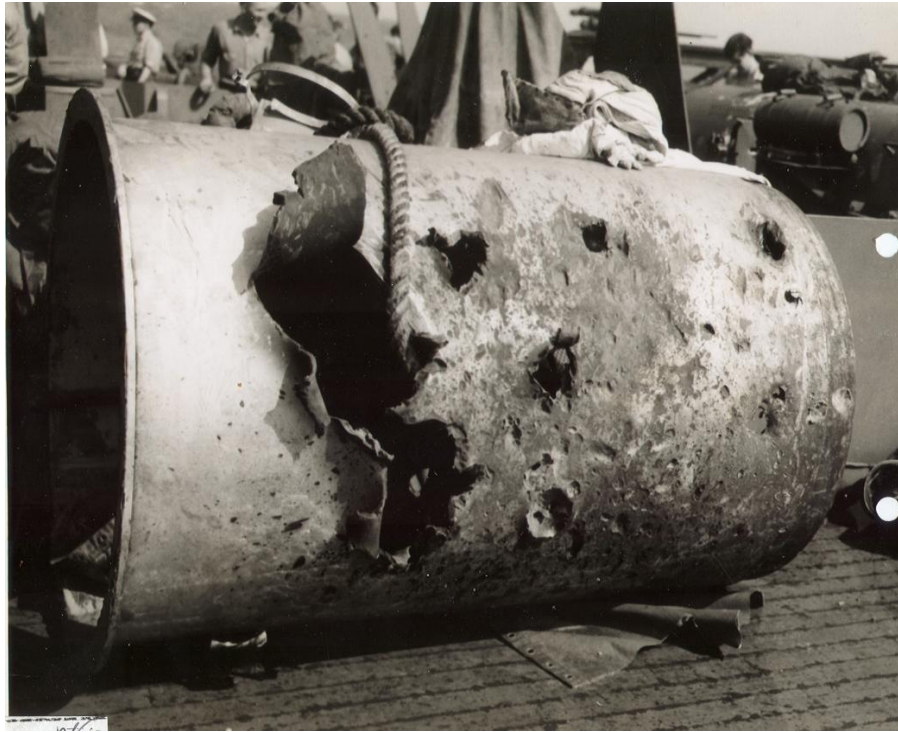
Figure 88 – Hit 26 – Damage to right gun sleeve

Figure 88 shows the damage to the right gun sleeve, which has been removed to make the gun serviceable. The damage to the gun sleeves and lack of damage to the gun barrels themselves indicates that the blast took place directly under these components. In all likelihood, the right gun was directly over the blast and the blast was then directed up and against the barbette itself. The right gun hoop received shallow indentations through the sleeve due to the fragment damage. The center gun sleeve also took damage but the gun was able to remain in service.

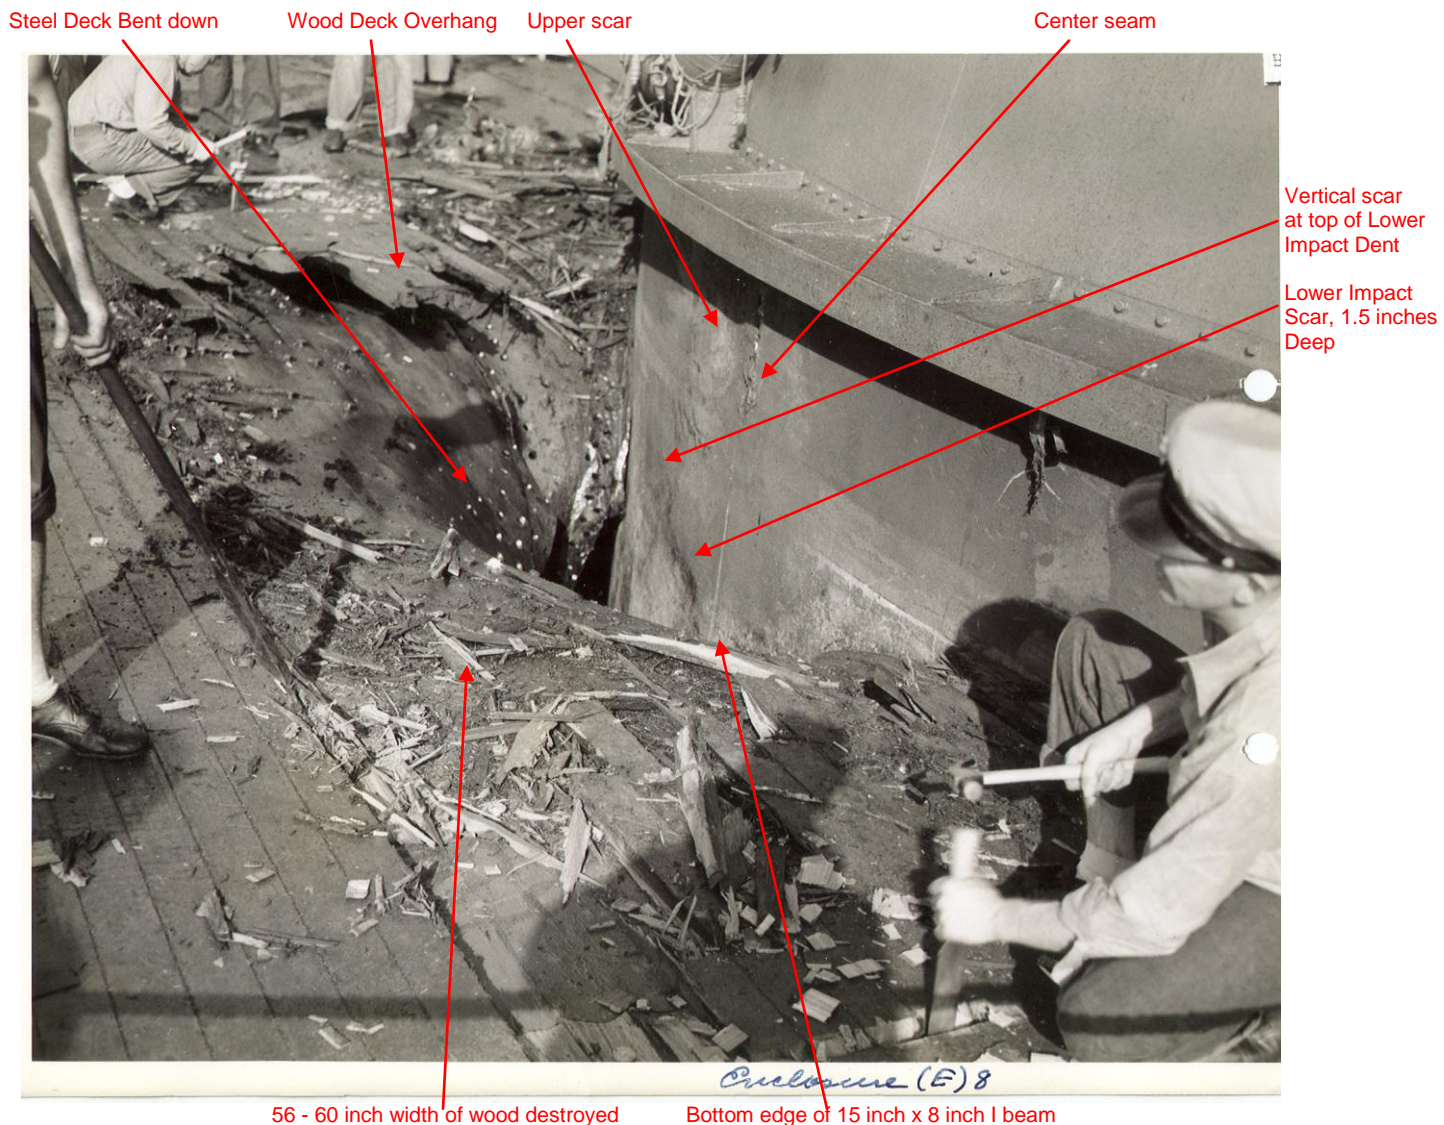
Figure 89 – Hit 26 – Deck Damage and Impact Scars

Figure 89 above was not used in the original report but is the best photograph of the damage that we have found. This photograph shows the area around Turret III above the main deck and shows that the barrette actually has two impact scars. The lower scar is deeper and represents the 15-inch x 1.5-inch deep scar noted in the report. The upper scar is a surface blemish with the center approximately 17 inches from the top of the barrette. This indicates that the original BuShips authors are applying measurements from two separate impacts as if there was only one. This photograph is looking aft with the turret now trained to the centerline. The impact is just aft of the center seam of the barrette where two 17.3-inch plates come together and the impact dislodged the joint between these two plates 8 feet down the barrette.

The lower impact seen in this photograph is below the main deck level and the steel deck is bent down in this area. The hole is directly up against the barrette and there are two measurements within the original documentation for the size of the hole. These are 3 x 10-feet and 2.5 x 12-feet. The original authors also estimated the hole was caused by the explosion but without the use of this photograph they could not see how the wood deck overhangs where the steel is bent down. This is an indication that the steel was pushed down from under the wood prior to any explosion. The shape of the hole and it being directly up

The area of wood planking damage seen in this photograph is relatively small. There are about 14 or 15 four-inch wide planks shown damaged in this photograph, giving a width of 56 or 60 inches of damaged deck area as noted in Figure 89. There would be 7 planks remaining before the outer limit of the hole is reached so this means that the hole is approximately 28 to 32 inches wide, which is close to the 2.5 foot x 12 foot measurement given in *South Dakota's* action report. Looking closely at the lower scar, there is a vertical scar from the top of the dent and a different color line that runs through the top of the dent which will help identify this impact scar in other photographs. The different color line that runs through this scar also marks the lower edge of a circular 15 inch x 8 inch I-Beam that supports the main deck, which will help estimate the distance below the main deck that the center of the lower impact was. The lighter color band on the barbette is where the main deck was pressed up against the barbette and marks the original deck level. Based on the documentation in the reports, the deck and Athwartship I-beams 123 and 126 underneath was bent down out to 8 feet from the barbette and then severely bent down the last 3 feet.

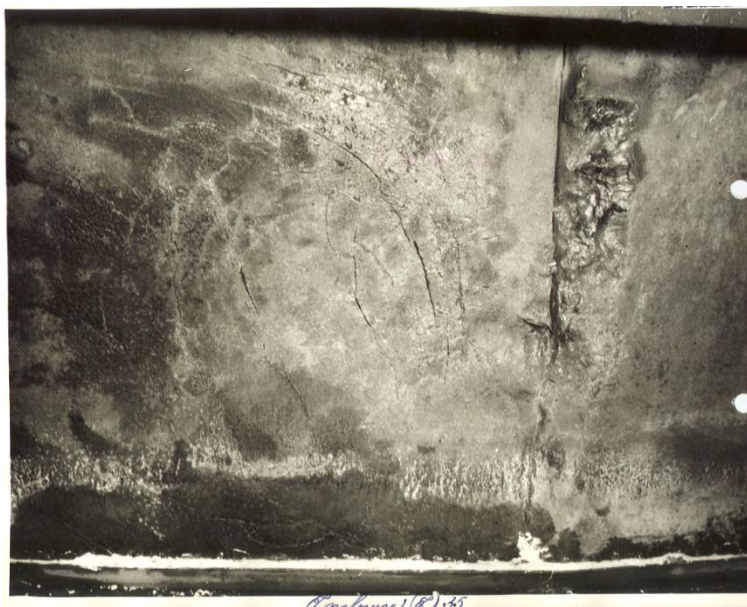
Figure 90 – Hit 26 – Upper Impact Scar

Figure 90 is a close up of the upper scar damage to the plate. This photograph was used in the original BuShips report and may have been the only one of two that the original authors used. The top of the flange at the very top of the barbette can be seen in the upper right corner of the photograph. The vertical seam and right side gouge can also be seen along with the lines that marked where the main deck used to be. This scar did not significantly dent the armor and resulted in surface flaking of the plate with deeper cracks at the center. If viewed by itself this photograph would suggest that the impact was made by a HE shell due to the lack of damage to the plate surface.

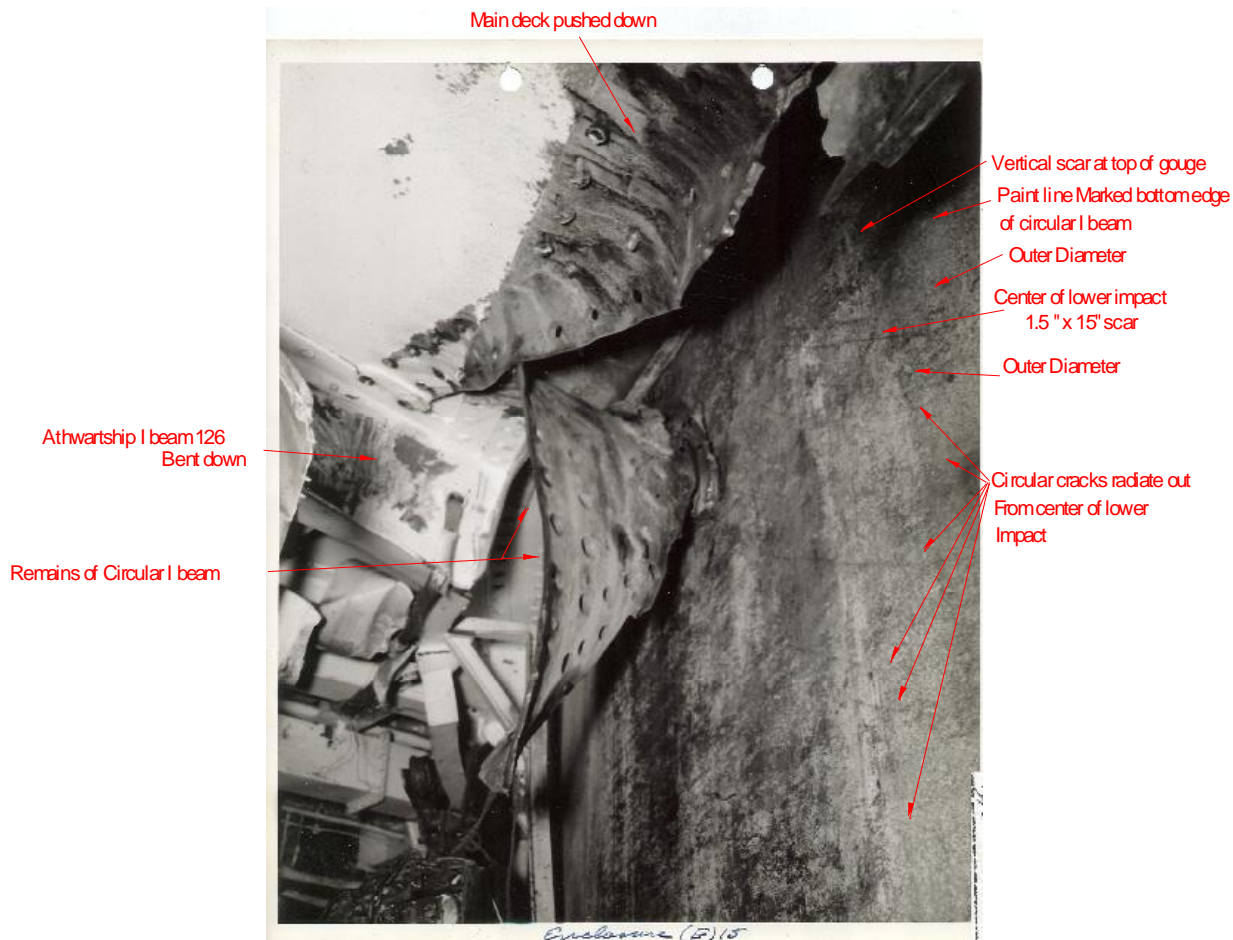
Figure 91 – Hit 26 – Lower Impact Scar

Starboard side of #3 barbette has plating dished in 1½" over an area of 15" in diameter aft of seam. Circular cracks extending over this area. Vertical cracks extend aft 8' around barbette.

Figure 91 is the second photograph used in the original report. This shows the lower impact site looking up from the 2nd deck level. The photograph is looking aft and shows that Athwartship I-beam 126 has been bent down and the remains of the circular I-beam it supported that surrounded the barbette. The main deck has been pushed down and the center of the lower gouge (marked with an X) is approximately 4" below the original line that marked the bottom edge of the circular I-beam. It also shows circular cracks on the surface of the Class "A" plate that radiate out from this impact and a minor vertical scar at the top of the gouge which can be seen in the photograph looking at the scars from above the main deck. These are the circular cracks documented in *South Dakota's* report, which is quoted here: "Starboard side of #3 barbette has plating dished in 1.5" over an area of 15" in diameter aft of seam. Circular cracks extending over this area."

Concentric cracks in the brittle face of Class "A" armor are virtually always seen when a face-hardened plate is impacted hard enough to make a significant dent or hole in it. The surface layer is extremely brittle and the shock waves rippling outward along the face and those going into the plate and reflecting from the plate back or hard-face-to-soft-back plate boundary cause a Moiré (interference) Pattern on the surface where they null and reinforce each other, which is why the cracks seem to be so evenly spaced. This is a very important clue because it shows that the 17.3-inch Class "A" plate took a major shock

below the normal level of the main deck. These cracks show that the shell body impacted here and not at the upper scar at 17 inches below the top of the barbette.

The center of the impact is approximately 4 inches below where the original bottom edge of the circular I-beam that supported the main deck was. This places the center of the lower impact at 20.5 inches below the top of the 1.5-inch STS steel weather deck and this is approximately 51 inches from the top of the barbette as measured from the top of the flange to the center of this impact site.

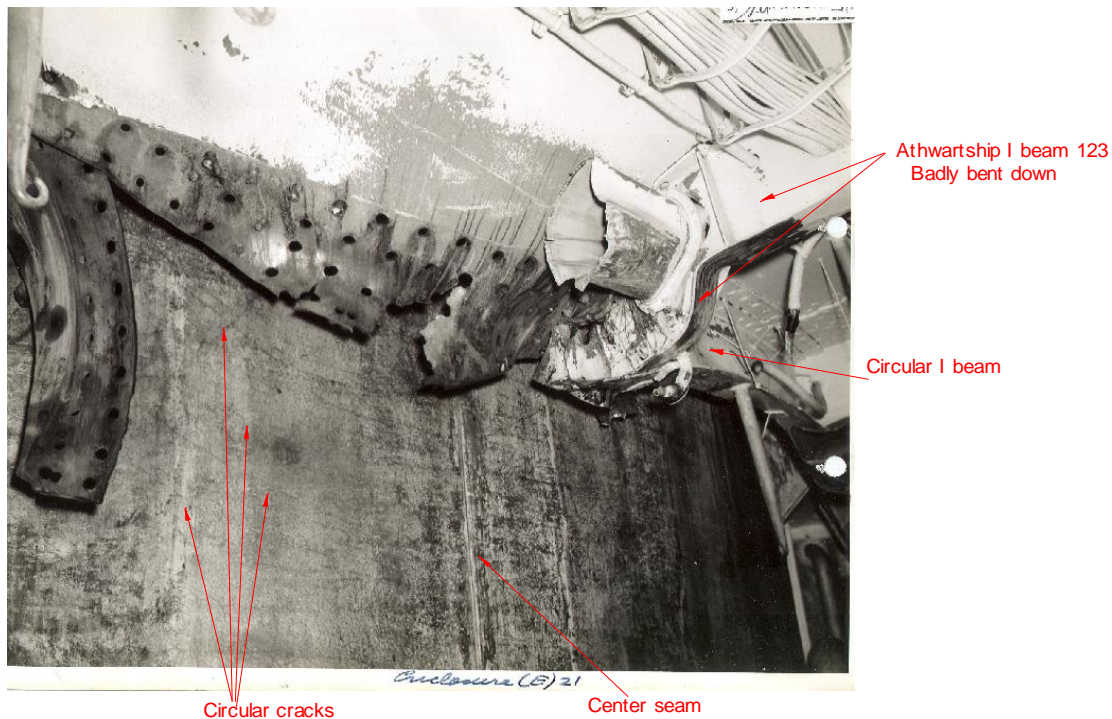
Figure 92 – Hit 26 – Bent Weather Decking

Figure 92 above is looking a bit forward. The lower impact scar is hidden due to the distorted main deck, but this view shows Athwartship I-beam 123 and how it is bent down. Also shown are the remains of the circular I-beam it once supported. You can still see the faint circular cracks along with the center seam between Class “A” plates.

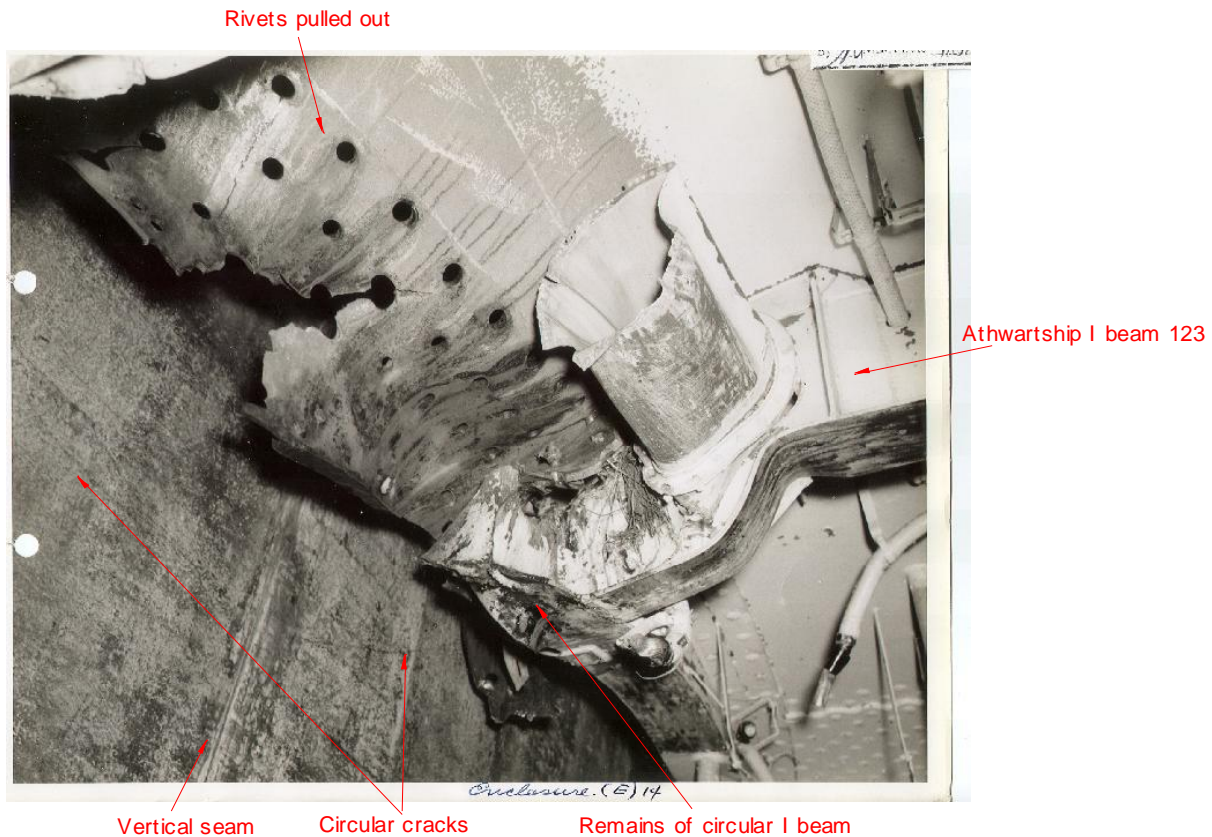
Figure 93 – Hit 26 – Remains of Circular I-beam

This closer look in Figure 93 shows how the riveted structure between the circular I-beam and the barbette was pulled apart with many rivet holes remaining intact. This view also shows how the circular cracks crossed over the seam between the two plates and that the circular I-beam itself was twisted and ripped in half. Athwartship I-beams 123 and 126 were bent down 8 feet out from barbette with the last 3-4 feet being severely bent down.

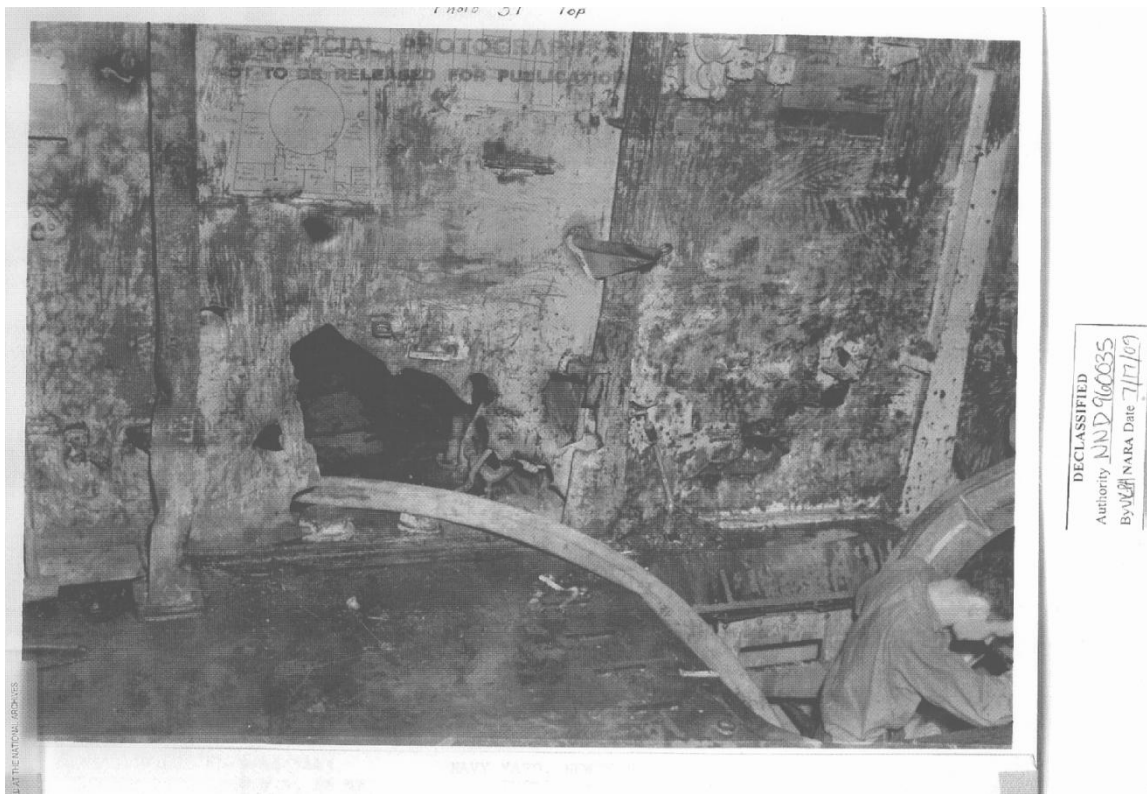
Figure 97 – Hit 26 – Damage to Bulkhead 129

4 steam lines carried away, 2 temporarily repaired. Large hole starboard side of door 2-129-1, is 26" by 38". 11 other holes at this side of door in same area are about 10' by 4' from deck.

Watertight door 2-129-1 bent and cut and is damaged beyond repair.

Door frame 2-129-1 bent and bulkhead and side of door frame dished in 6". 3 holes near deck 3' from starboard of door are 12" by 4" and 10" by 3".

Figure 97 taken aboard the USS *South Dakota* shows the damage to bulkhead 129 and the size of the fragments. The large hole is probably the 26 inch x 35 inch hole documented in the report. There appear to be scars on the armored second deck where fragments were deflected through the bulkhead. The I-beams have been twisted and some cut.

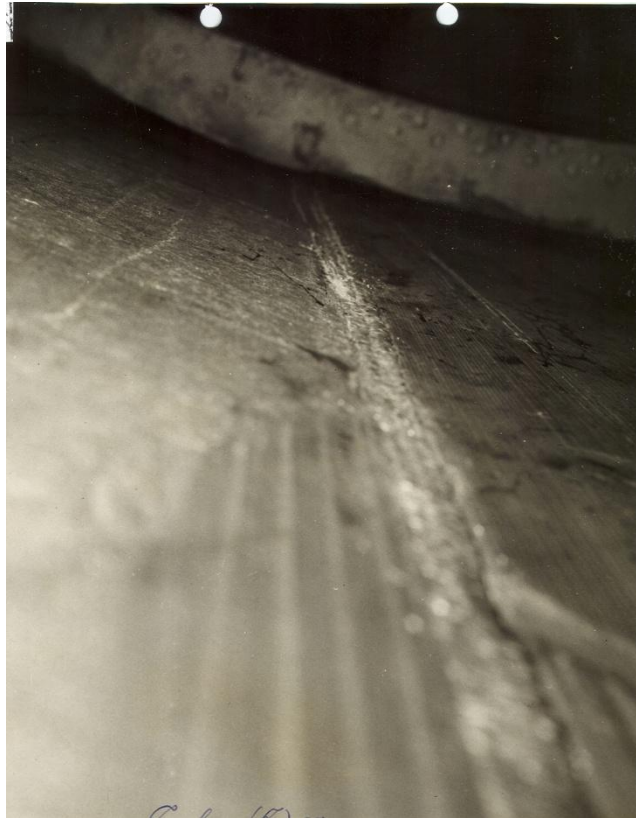
Figure 104 – Hit 26 – Damage to Roller Path

Figure 104 shows the center seam between Class “A” plates within the barquette and the twisted and bent roller path that gave the turret difficulty in training after the battle. This damage was most likely caused by shock either by the impact force or by the explosion transmitted through the 17.3-inch Class “A” plate that protected the roller path.

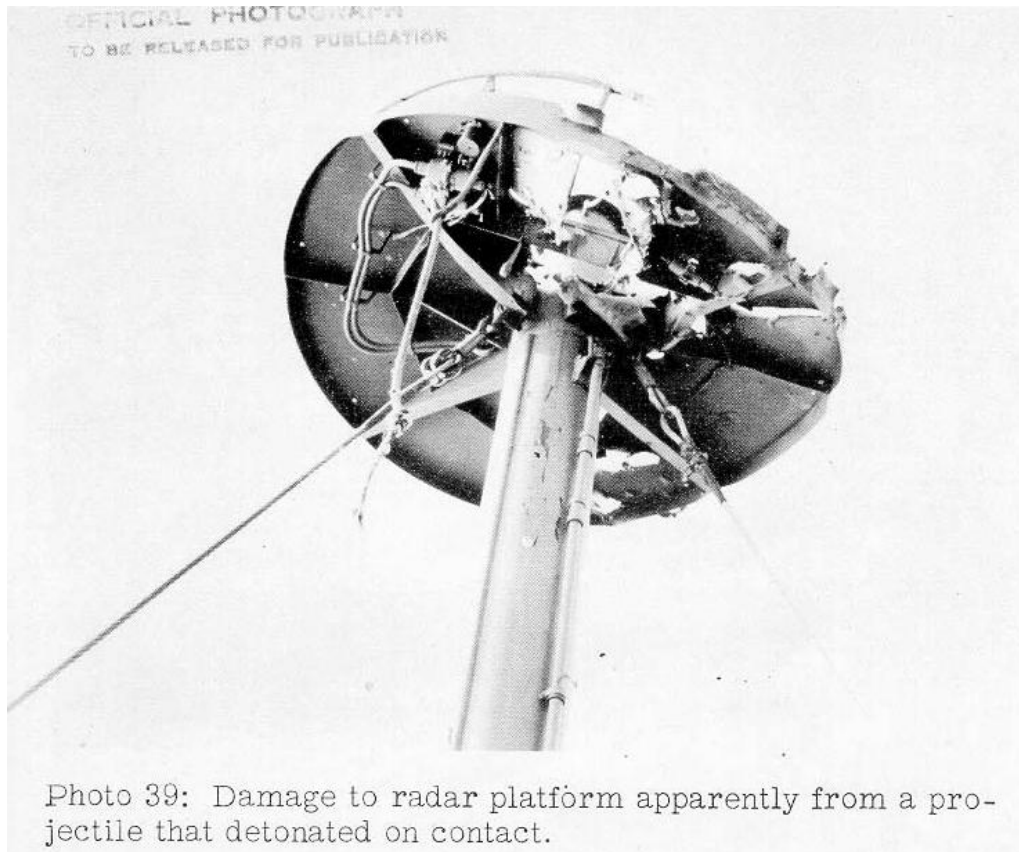
Figure 117 – Hit 27 – Radar Platform

For this damage it is not clear if it was caused by fragments or a direct hit. In BuShips report Plate 1 it is listed as fragment damage but the BuShips' caption on the photograph in Figure 117 implies a direct hit. If so, a 5-inch nose fuze, Type 0 HE projectile is the most likely due to the relatively small area of the platform destroyed and it appears the shell detonated on impact. There are not many shell impacts close to the platform that actually detonated, so it seems unlikely that this damage was from fragments. Most of the shells that struck near Sky Control passed through the superstructure without detonating (Refer to [Hits 9](#) and [12](#)).
