Hit 6 – No. 1 Secondary Director

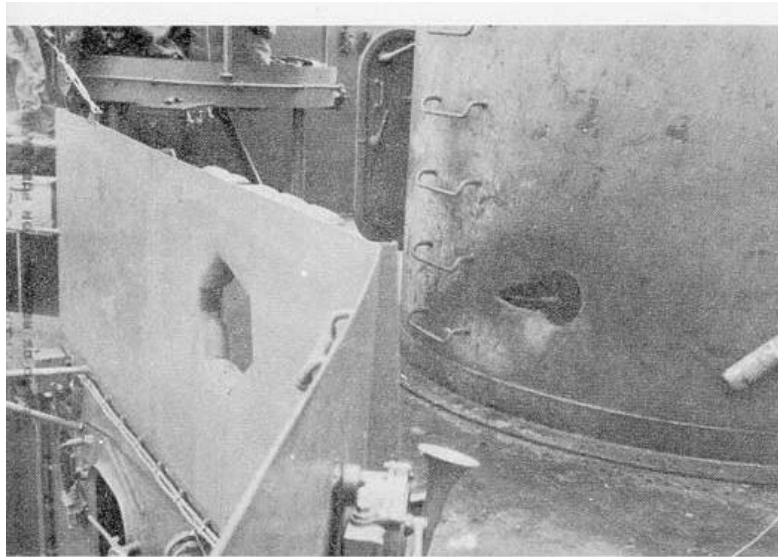
Figure 18 – Hit 6 – Entry Holes

1 18" hole in ¼" STS splinter shield two feet above deck level at frame 73 starboard.
1 36" by 48" hole in ¼" STS splinter shield at frame 74 port 3' above deck level.
1 shell hole 10" by 16" through 1½" STS circular foundation plate of #1 5" director at frame 73 starboard, 6" above bottom level.
1 12" shell hole through 1½" STS circular base of #1 5" director at frame 73 port, 6" above deck level.
Center column structure and bounding angle of #1 5" director completely demolished.³⁹

Photo 6: Hit No. 6. Projectile holes through starboard splinter shield and into 5-inch secondary battery director foundation.

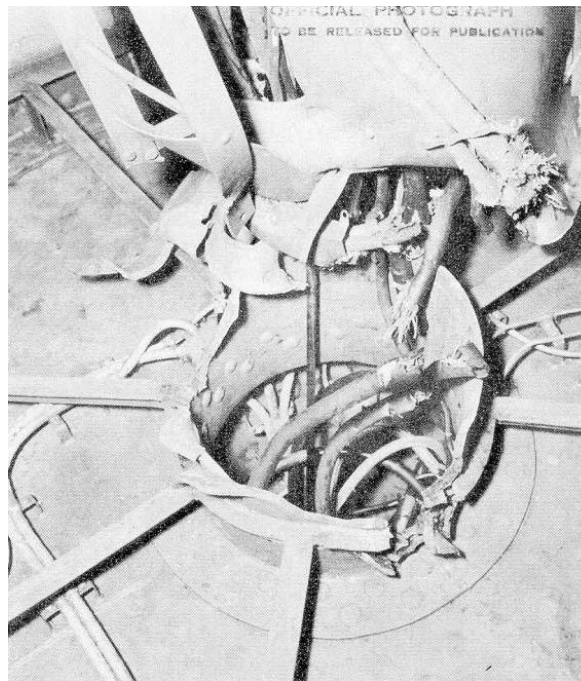
Figure 19 – Hit 6 – Damage to Secondary Battery Director

Secondary Battery Director #1 was struck by an 8" projectile which entered foundation about one foot from deck, starboard side, passing through center column and out port side. All cables were out. Roller path believed to be completely out of alignment.⁴⁰

Photo 7: Center column of 5-inch secondary battery director destroyed by hit No. 6.

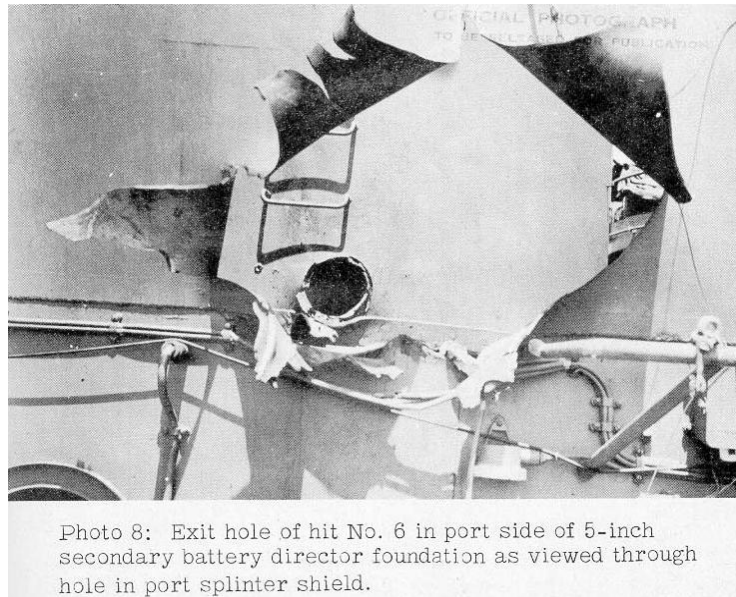
Figure 20 – Hit 6 – Exit Hole

20. The 10-pound STS splinter shield was hit at frame 74 about two feet above the house top deck. The projectile penetrated the 60-pound STS foundation of No.1 five-inch secondary battery director, severed the center column, passed out through the port side of the director foundation and the port splinter shield at frame 75 without detonating. A small electrical fire started and ignited some life jackets. It is estimated that this was an 8-inch AP projectile.³⁷

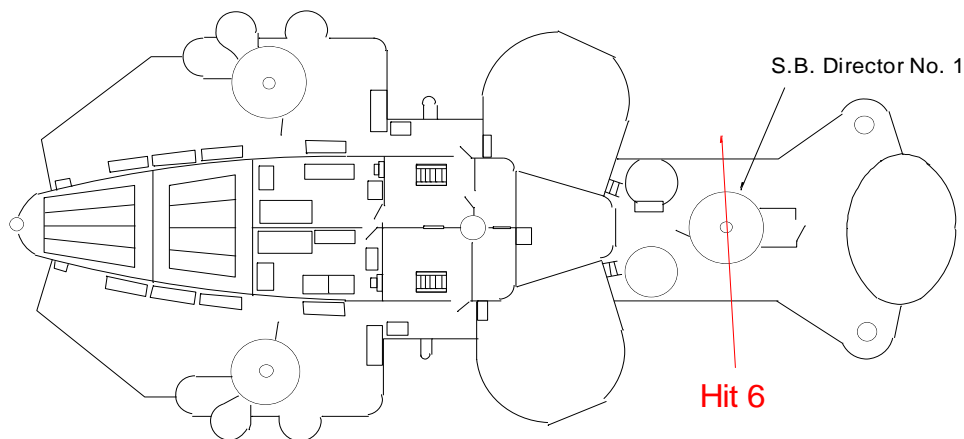
Figure 21 – Hit 6 – Path of Shell

There is not any inconsistency with this estimate of the shell being an 8-inch AP projectile. The reported 10-inch and 12-inch holes through the circular foundation eliminate any possibility this was from a larger caliber. The hit is documented in *South Dakota's* action report as occurring at 0102 and this is also the time when *Takao* opened fire.⁴¹

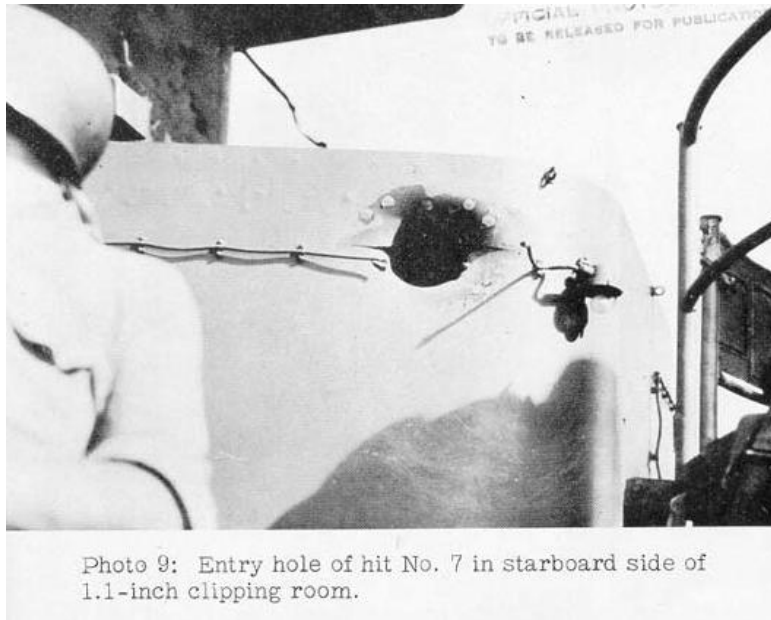
Figure 22 – Hit 7 – Entry Hole

10" hole in STS structural bulkhead in 1.1" magazine and clipping room 6' above deck level at frame 78 starboard.

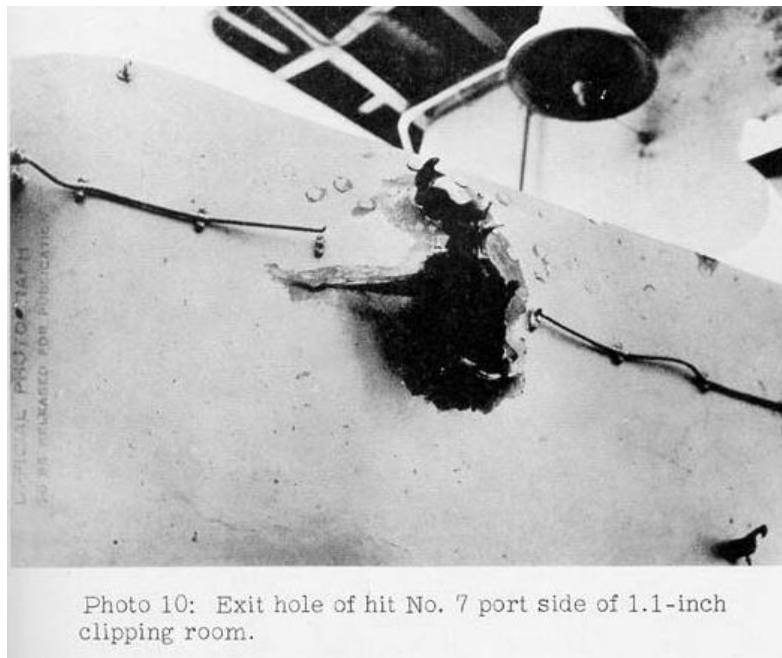
Figure 23 – Hit 7 – Exit Hole

18"-24" shell hole in STS structural bulkhead in 1.1" magazine and clipping room 6' above deck level, frame 78 port.

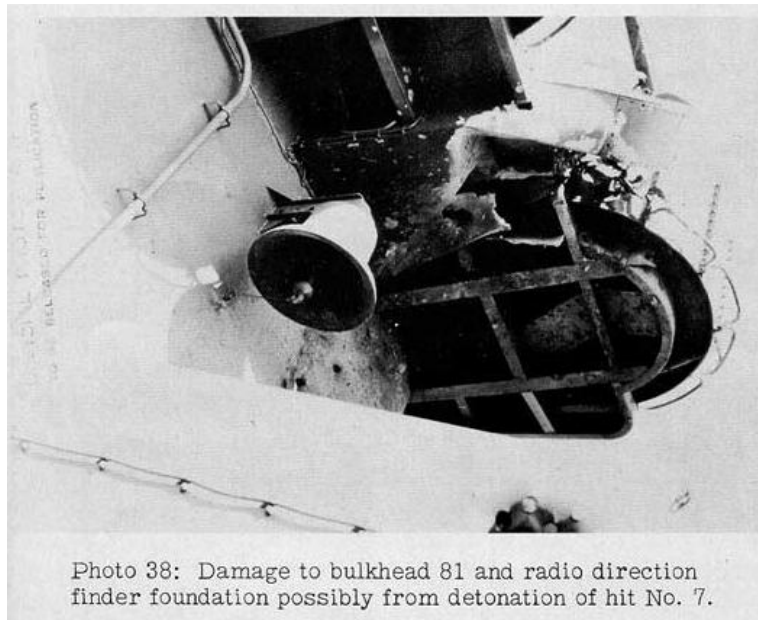
Figure 24 – Hit 7 – Shrapnel Damage near ship's bell

1-6", 3-7" and 1-4" shrapnel holes through 3/8" STS splinter shield around 1.1" quad No. 4, frame 78 port.

6 shrapnel holes in steel deck plating within circular area of 1.1" quad No. 4. Average size of holes 4".

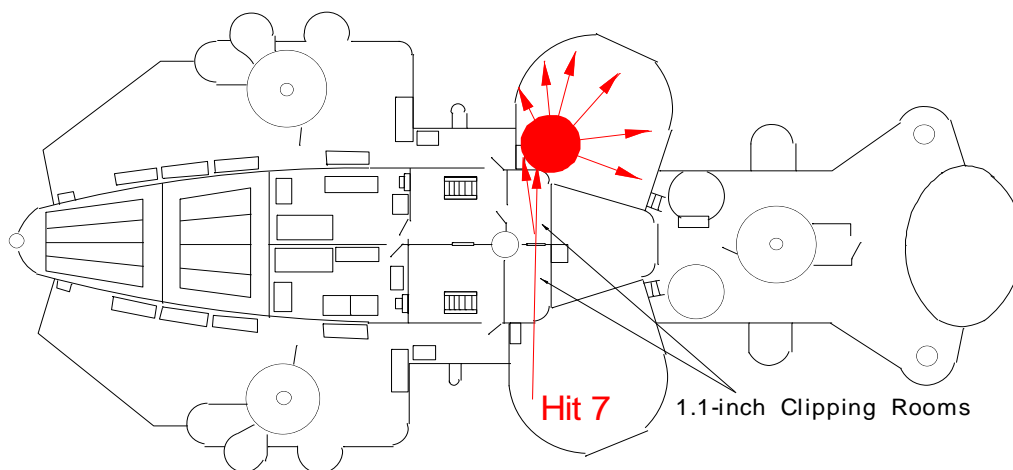
Figure 25 – Hit 7 – Path of Shell and Splinters

21. The 30-pound STS bulkhead of the 1.1-inch clipping room was pierced by a projectile that passed through and out about 6 feet above the housetop at frame 78-1/2 and detonated over No. 4 1.1-inch quadruple mount. Three fragments penetrated the 15-pound STS splinter shield around the mount exploding the ready service ammunition on the shield and six fragments pierced the deck within the working circle of the mount. The mount itself was badly damaged by fragments. Within the 1.1-inch clipping room the centerline beam was severed, the overhead blown open, ventilation ducts crushed and insulation badly damaged. Several 1.1-inch clips exploded and ignited life jackets of dead and wounded men. The sprinkling system was cut in three places and 75 1.1-inch clips were destroyed. From the size of the hole it is estimated that this hit was an 8-inch AP projectile.⁴²

This hit is documented as being the first one received by *South Dakota* and occurred at 0049. At this time, the heavy cruisers are 11,000 yards off *South Dakota*'s bow heading west and have not yet even spotted *South Dakota*. This makes BuShips' estimate of an 8-inch shell impossible. It also could not have come from any of the destroyers as they were equipped with only nose-fuzed projectiles which would have exploded on impact, which this shell did not, indicating that it was a base-fuzed projectile. The light cruisers *Nagara* and *Sendai* were engaged with *South Dakota* at this time and this hit is most likely a 5.5-inch capped Common projectile or a base-fuzed 5.5 inch Type 4 Common projectile from one of them. The shell detonated as it exited the port side, blowing the larger hole in the second bulkhead. The shell trajectory being almost straight through the compartment matches *Sendai*'s position at 0049 which was abeam of *South Dakota* while *Nagara* was slightly aft of her beam.

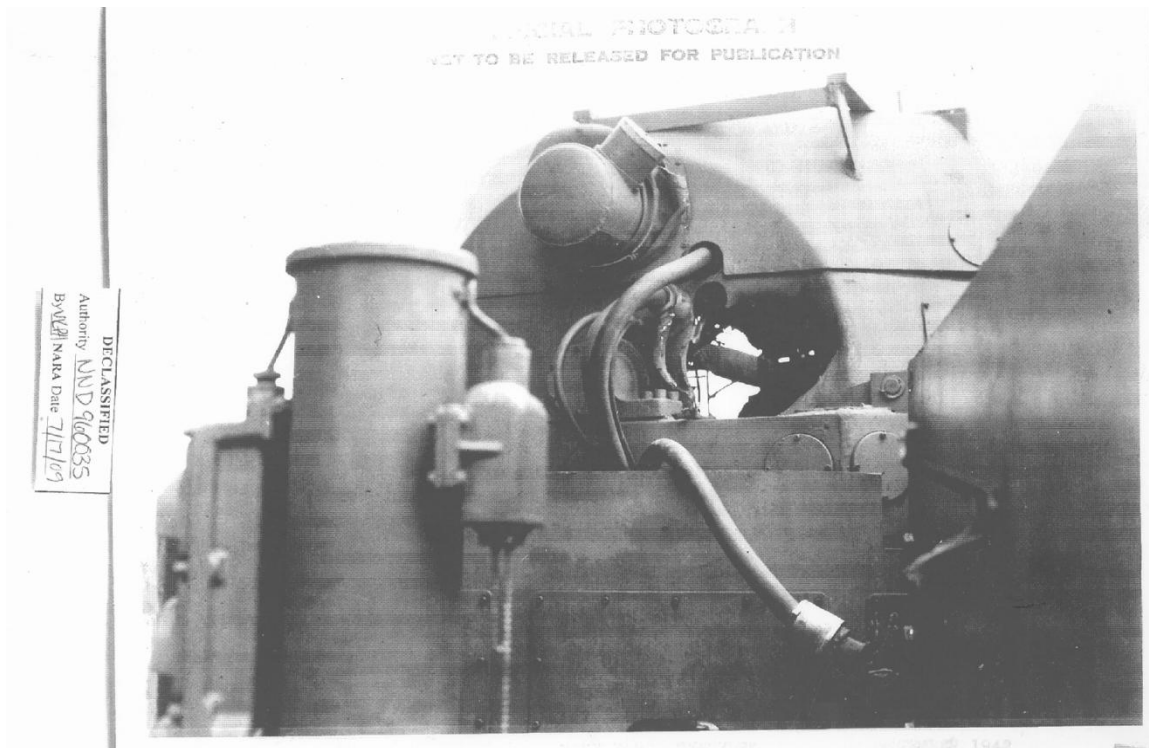
Figure 26 – Hit 8 – Mk. 45 1.1-inch Director

22. This projectile, probably 8-inch, hit the Mk. 45 1.1-inch director on the third level above the house top at frame 79. It ripped through the director apparently without exploding.⁴⁷

Mark 45 1.1" director demolished.⁴⁸

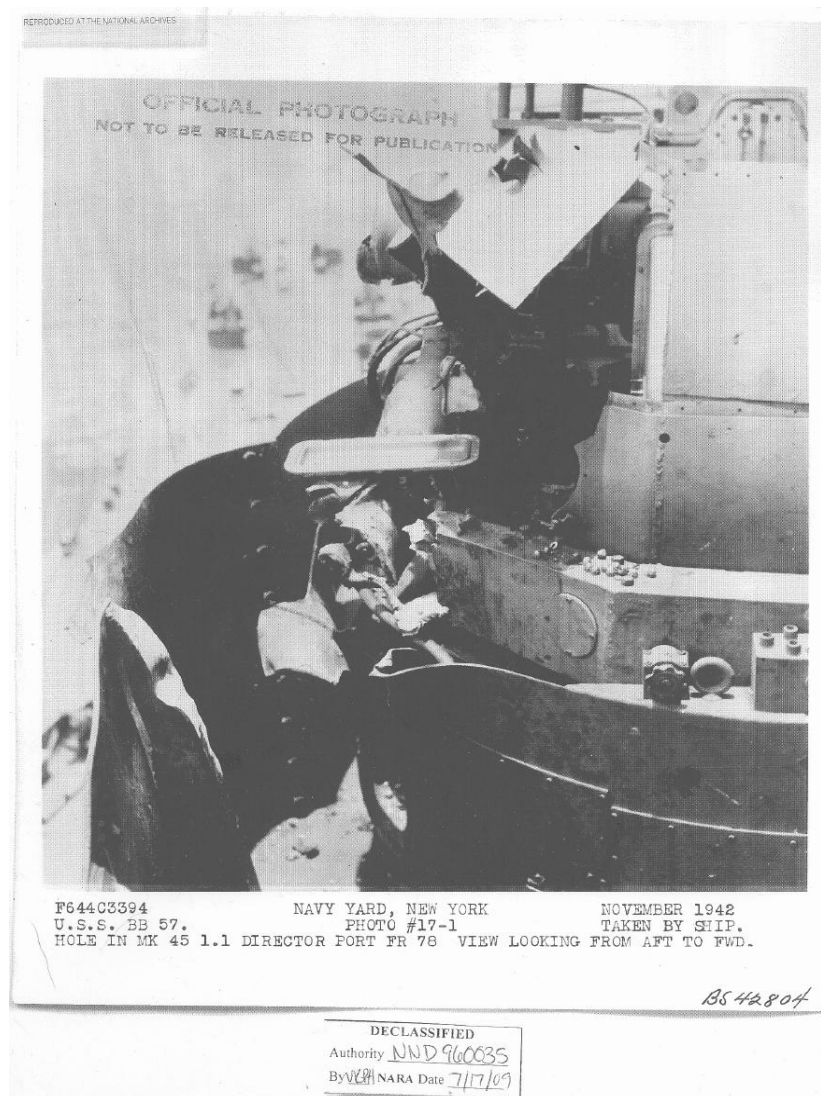
Figure 27 – Hit 8 – Damage to Mk. 45 Director

A 5.5-inch base-fuzed projectile fired by the light cruisers may be a better estimate for this hit. An 8-inch shell should have caused much more damage to the director due to the nose coverings flattening out on impact. This hit may have occurred at a similar time as [Hit 7](#), which struck just below this level and which would have occurred before the Japanese heavy cruisers opened fire. The dimensions of the damage for Hit 8 are not recorded, so it is difficult to make an accurate estimate for this hit.

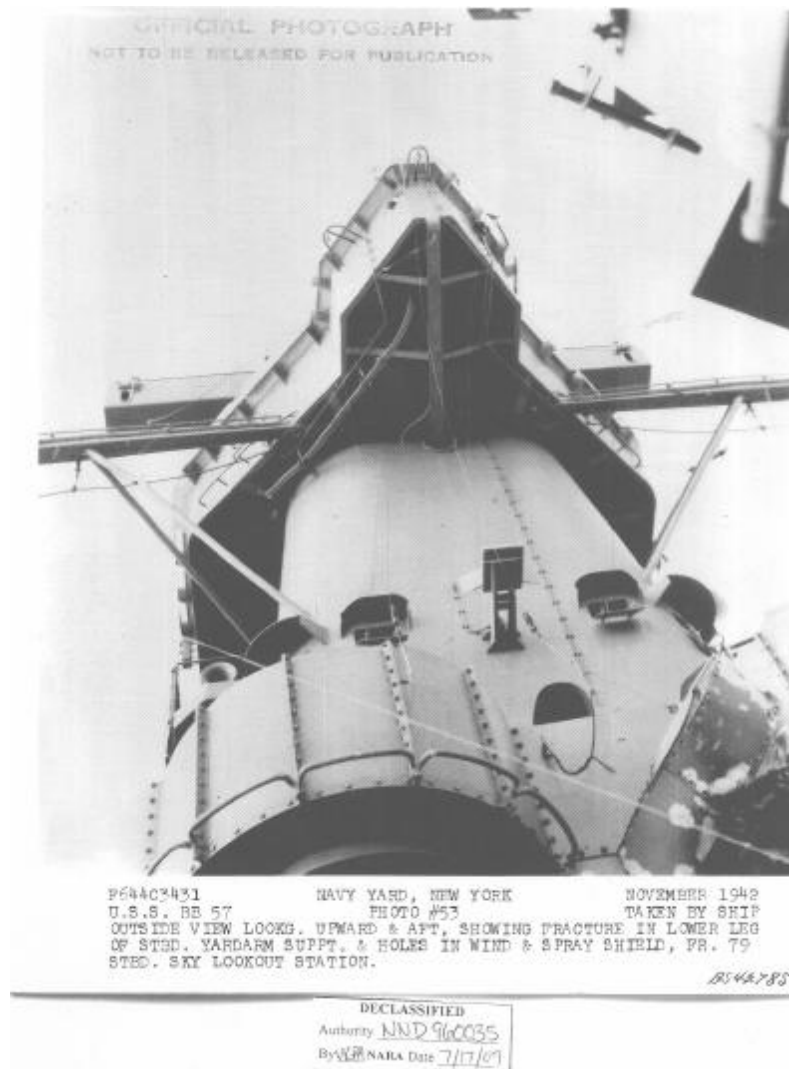
Figure 28 – Hit 9 – Sky Lookout Station

23. The wind and spray shield around air defense forward at frame 79 had one hole on the starboard side and two holes on the port side. It is possible that the two holes on the port side were caused by different projectiles. However, it appears more likely that the cap head of an 8-inch AP projectile broke off upon hitting the starboard side of the windshield and made the second hole in the port side of the windshield. Apparently the projectile or projectiles did not detonate.⁴⁹

Forward centerline section of wind and spray shield around search radar demolished. 3-17” holes.⁵⁰

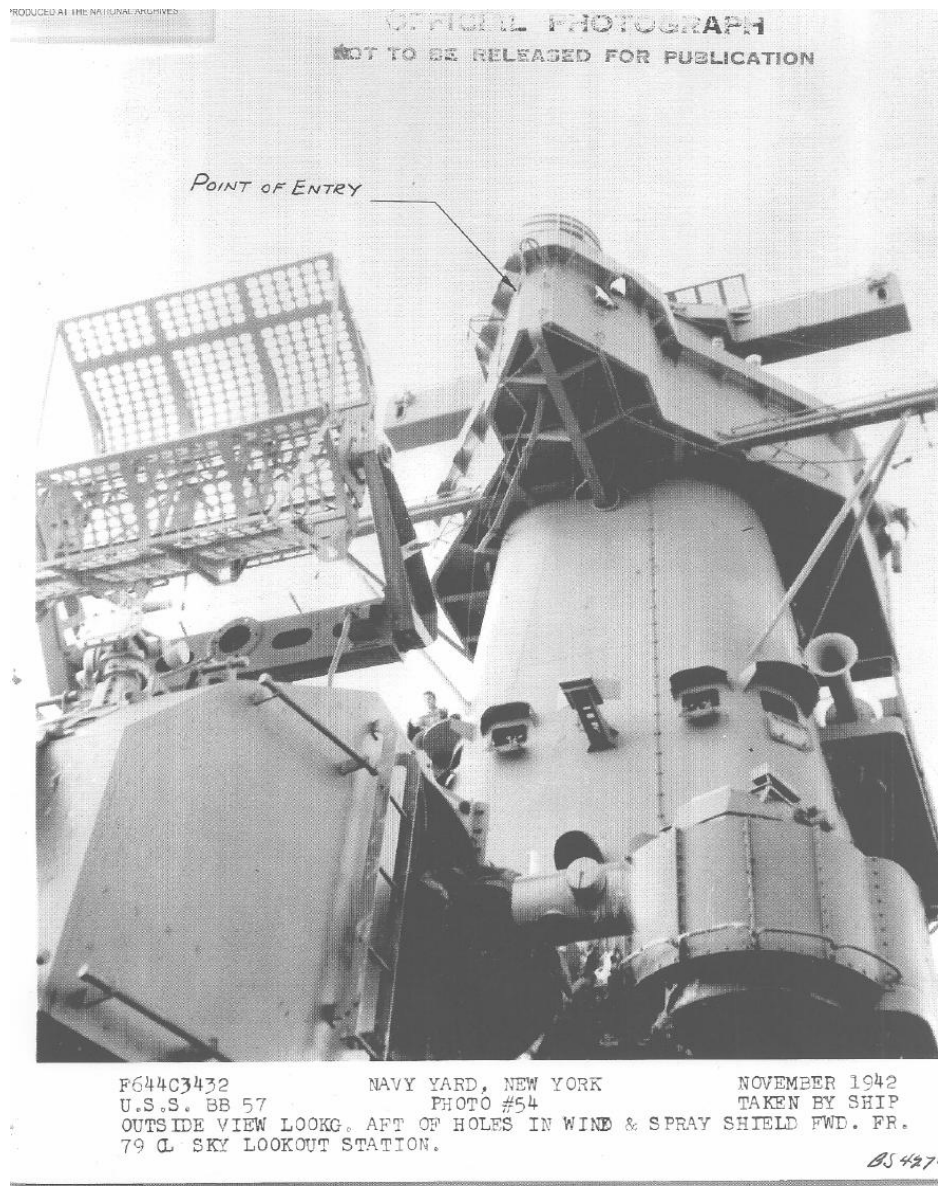
Figure 29 – Hit 9 – Entry Hole

In the left foreground of Figure 29 is the radar antenna atop Secondary Battery Director Number 1. This is not the search radar mentioned above as being damaged by Hit 9. This search radar antenna is not visible in the above two photographs.

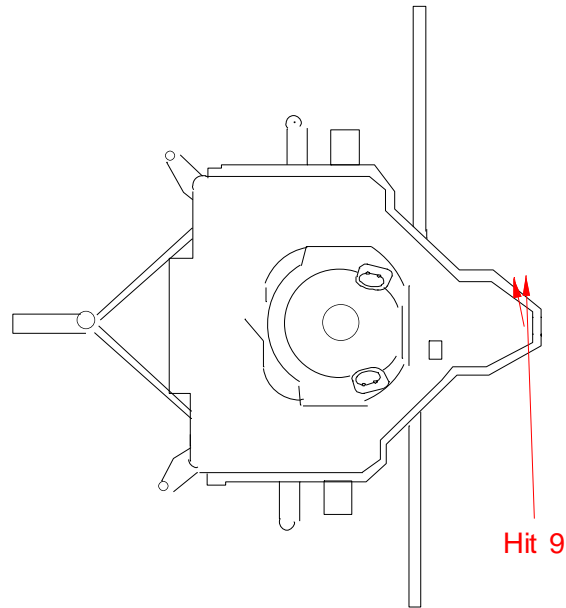
Figure 30 – Hit 9 – Path of Shell

This damage was documented in *South Dakota*'s report as occurring around 0102, so BuShips' estimate of an 8-inch AP projectile is possible. This is probably the best estimate due to the 17-inch entry and exit holes through the 0.25-inch STS plate. The cap head flying off estimate by BuShips also makes sense and accounts for the second exit hole. *Takao* opened fire at about this time, so she may be responsible for this damage.⁵¹
