Hit 26 – Turret III Barbette

From the BuShips damage report:

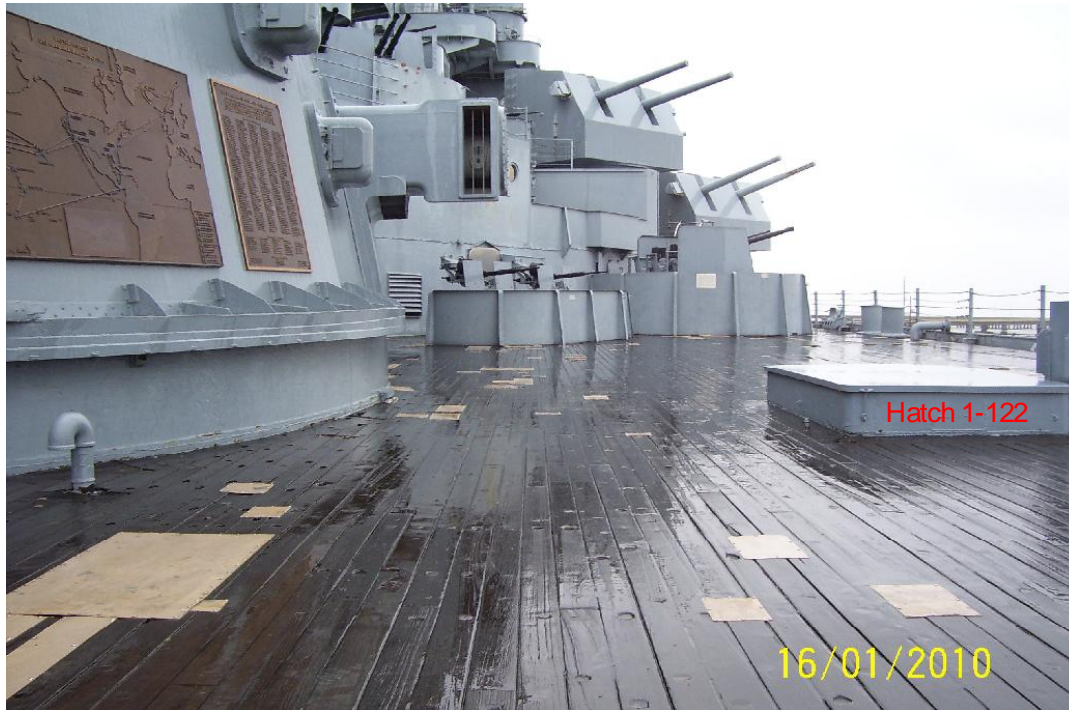
Figure 85 – Hit 26 – Turret III and Hatch 1-122 on USS Alabama
Photograph of USS *Alabama* copyrighted by Robert Lundgren

The photograph in Figure 85 was taken aboard USS *Alabama* and shows Hatch 1-122 in relation to Turret III. The damage listed in *South Dakota's* damage report is that there was a 15-inch deep semi-circular cut on both sides of the hatch. Though the BuShips report labeled this hatch as 1-128 in their report, most people believe they were actually referring to Hatch 1-122. Hatch 1-122 measures 56 inches wide x 96 inches long by 12 inches high. The forward edge lines up with frame 122 with the center seam of the barbette at frame 123.5. The aft side of the hatch is at frame 124. The distance from the inboard side of the hatch to the barbette is 118 inches. This matches the copies of USS *South Dakota's* builder's blueprints which were used for the damage report. The flange seen over the barbette is 7.5 inches wide and the distance from the deck to the bottom of the flange is 21.0 inches. The total height of the barbette measured from the top of the flange to the main deck is 28.5 inches at the center seam or frame 123.5.

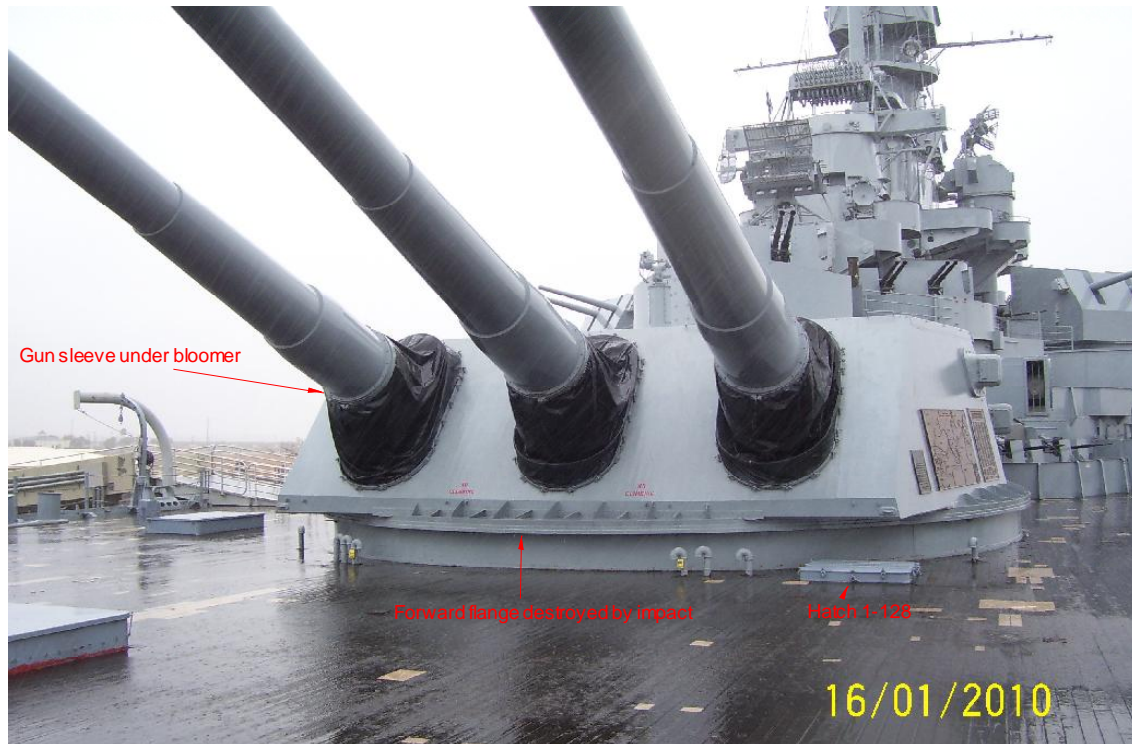
Figure 86 – Hit 26 – Turret III and Hatch 1-128 on USS Alabama
Photograph of USS *Alabama* copyrighted by Robert Lundgren

The photograph in Figure 86 was also taken aboard the USS *Alabama* and shows the relationship of Hatch 1-128 to the forward edge of the barbette. The damage listed for this hatch in *South Dakota's* report is as follows: “Davit holder besides [sic] Hatch 1-128 bent and twisted. Hatch coaming around Hatch 1-128 is torn, twisted, and cut by many pieces of shrapnel.” The forward edge of this hatch lines up with ship Frame 128. The barbette itself runs from frames 118.5 to 128.5 and each frame is 4 feet wide.

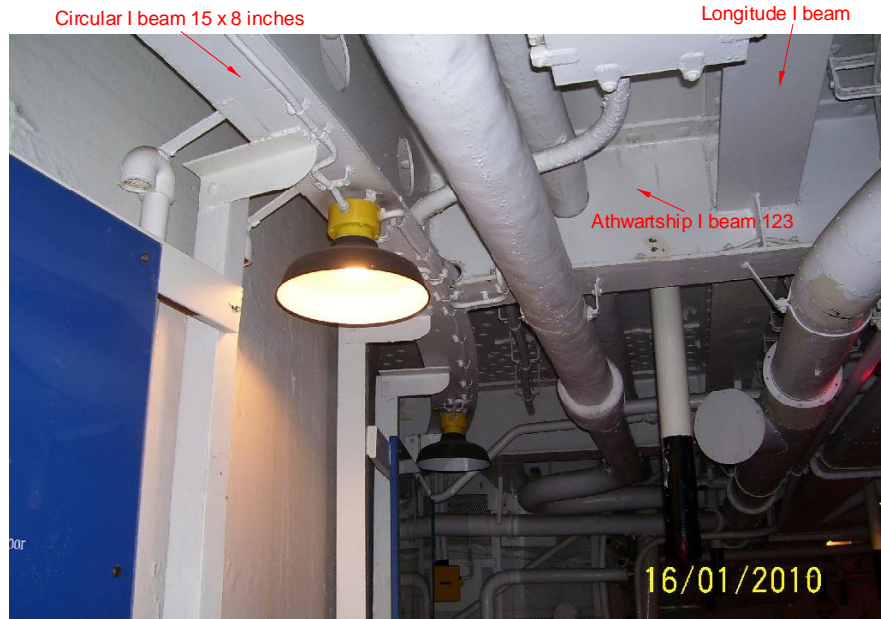
Figure 94 – Hit 26 – Athwartship I-beam 123 on USS Alabama
Photograph of USS Alabama copyrighted by Robert Lundgren

Figure 94 shows Athwartship I-beam 123 which is seen supporting the 15 x 8 inch circular I-beam that surrounds the barbette. The small angle irons seen attached to the circular I-beam are supports for the mess tables that surround the barbette and do not imply any vertical support for the circular I-beam itself.

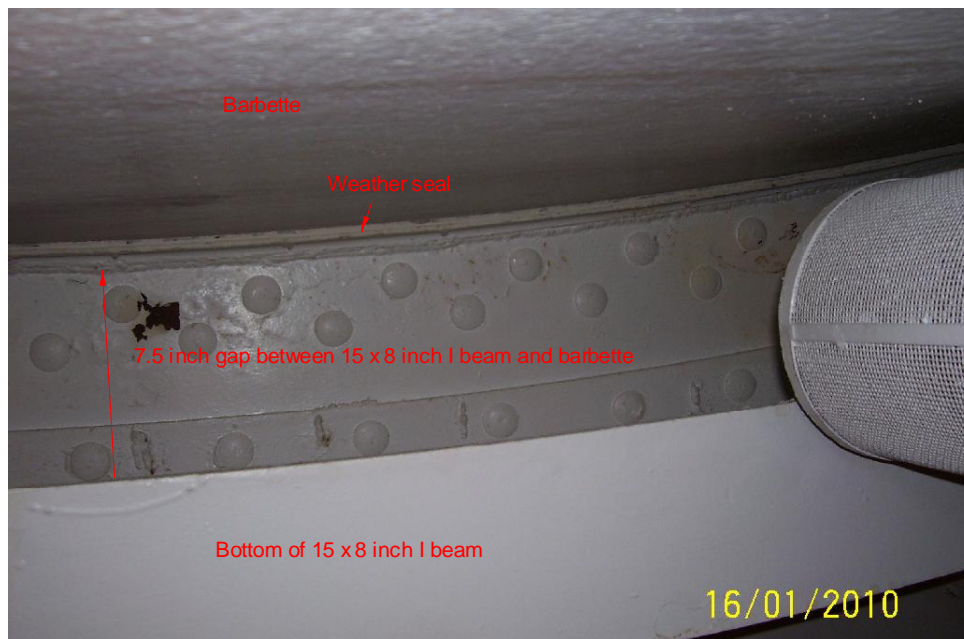
Figure 95 – Hit 26 – Circular I-beam and Barbette on USS Alabama
Photograph of USS Alabama copyrighted by Robert Lundgren

Figure 95 shows the gap between the circular I-beam and the barbette itself. The riveted structure attaching this I-beam to the main deck will be ripped down as seen in the damage photographs. The deck is not directly attached to the barbette but is sealed with a weather seal and pressed up against the barbette. The upper strength decks of the hull girder (main and second deck) are relieved of supporting the massive weights of the turrets. These weights are taken up by the platform decks, the ships sides, and the keel. In this way when the ship sags or hogs the upper strength decks are not bent by these actions. The armored weather deck, by being pressed so tightly up against the barbette, assists in holding the barbette structure rigid from lateral movements like when the ship heels or rolls. This however does leave a natural weak spot where the deck can be pushed down if the impact is heavy enough.

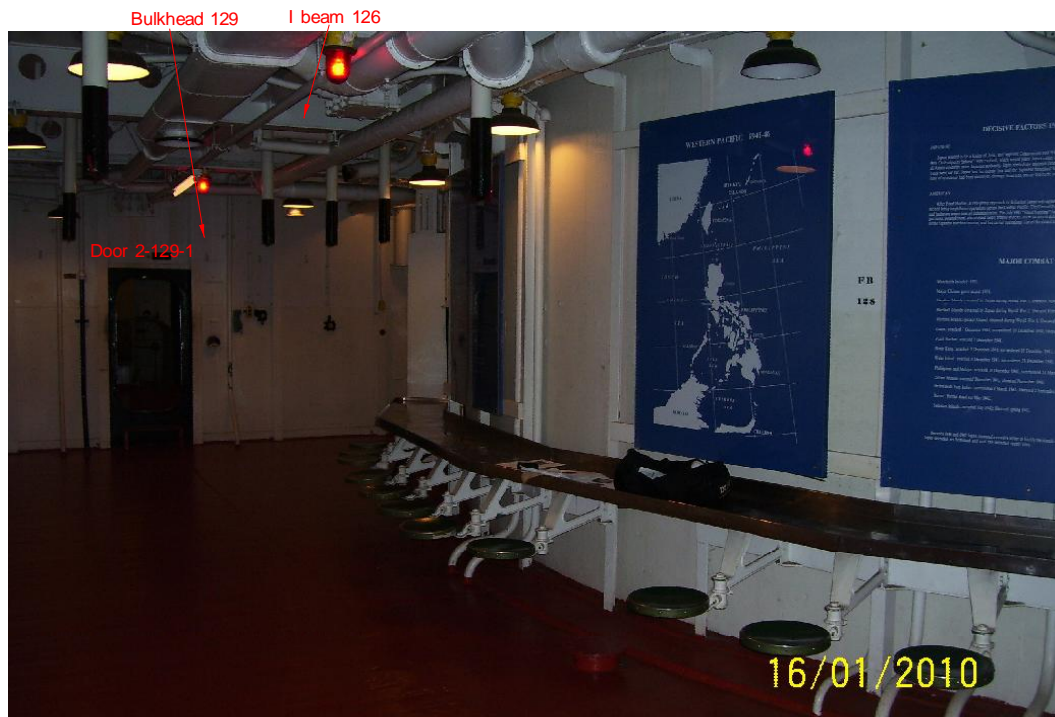
Figure 96 – Hit 26 – Bulkhead 129 and Mess Area on USS Alabama
Photograph of USS Alabama copyrighted by Robert Lundgren

Figure 96 was taken on board USS Alabama looking aft and shows bulkhead 129 and doorway 2-129-1. The equivalent compartments on USS South Dakota were heavily damaged by shell blast. This photograph also shows the ceiling filled with ventilation ducts and piping and 20 feet of mess tables with their support structure, all of which were badly damaged or destroyed when this shell exploded. A large percentage of the fragments from this hit were thrown aft towards bulkhead 129 with a very few fragments traveling sideways or forward.

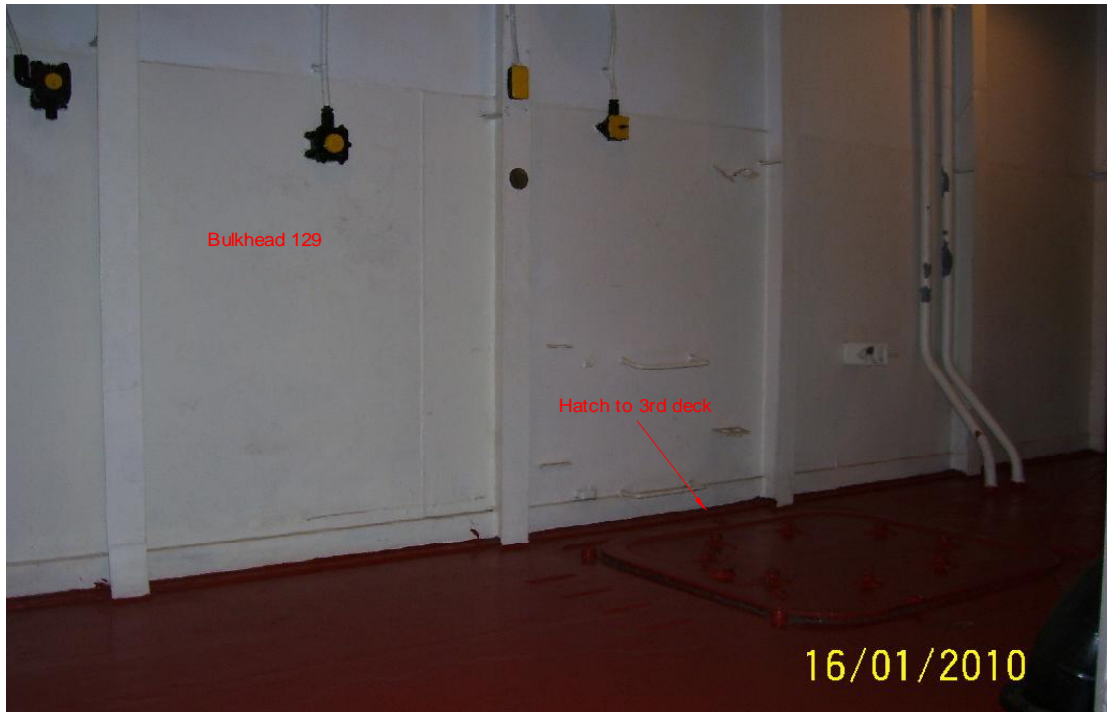
Figure 98 – Hit 26 – Bulkhead 129 on USS Alabama
Photograph of USS *Alabama* copyrighted by Robert Lundgren

Figure 98 taken on USS *Alabama* is of the same bulkhead. Note that even the vertical I-beams that make up the bulkhead are in identical locations. The two ships are framed identically around the turret with frame numbers painted on the hull and doors being labeled with identical numbers that match the *South Dakota*'s damage report. The hatch leading to the third deck is Hatch 2-128-2. On the main deck Hatch 1-128 is directly above this hatch.

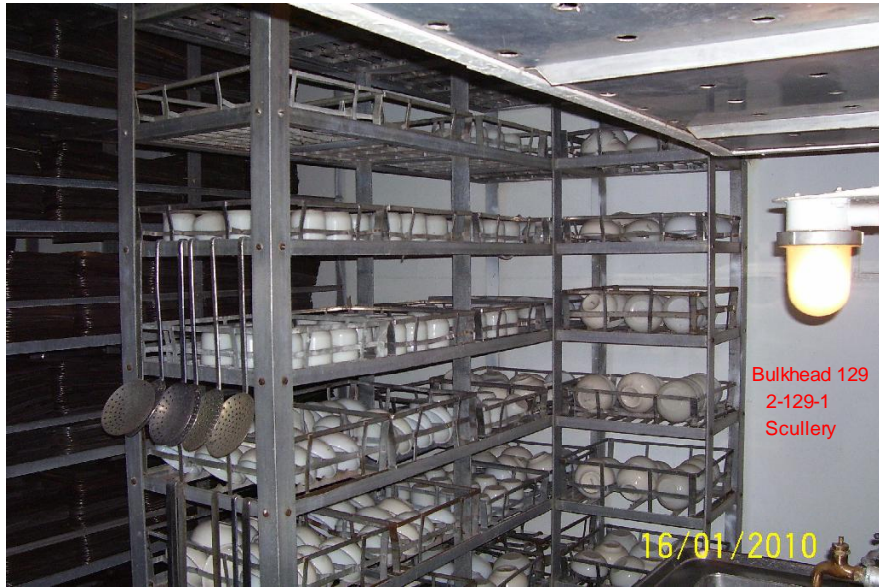
Figure 99 – Hit 26 – Scullery near Bulkhead 129 on USS *Alabama*
Photograph of USS *Alabama* copyrighted by Robert Lundgren

Figure 99 and Figure 101 show the ship's scullery on the opposite side of Bulkhead 129 as seen on board USS *Alabama* and give an idea of how the same area on USS *South Dakota* may have appeared.

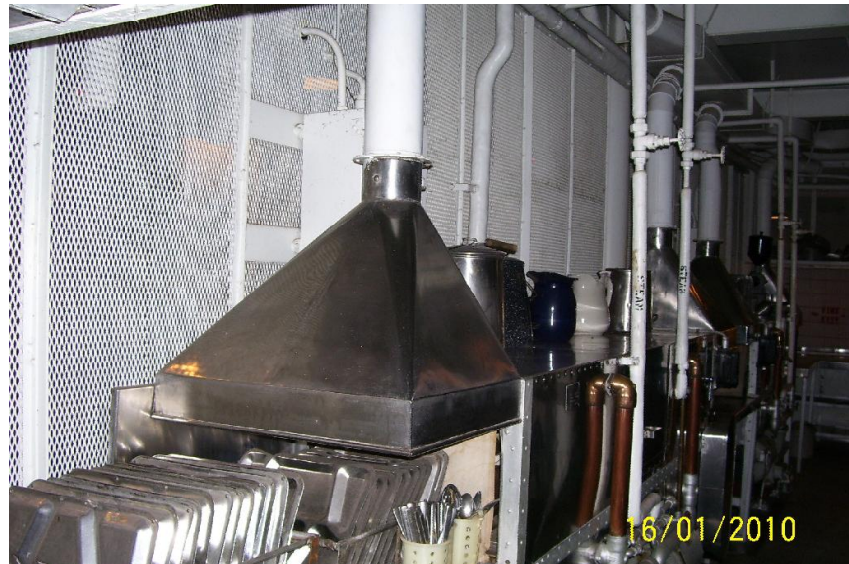
Looking aft in scullery Frame 131

Figure 101 – Hit 26 – Scullery near Frame 131 on USS Alabama
Photograph of USS Alabama copyrighted by Robert Lundgren

Figure 101 shows the scullery looking aft. The wire screen is at Frame 131. Fragments ripped through this area damaging the kitchen supplies.

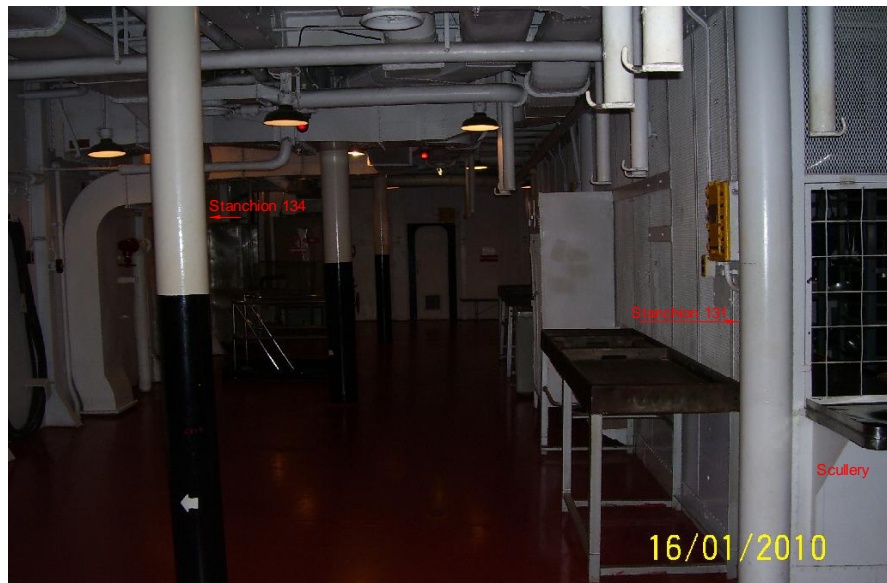
Figure 102 – Hit 26 – Aft of Scullery on USS Alabama
Photograph of USS Alabama copyrighted by Robert Lundgren

Figure 102 shows the compartment aft of the scullery. Both Stanchion 131 and Stanchion 134 on *South Dakota* took damage as did the ventilation ducts seen in the overhead.

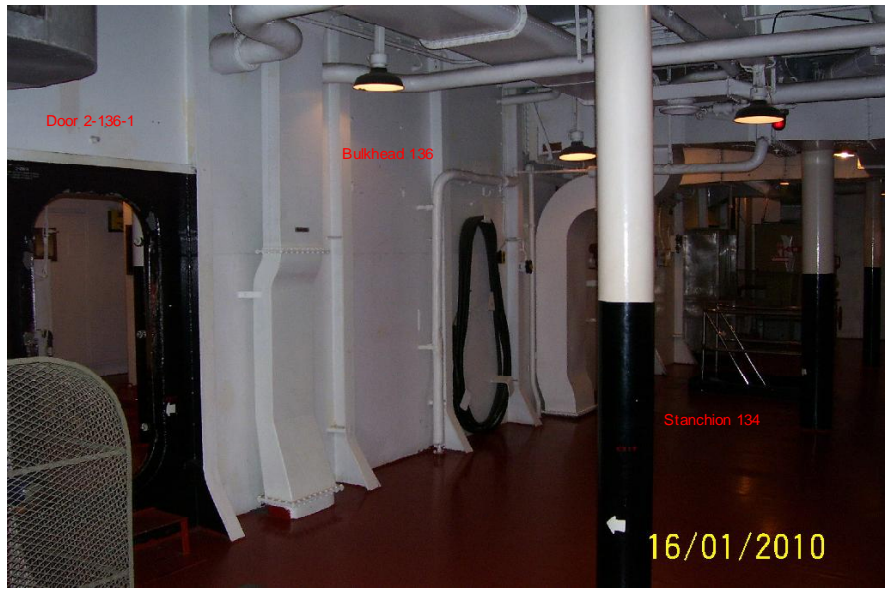
Figure 103 – Hit 26 – Bulkhead 136 on USS *Alabama*
Photograph of USS *Alabama* copyrighted by Robert Lundgren

Figure 103 shows Bulkhead 136 and Door 2-136-1 which were both damaged by fragments. Bulkhead 136 was the farthest that any fragments traveled from the blast point on the barbette, some of which penetrated this bulkhead.

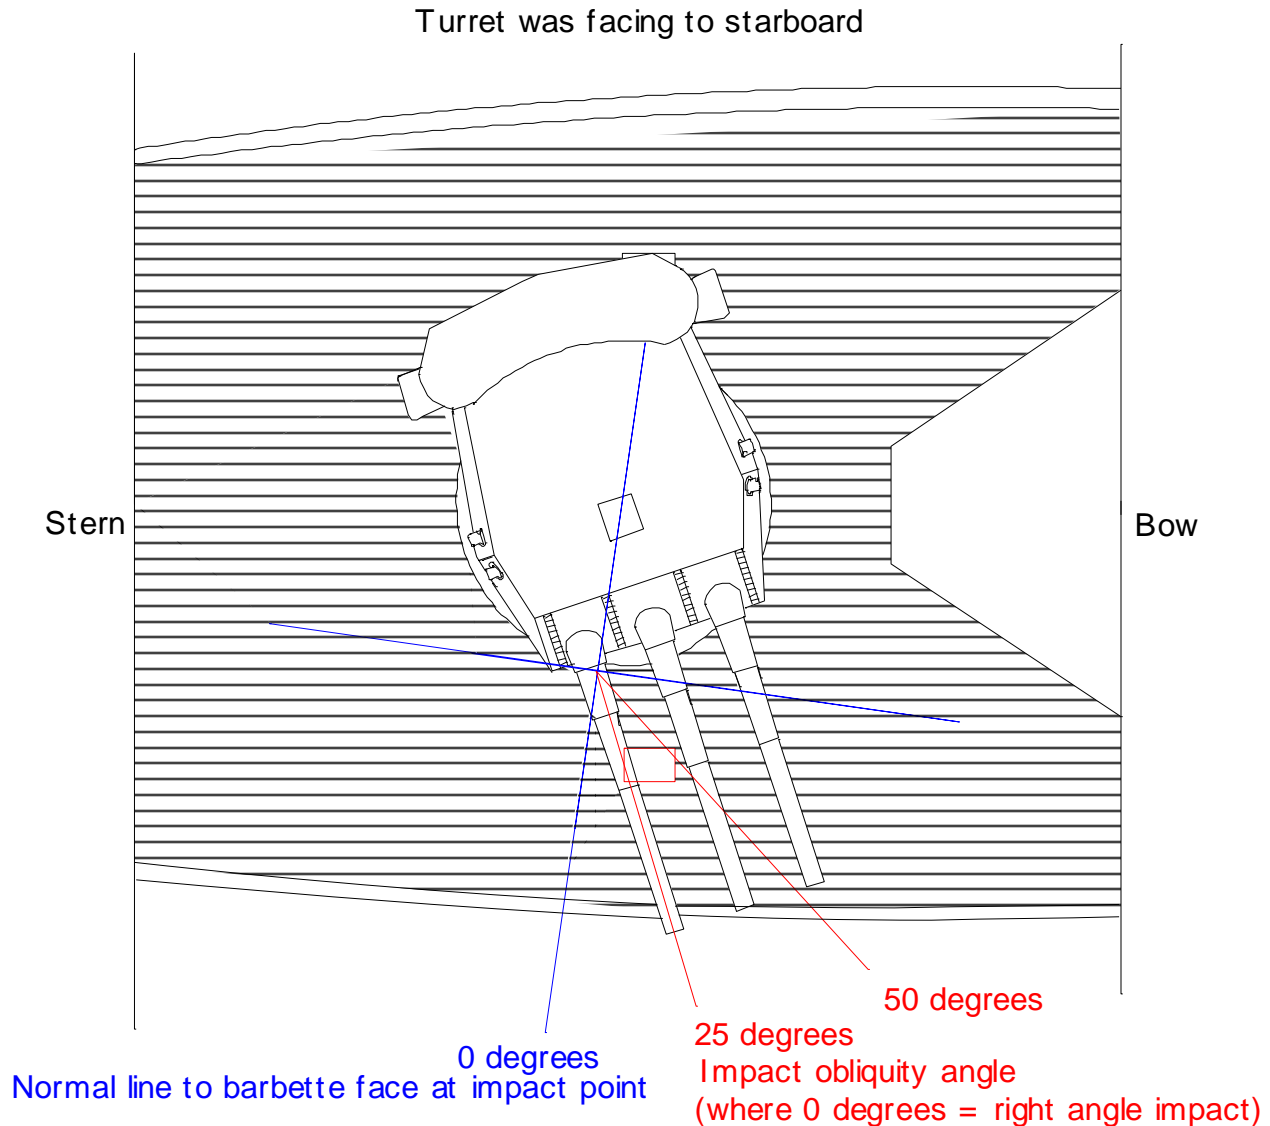
Determining the true shell trajectory was one of the first obstacles for the analysis of this impact. BuShips assertion that the projectile passed through Hatch 1-122 and then struck the barquette gives us two impact points on the ship from which we can determine which impact obliquity angles were possible and then using the track chart for the ships movements determine the range and time *Kirishima*, the hatch, and the barquette line up. The hatch begins at Frame 122 and ends at Frame 124. The center seam of the barquette is at Frame 123.5 with the projectile hitting the barquette just aft of the center seam. Zero degrees is the normal line to the barquette face at a right angle to the impact site. For the shell to pass through this hatch and strike where it did on the barquette, it can be shown that the range of possible impact angles runs from +25 to +50 degrees as illustrated in Figure 105.

Figure 105 – Hit 26 – Shell Trajectories and Impact Point if shell hit Hatch 1-122

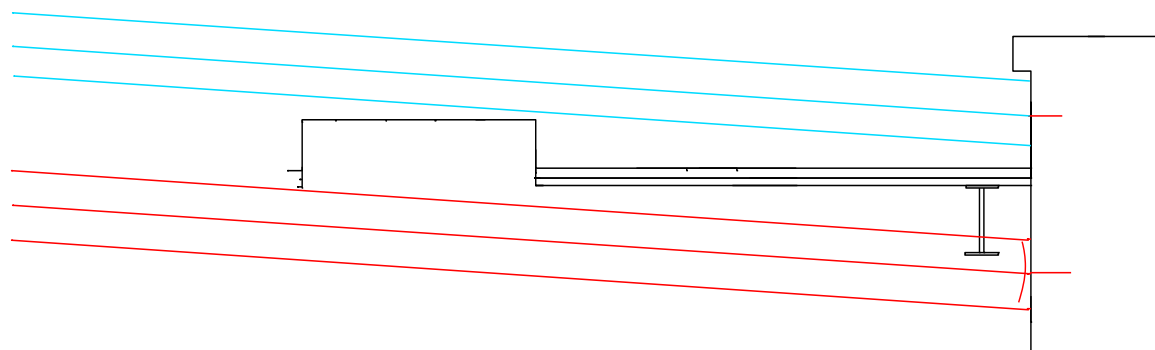
Figure 106 – Hit 26 – Shell Trajectories and Hatch 1-122

If the projectile impacted the upper scar implied by the original BuShips report and if *South Dakota* was on an even keel (no documented turn between 0101 and 0103), then with a 4 degree angle of fall a 14-inch projectile will miss the hatch entirely. The light blue lines in Figure 106 represent a 14-inch shell impacting the upper scar and the red lines represent it impacting at the lower scar. In the case of the lower scar, the shell would have impacted the deck prior to the hatch.¹⁰⁸ It is, however, the lower impact scar which is the main impact site. The gouge is 1.5 inches deep with the major shock cracks radiating out from this site.

In fact, there is no trajectory at the ranges where this battle took place which will allow the hatch to be hit and the projectile impact the barbette where the photographs show us it occurred and still duplicate the damage documented in the reports. It becomes clear that the original assertion made by BuShips that the shell passed through Hatch 1-122 on its way to the barbette must be incorrect.

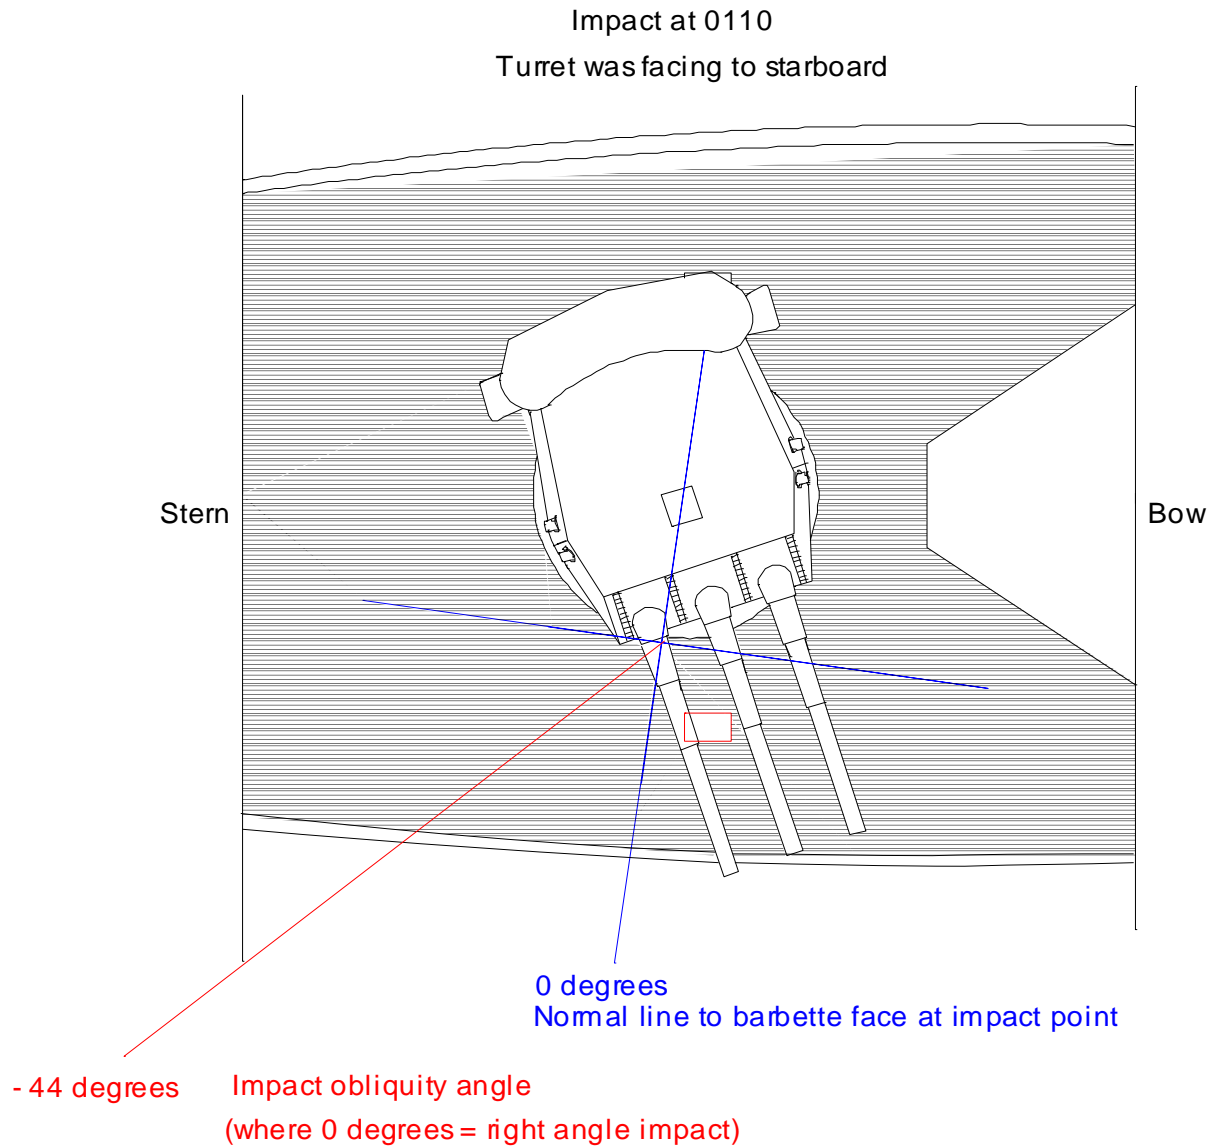
The new horizontal impact obliquity angle on the barbette for the lower pit is circa 44 degrees. This is from the computation that *Kirishima* is 62 degrees true from *South Dakota* and *South Dakota* is on a course of 285 degrees true, which gives an angle of 62 degrees - (285 + 90 - 360 for the transverse centerline of the barbette at right angles to the wood deck planks) - (3 degrees for the actual impact point on the barbette a few feet aft of this centerline) = 62 - 15 - 3 = 62 - 18 = 44 degrees horizontal impact obliquity on barbette face. This scenario is shown in Figure 107.

Figure 107 – Hit 26 – Shell Trajectories if shell did not hit Hatch 1-122

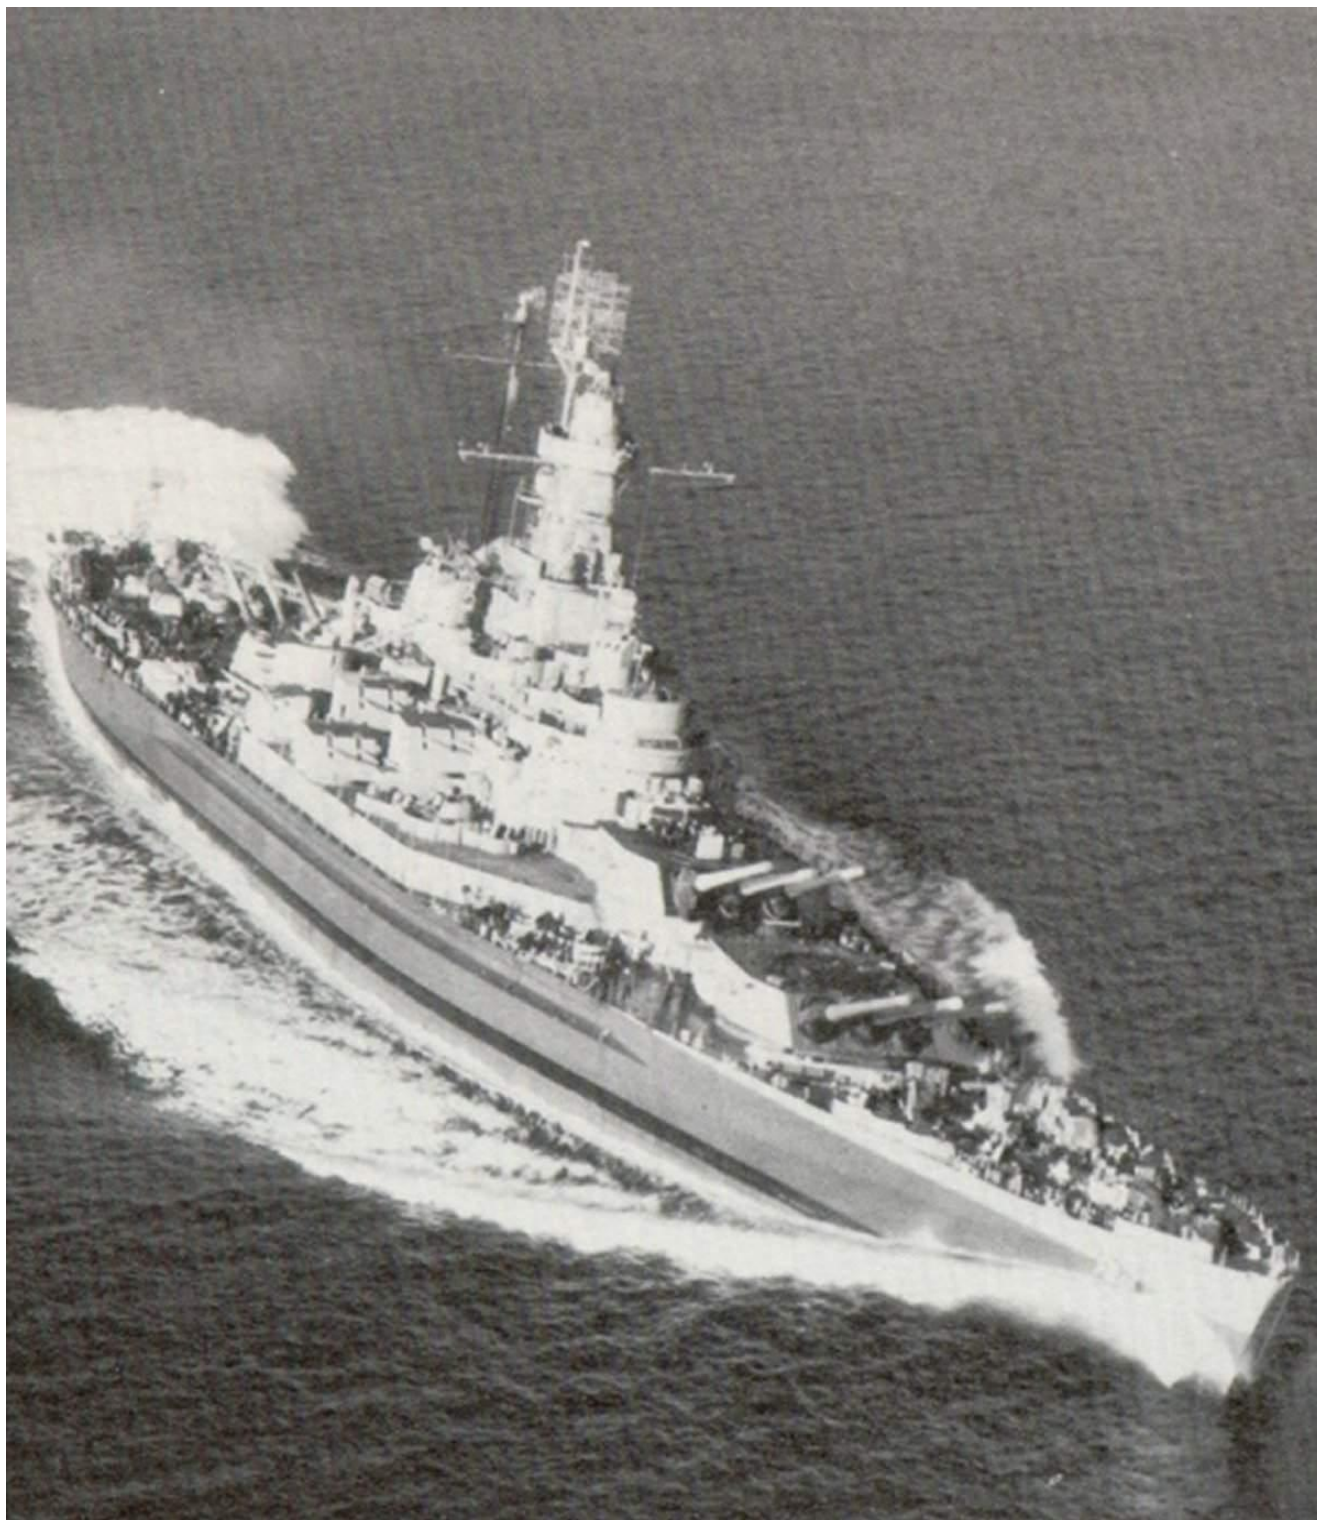
South Dakota is making a turn at this moment at flank speed. She will heel over to port as she turns from 285 degrees to 235 degrees. The two following photographs show USS *Indiana* in a high speed turn heeling to port. We estimate that the absolute maximum heel angle for the *South Dakota* class battleships under these conditions was 9.5 degrees.

Figure 108 – Hit 26 – Starboard side view of USS *Indiana* heeling during turn
USN Photograph courtesy of NavSource.com

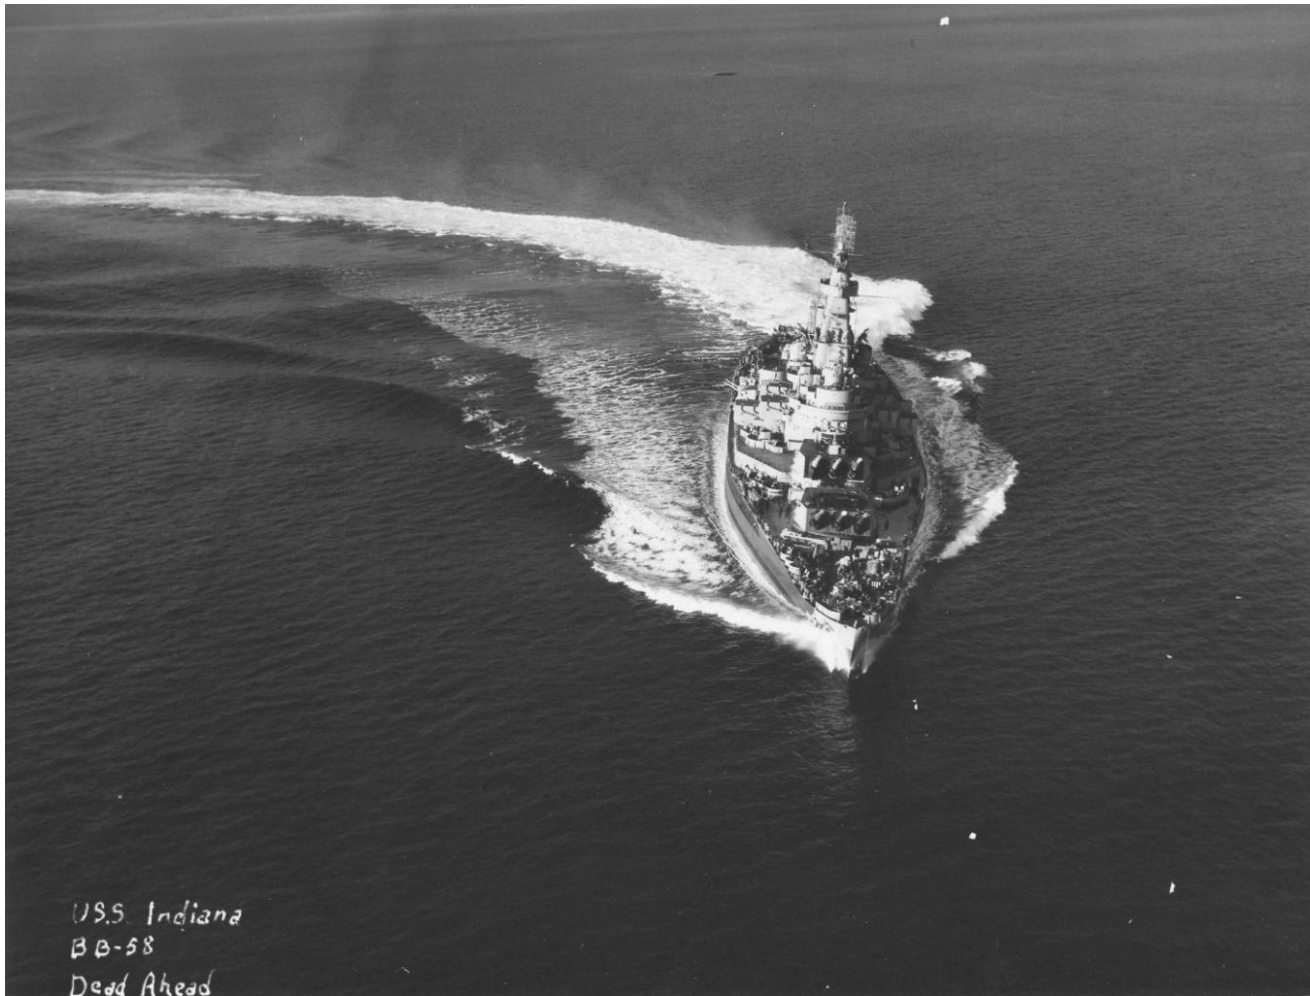
Figure 109 – Hit 26 – Bow view of USS *Indiana* heeling during turn
USN Photograph courtesy of NavSource.com

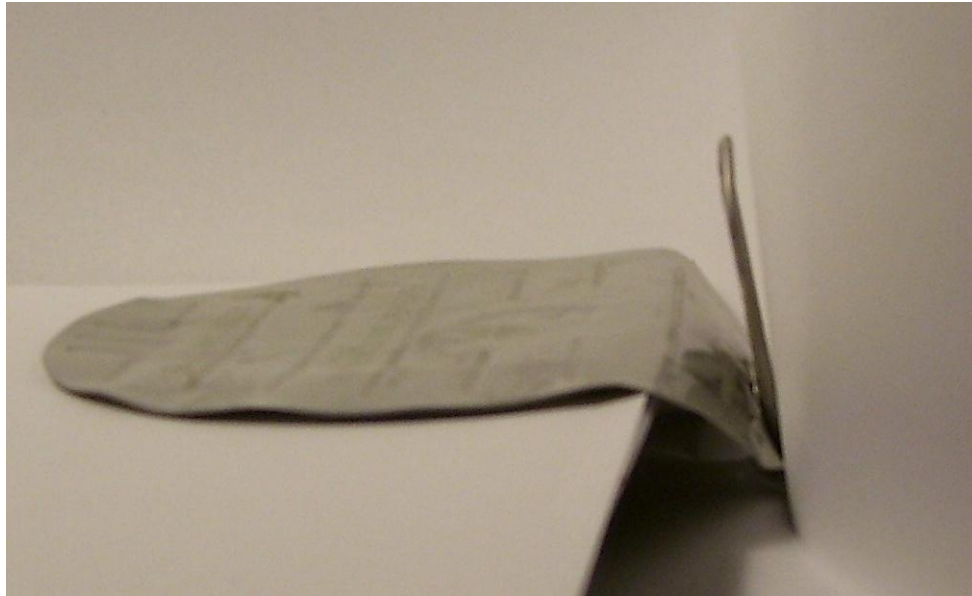
The best estimate for the shell type that resulted in this damage is a 14-inch Type 1 AP projectile. The main deck was not blown down due to an explosive force but pushed down by the weight, velocity, and frontal density of the projectile impacting the deck. The wood deck overhang seen in Figure 89 again shows us how the steel was pushed down from under the wood. The shell impacting the deck approximately 78 inches away begins to bend the deck down and tear the weather seal and riveted structure away from the surface of the barbette. A simple analogy is the pull tab on a large soup can. When you lift the tab up the front edge of the tab forces the lid's lip into a large "smiley-face" arc. In the case of the barbette, the arc is in the opposite direction because the deck is outside the barbette and the lid for the soup can is on the inside of the can but the principle is the same.

Figure 110 – Hit 26 – Tin Can demonstration of AP projectile impact

Replace Pull Tab with AP projectile and the principles remain the same.

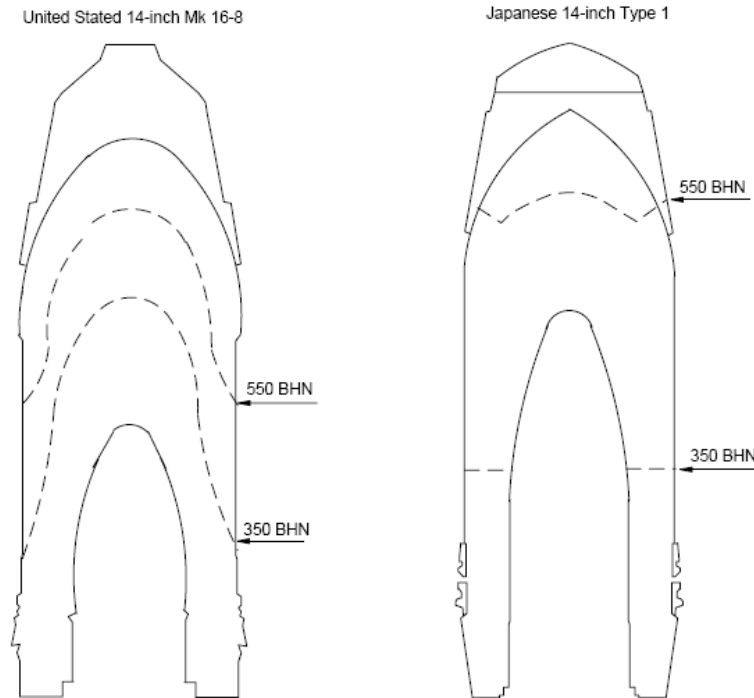
The lower body of the projectile pivots up as the nose is forced down until the projectile is, in effect, standing on its nose with the broken tip sticking into the space beneath the bent weather deck and the base slammed up against the barbette near that upper “blemish” point just below the turret. This base-end rotation is so fast and violent that it is like a baseball bat hitting a home run (a rather extreme form of “base slap,” as this lower body impact against the armor is termed in the US Navy). Since the armor's 1-inch-deep “cemented” face is about 650 Brinell hardness (approaching the hardness of hardened machine cutting tool steel), backed up by a circa 35% deep face of circa 500 Brinell, then another 20% dropping in a ski-slope curve to the circa 225 Brinell ductile back layer to the back surface of the plate (this last of “merely” bank vault steel hardness), the barbette armor face is essentially absolutely rigid and the rather soft lower body of the projectile flattens out against it as if the projectile was made from soft clay. A comparison of USN and Japanese hardening patterns for 14-inch AP projectiles is shown below in Figure 111.

Figure 111 – Hit 26 – Differences between USA and Japanese 14-inch projectiles

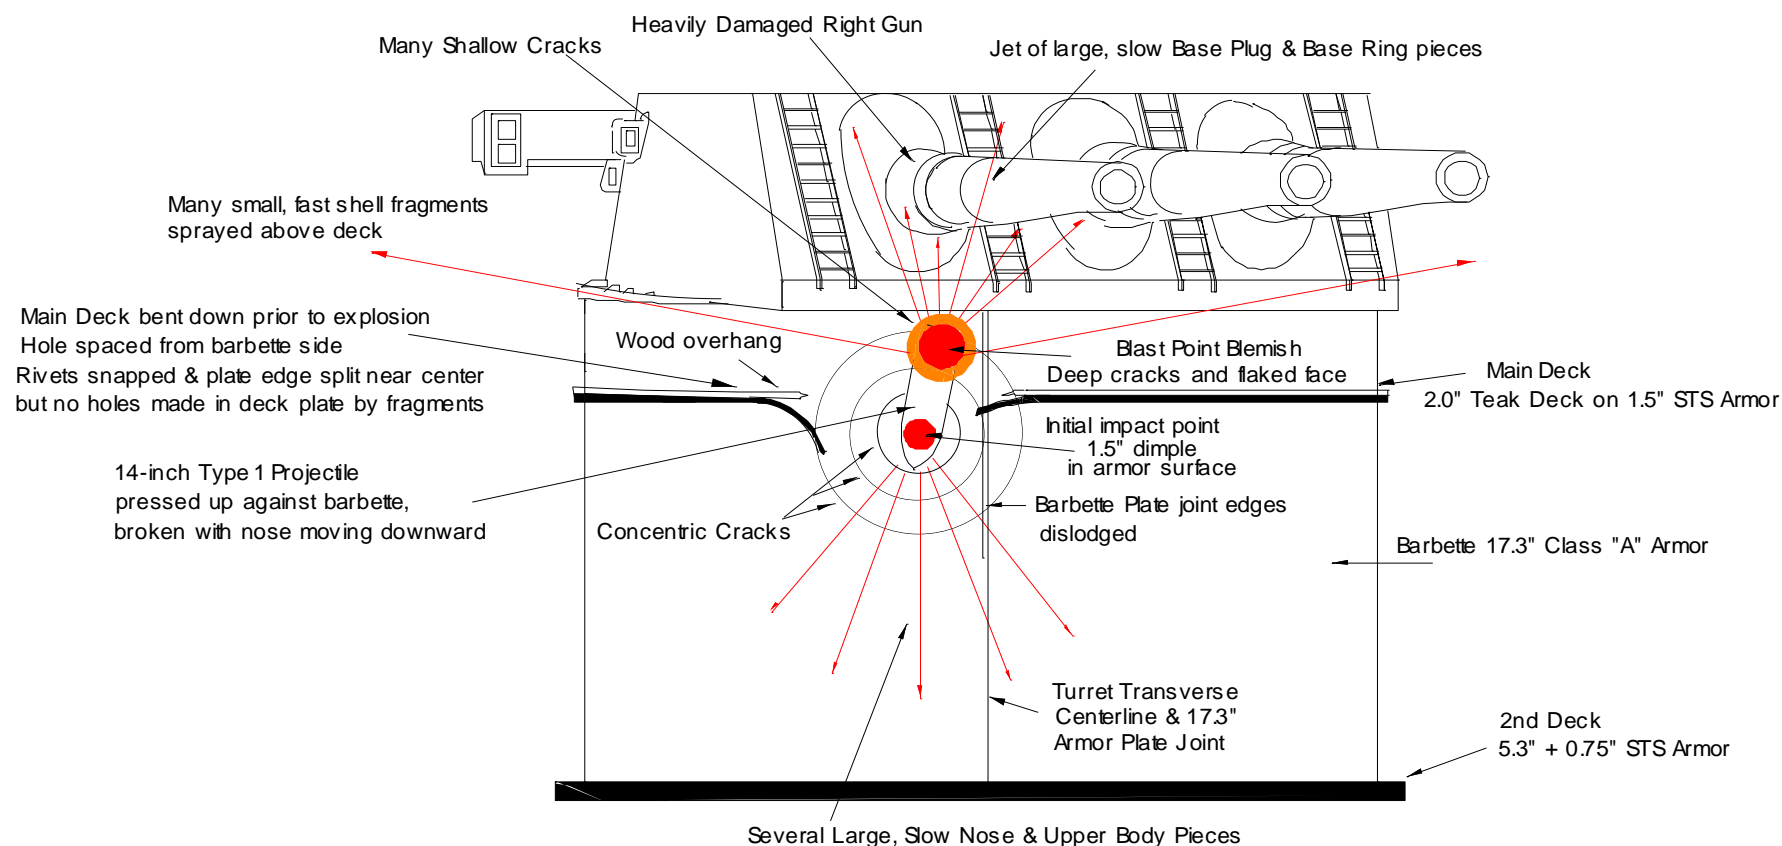
Figure 112 – Hit 26 – Base Slap Diagram

With half of the shell below the main deck and the other half above the main deck and the shell in a vertical position pressed up against the barbette, we get the above main deck fragment pattern described in the report. The right gun was probably directly over the blast point with the base fragments being blasted up into the gun sleeve.

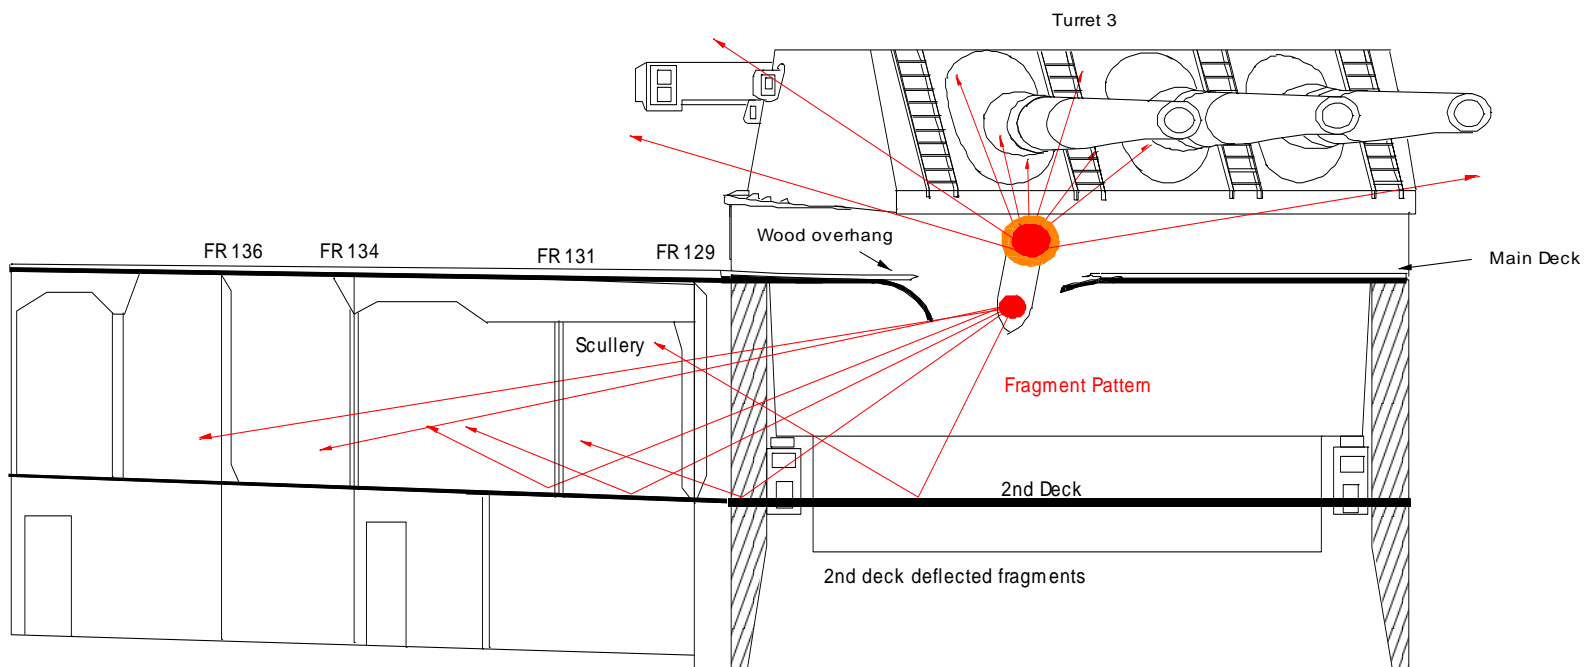
Figure 113 – Hit 26 – Fragment Damage Pattern below the Main Deck

The fragment pattern below the main deck is largely traveling aft due to the curvature of the barbet as shown above in Figure 113 and earlier in Figure 100. The size of the fragments that would create the holes in bulkhead 129 as seen in Figure 97 are huge but are also relatively few in number. These could only have been produced by the large nose pieces of a fragmented AP projectile. The armored second deck deflected all fragments and some of these fragments had enough mass and energy to be able to penetrate bulkheads as far aft as bulkhead 136.

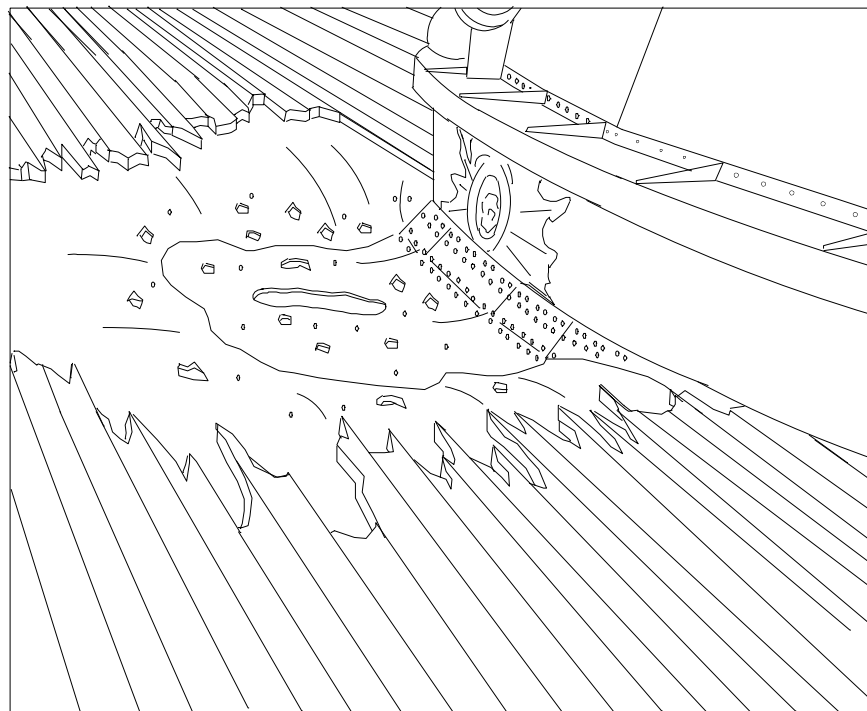
For the Type 0 HE, the way the BuShips damage report originally described this impact as passing through Hatch 1-122, impacting the barbette 17 inches from the top, and then detonating and blowing a 3 foot by 10 foot hole into the deck, has led many to believe this impact was made by a HE projectile. A closer examination of this idea as described above shows why this is not possible. Had a HE shell detonated horizontally to the deck, the damage around the barbette would have been greatly different. The impact from this type of shell would have given a shallow oval dent over a wider area, with no wood left for several feet on all sides, especially sideways. It would have created a small, irregular, roughly oval hole in the deck under the center of the shell, surrounded by many tiny holes and dents up close to the big hole which would have been caused by fragments going mostly sideways. The deck edge up against the barbette would have been bent up slightly as it had the most reinforcement from underneath and it would not have been bent down as much as directly under the explosion point. There would not have been any way for any projectile pieces other than a few tiny middle-body fragments from going below the weather deck, with only deck pieces blown out causing any major damage below the deck, and those being thrown straight down, not sideways. The likely damage caused by a HE shell is shown in Figure 114.

Figure 114 – Hit 26 – Projected Shape of Hole if HE Projectile Detonated over Deck

A Type 0 HE projectile is 4 feet long which places the center of the explosive force two feet away from the barbette surface. If the shell struck the upper impact scar 17 inches from the top of the barbette, then it would produce an open air explosion over the deck which would have caused the deck to dish. There would be no wood overhanging where the steel is bent down and the 64-pound TNA filler is not powerful enough to produce a 10 to 12 foot long hole in the 1.5-inch STS steel deck. The shell body of a HE

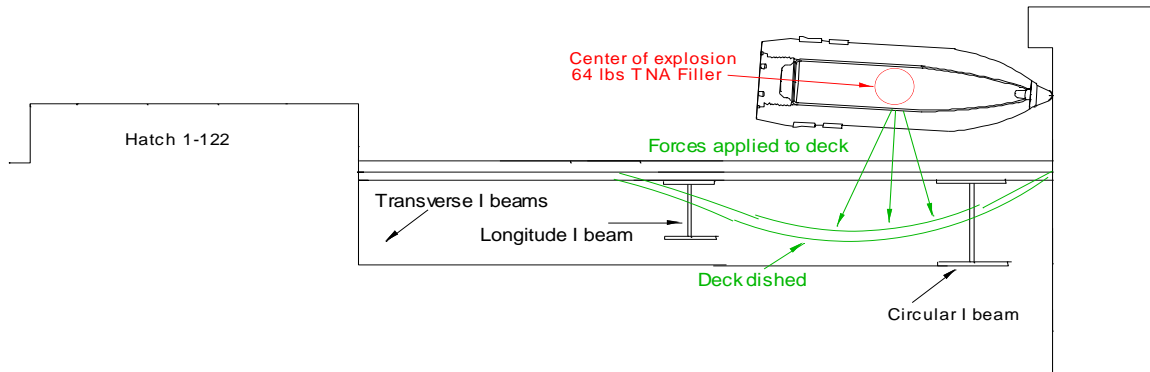
Figure 115 – Hit 26 – Likely Damage from HE Projectile Detonating over Main Deck

projectile will never reach the barbette because when the fuze is crushed the shell will destroy itself almost instantaneously.

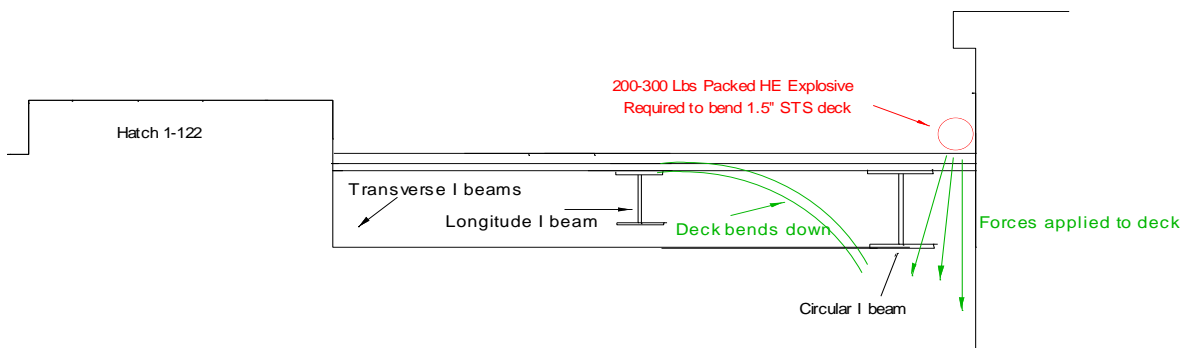
Figure 116 – Hit 26 – Explosive Force required to bend Main Deck

For the deck to get bent down and the hole to be directly up against the barbette surface due to an explosive force, the center of the charge must be placed directly up against the barbette and on the deck. The charge weight to produce such a large hole between 10 and 12 feet long in the 1.5-inch STS steel would need to be in the order of 200-300 lbs. of HE explosive. This size burster is impossible for a Japanese 14-inch Type 0 projectile.
